BUTTAI QUARRY

ANNUAL ENVIRONMENTAL MANAGEMENT REPORT (AEMR)

2021

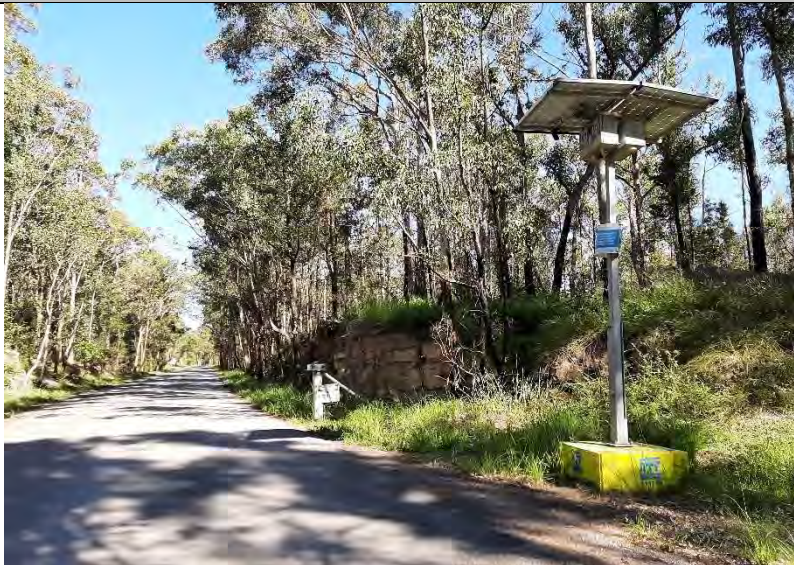
No.	Location (Area / description)	Issue / Comment	Recommended priority	Action	Close out date		
1	Buttai Quarry

N/A	Nil – At the time of inspection, there was no evidence of dust generation on site. A number of alarmed security cameras are located in strategic locations on site to deter trespassing – Positive observations.	N/A

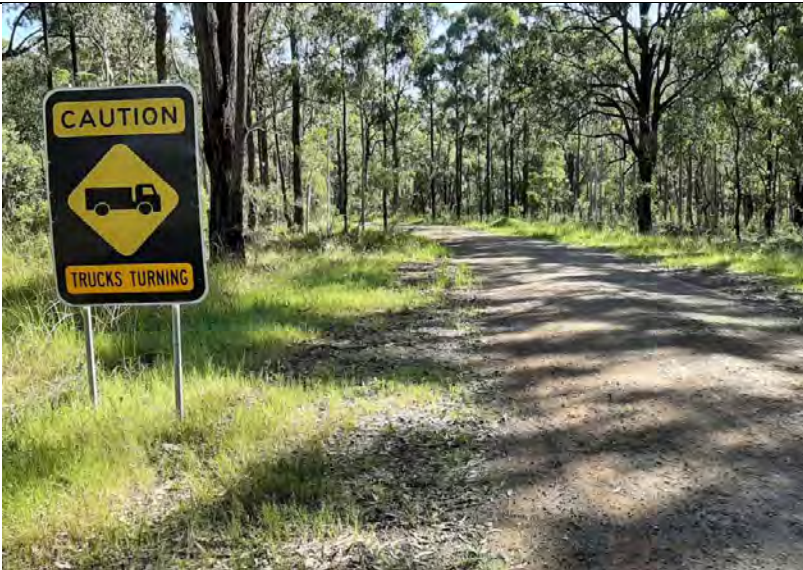
2	Old Buttai Road and quarry access road

N/A	<p>Nil – Appropriate signage and “call-up” points are present and visible along the access route. Additionally, the bitumen sealed sections of the access road are well maintained reducing the risk of erosion and dust generation. Large “trucks turning” signs installed at approach to the intersection with Old Buttai Rd - Positive observations.</p>	N/A
---	--	--	-----	---	-----

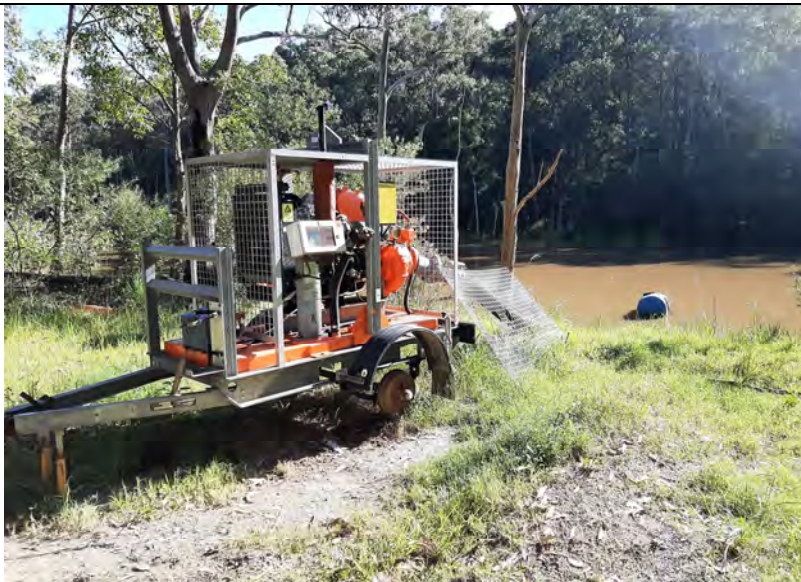
4	Dam #4

N/A	Nil – Dam #4 is carefully managed to ensure there is enough water available for the site to operate effectively whilst also ensuring that water does not discharge from Dam #4 – Positive observations.	N/A
5	Stockpile on the eastern side of the quarry pit “Lot 76” area

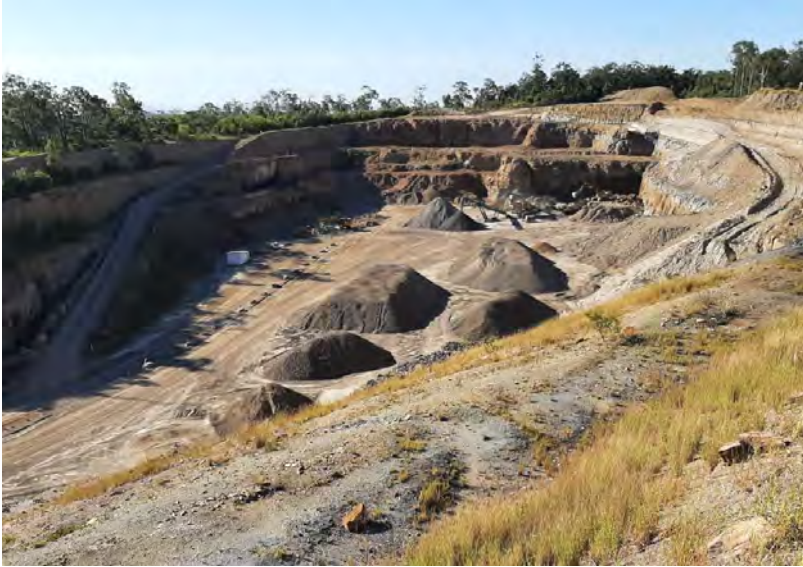
6	Stockpile and crushing areas

N/A	Nil – Both the stockpile and crushing areas were tidy with no evidence of dust generation at the time of inspection – Positive observations.	N/A
---	------------------------------	--	-----	--	-----

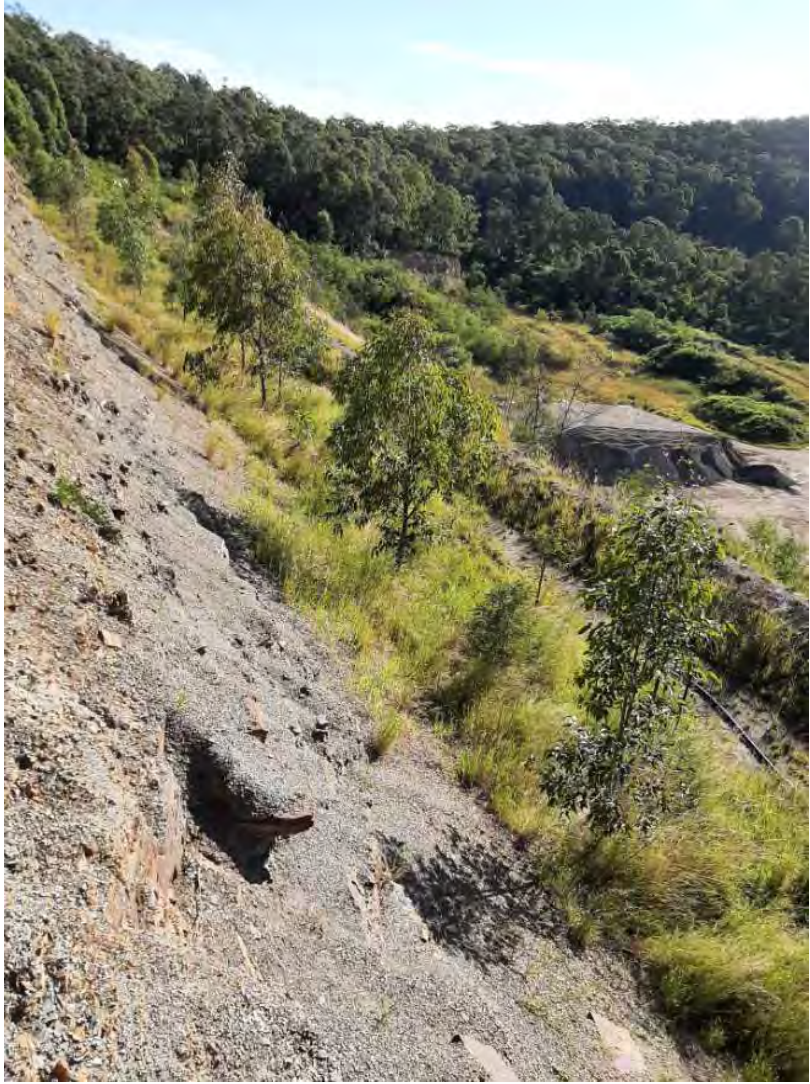
9	Bench #3 rehab' work

N/A	Nil - As before, Bench #3 rehabilitation continues to progress effectively with the planted vegetation now well established – Positive observation.	N/A
---	----------------------	---	-----	---	-----

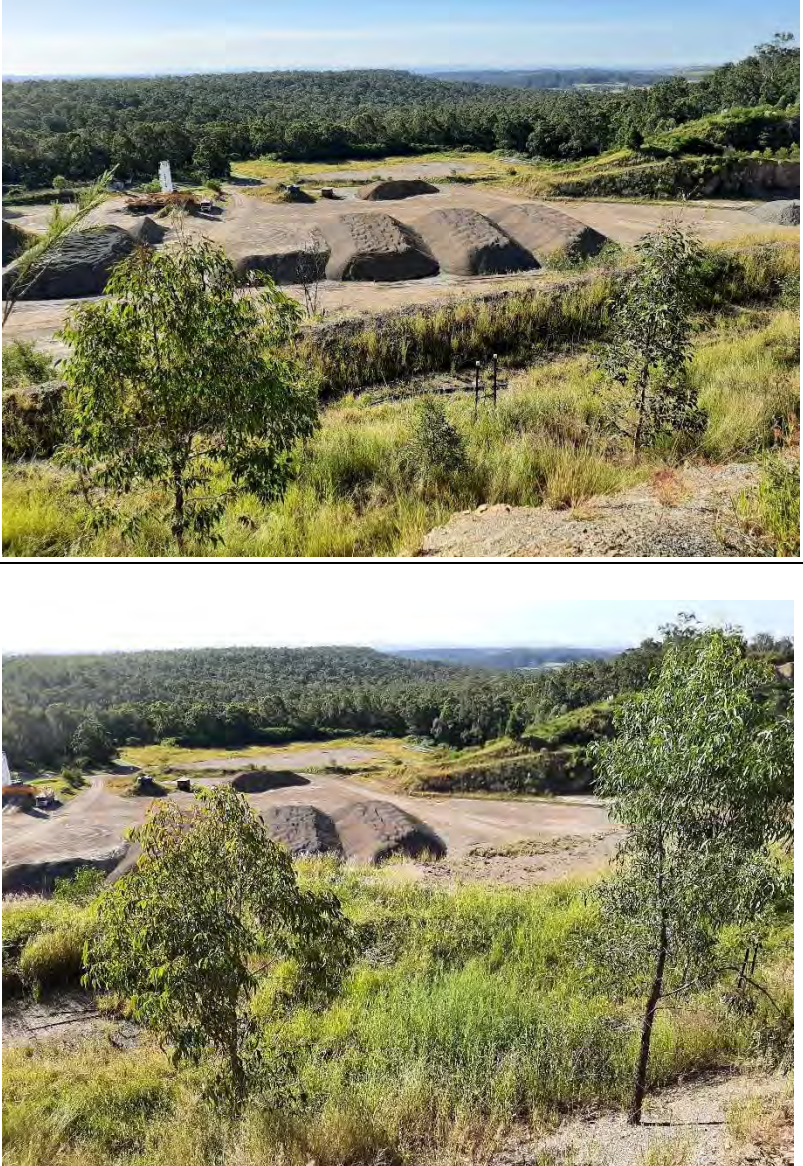
10	<p>MORE</p> <p>Bench #3 rehab' work looking north towards John Renshaw Dve standing on Bench #2 with Bench #3 in the foreground</p>

N/A	Nil – Trees are progressing well in this area – Positive observation.	N/A
----	--	---	-----	---	-----

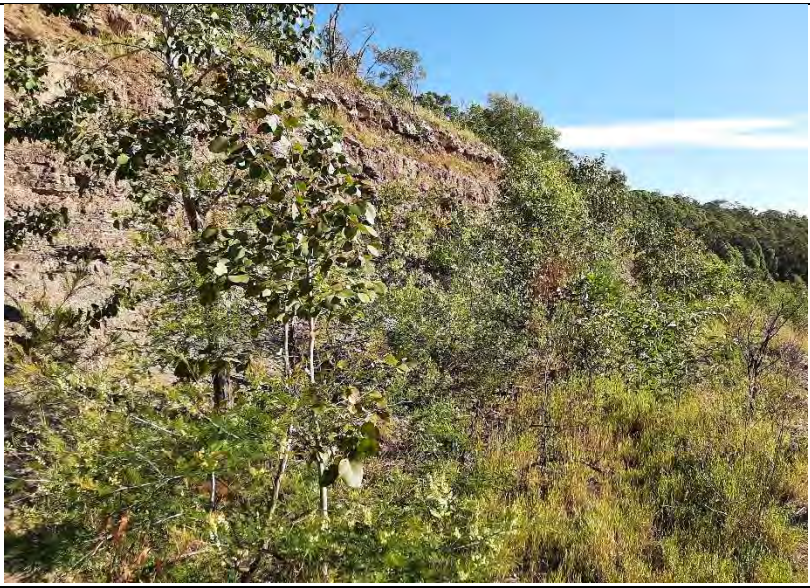
11	Bench #2 rehab' work

N/A	Nil – As before, Bench #2 rehabilitation continues to progress and evolve with the older species selectively dying off and being replaced with natural regeneration over time – Positive observation.	N/A
12	Panoramic image of the quarry – Looking north along Bench #2

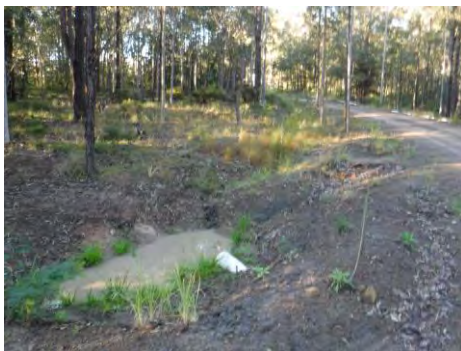
1.	Dam 4.	The area around Dam 4 was inspected. The controls adjacent to the haul road remain in position and functional. Water in Dam 4 continues to be transferred to dams in the upper floor of the quarry.		The controls in the area remain functional and no actions are required.

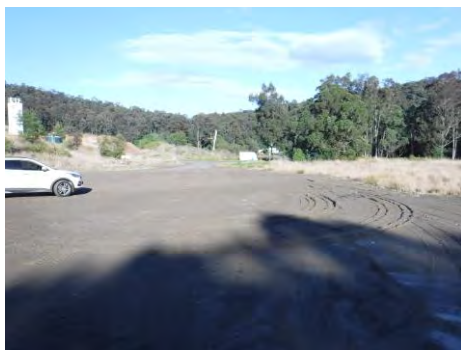
2.	Proposed Resource Recovery Facility (RRF).	Preparations are underway for the proposed Resource Recovery Facility (RRF). The main operational area of the RRF will be regraded to shed runoff toward the east which will drain through the central drainage system.		As discussed, continue to plan, and implement measures and controls to mitigate potential impacts to air and water quality from the proposed RRF operations.

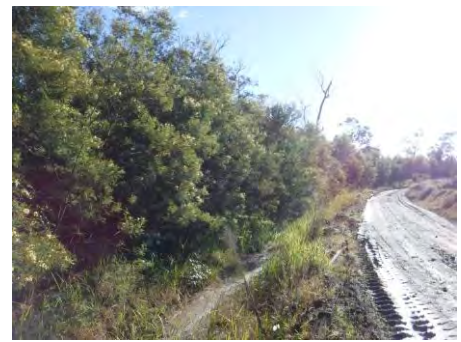
3.	North-western bund.	The area along the previously rehabilitated north-western bund was inspected. The onset of the rehabilitation plantings was noted to be well established and the area is fully vegetated. The cut-off drain above the access ramp continues to convey and filter run-off before directing flows back into the quarry floor.		The controls in the area remain functional and no actions are required.

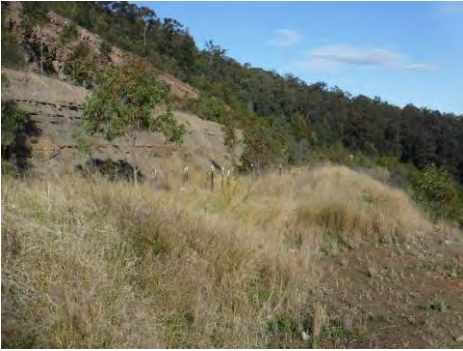
ISSUE NO.	LOCATION	ISSUE/MATTER	RECOMMENDATION/COMMENT	PHOTOGRAPH
4.	Bench 2 and Bench 3 rehabilitation areas.	The revegetation along Bench 2 and Bench 3 was inspected. The rehabilitation plantings are well established in most areas however a few isolated areas remain where the onset of seedlings is impacted due to the aspect and weather impacts.	As discussed, we recommend considering harvesting seed bearing foliage from the adjacent vegetation and applying it as brush matting over any exposed soil areas or other areas where seedlings have poor establishment.

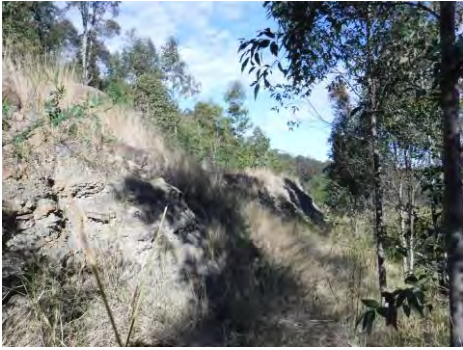
5.	Bench 2 and Bench 3 rehabilitation areas.	As noted above, the bench rehabilitation areas were inspected. The rehabilitation in the area is progressing well however some castor oil weed outbreak was noted in the northern section of Bench 3.	As discussed, continue to implement the periodic weed suppression, targeting the weed identified on Bench 3.

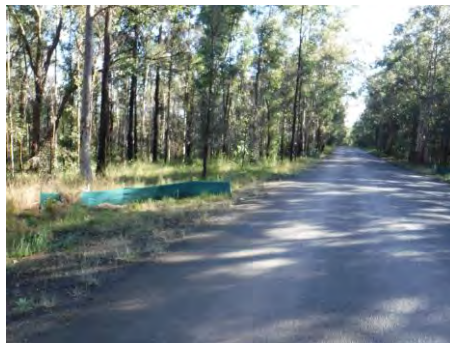
ISSUE NO.	LOCATION	ISSUE/MATTER	RECOMMENDATION/COMMENT	PHOTOGRAPH
7.	Main access road.	The areas along the main access road were inspected. The road is being well maintained and installed sediment controls are functional and in good condition.	As discussed, continue to monitor, implement, and maintain the controls to minimise erosion and improve runoff water quality.

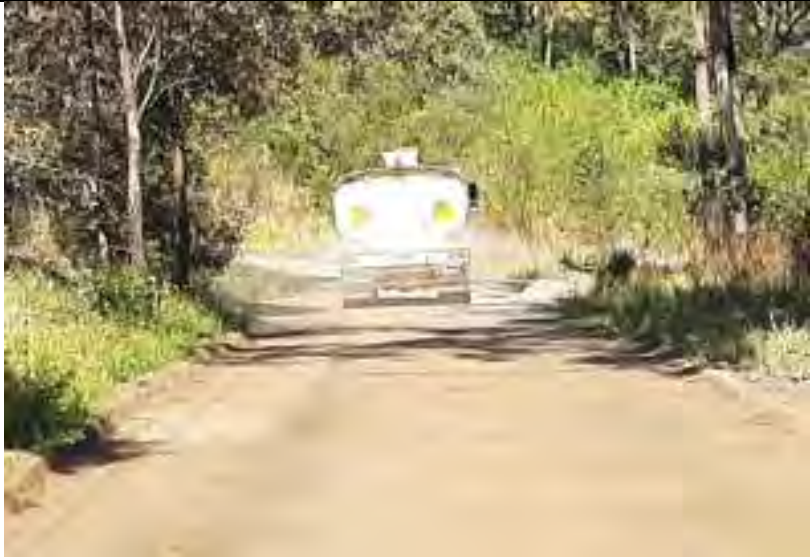
No.	Location (Area / description)	Issue / Comment	Recommended priority	Action	Close out date		
1	Buttai Quarry

N/A	Nil – At the time of inspection, there was no evidence of dust generation on site with watercart actively wetting all areas as required – Positive observations.	N/A

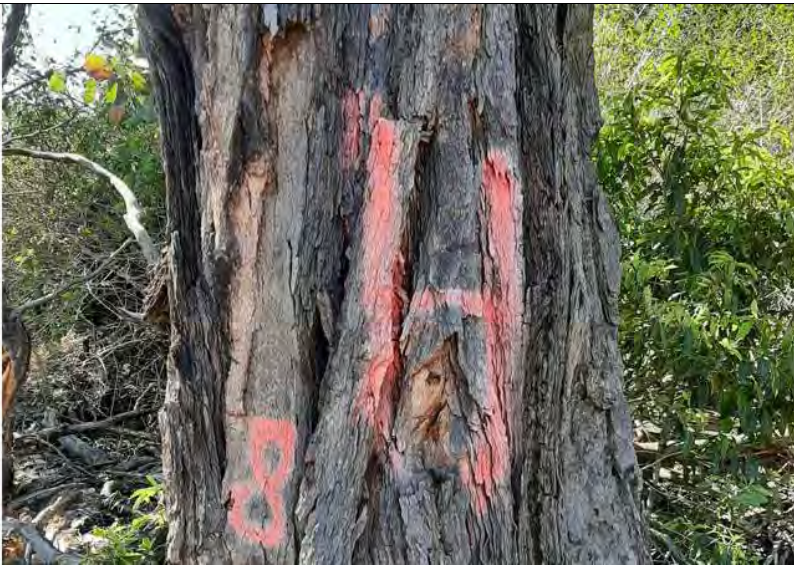
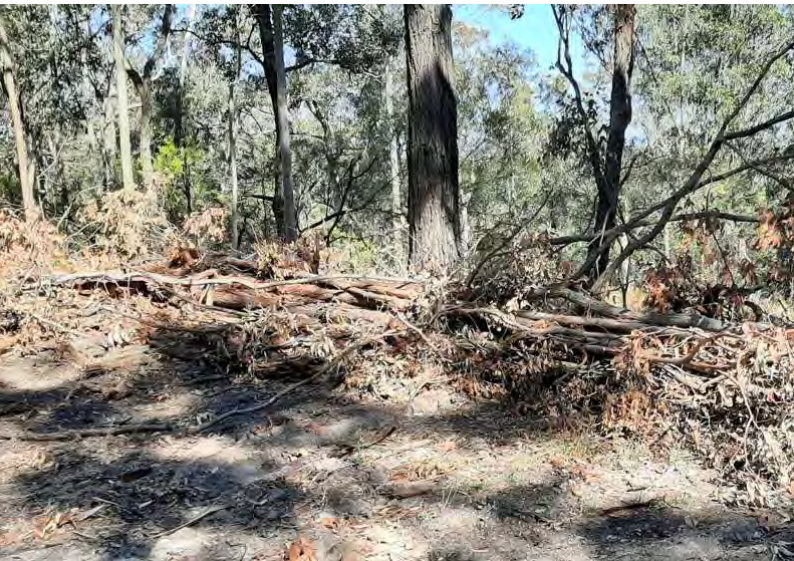
3	Quarry progress to the north of current active areas

N/A	<p>Nil – We recently engaged the services of Wild Thing Ecological Services (WTES) to inspect the vegetation to the north of current active area to allow the expansion of the quarry footprint. WTES inspected the area and marked the likely ‘habitat trees’ as shown in the image. Clearing had commenced at the time of inspection (excluding ‘habitat trees’ for now) with WTES to return when ‘habitat trees’ are to be felled. All felled trees were placed along the downstream edges to mitigate sedimentation issues – Positive observations.</p>	N/A
---	--	--	-----	---	-----

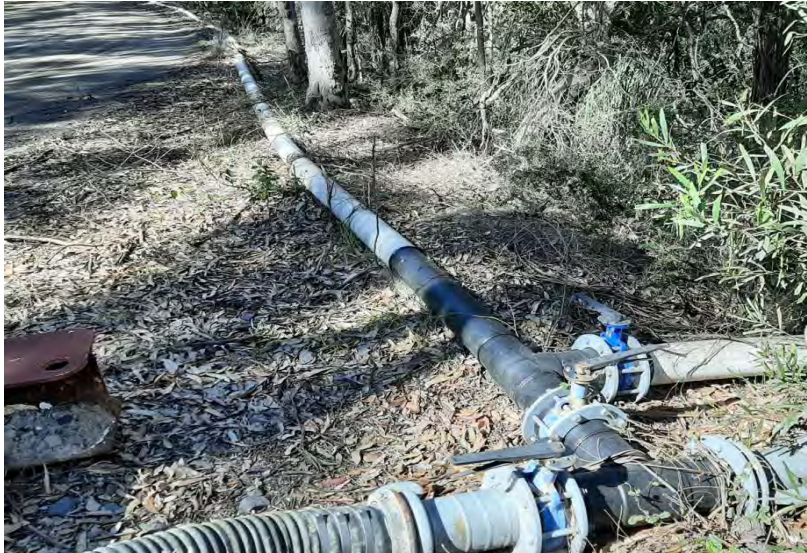
4	Dam #4

N/A	Nil – Dam #4 continues to be managed effectively to ensure water is available for the site to operate effectively whilst also ensuring that water does not discharge from Dam #4 by pumping back to other water storage areas on site when required – Positive observations.	N/A
---	--------	--	-----	--	-----

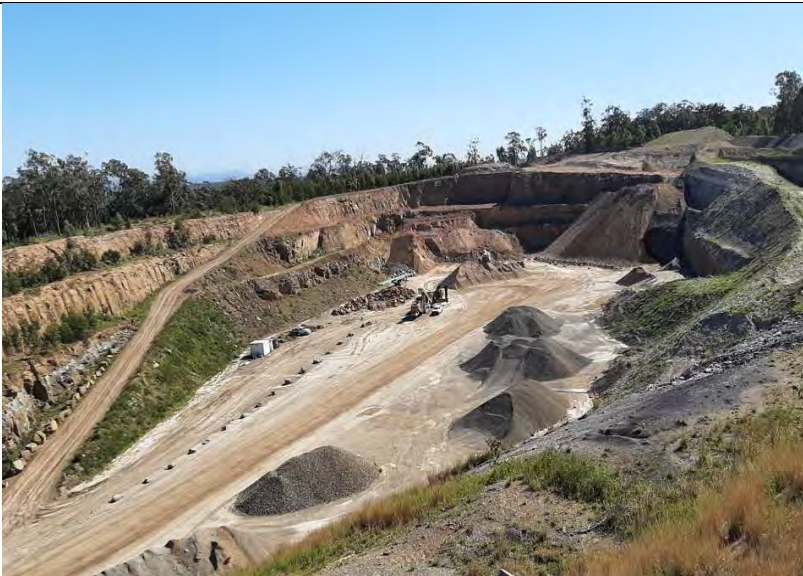
5	Stockpile and crushing areas

N/A	Nil – Both the stockpile and crushing areas were tidy with no evidence of dust generation at the time of inspection – Positive observations.	N/A
---	------------------------------	--	-----	--	-----

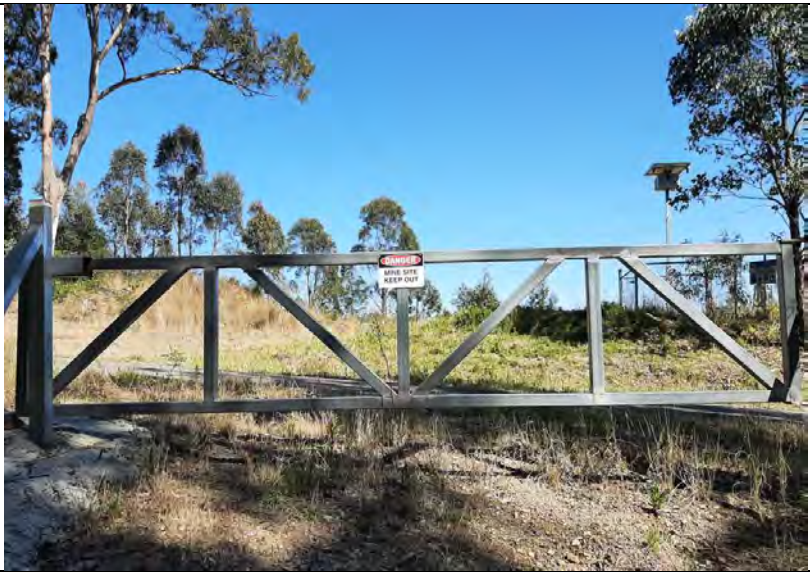
6	RFS access gate at top of quarry

N/A	Nil – The gate installed to allow access to the Rural Fire Service (RFS) if required is still intact and operating effectively. Appropriate signage installed – Positive observations.	N/A
7	Recently re-shaped batter along eastern edge of the quarry pit “Lot 76” area	 	Low	Seeding of the recently re-shaped eastern batter is required.	Completed 14/12/21 - LR

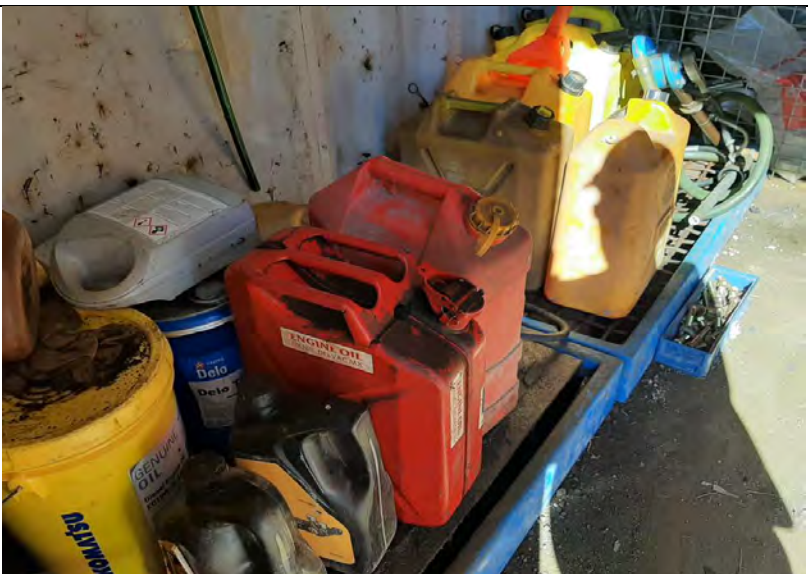
8	Chemical storage container

N/A	Nil – All relevant items were stored in a bunded area and were appropriately labelled. Spill kit was readily available – Positive observations.	N/A
---	----------------------------	--	-----	---	-----

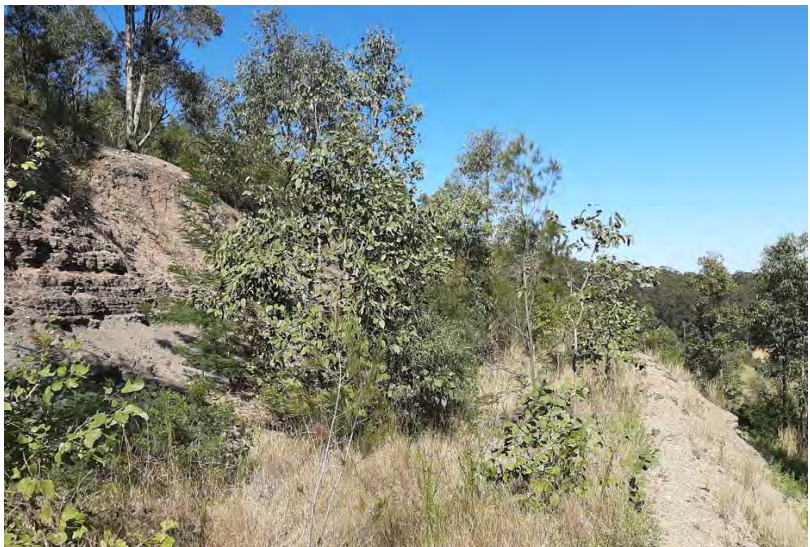
N/A	Nil – As before, Bench #2 rehabilitation continues to progress and evolve with the older species selectively dying off and being replaced with natural regeneration over time – Positive observation.	N/A

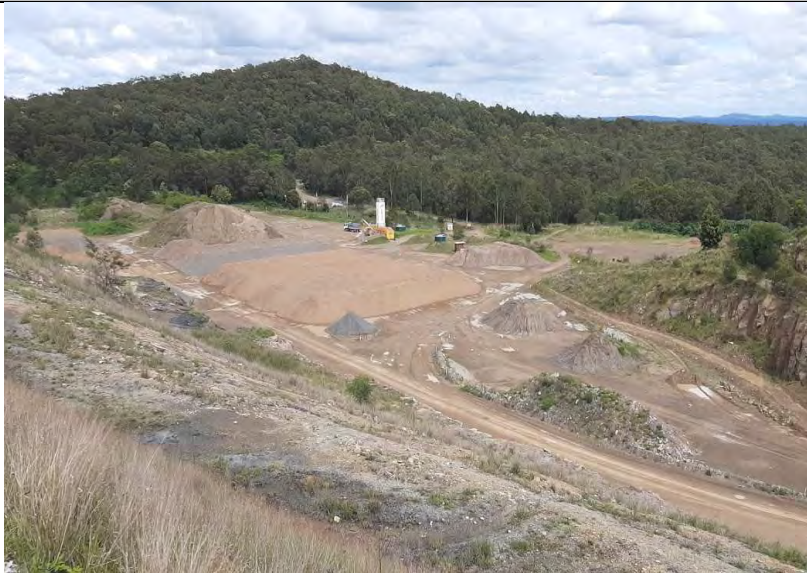
No.	Location (Area / description)	Issue / Comment	Recommended priority	Action	Close out date		
1	Buttai Quarry

N/A	Nil –There was no evidence of dust generation on site with recent rainfall assisting – Positive observations.	N/A

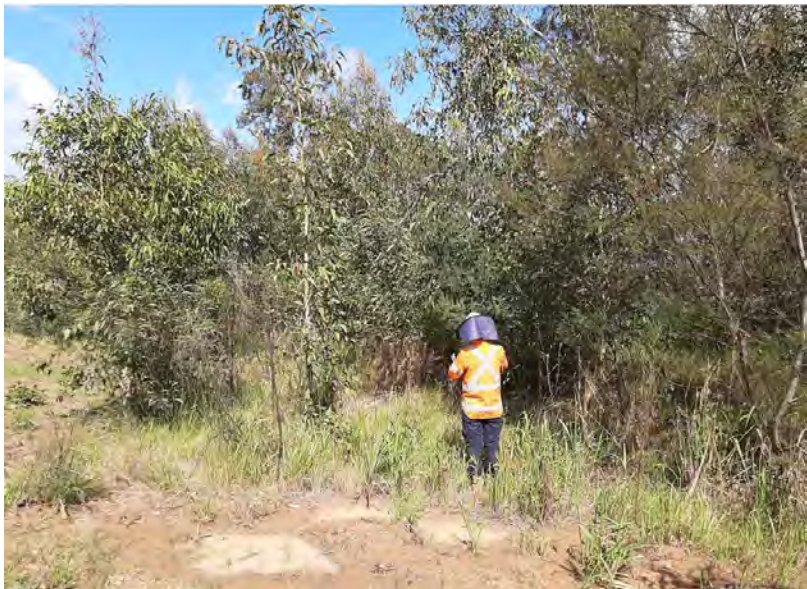
2	Rehab' area along western edge of the quarry pit "Lot 76" area

N/A	<p>Nil – As shown in the images, the western rehabilitation planting is progressing very well, with the naturally regenerated trees out growing the planted tube-stock. The annual rehabilitation inspection occurred at the same time as this inspection – Positive observation.</p>	N/A
---	---	--	-----	--	-----

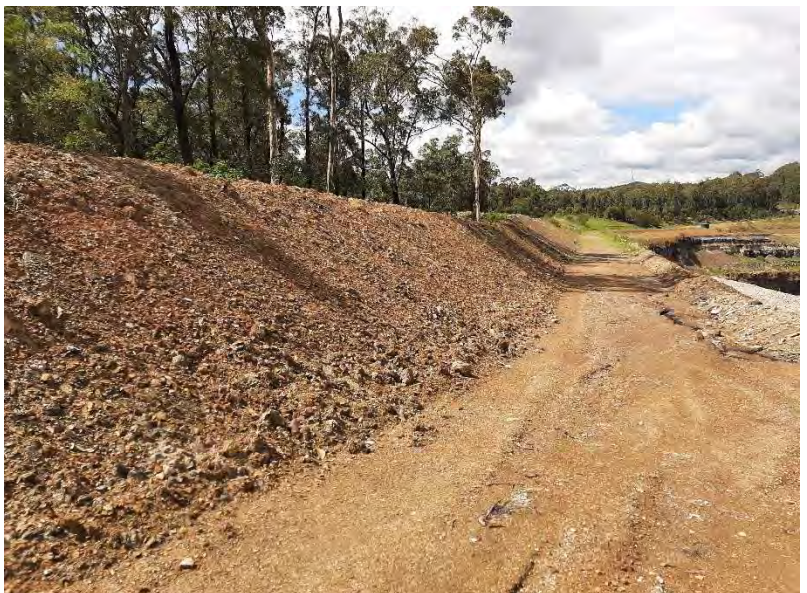
3	Recently re-shaped batter along eastern edge of the quarry pit "Lot 76" area

Medium	As previously described, the eastern batter was recently shaped and prepared for seeding. Seeding of the recently re-shaped eastern batter is required.	Completed 14/12/21 - LR
---	--	--	--------	---	-------------------------------

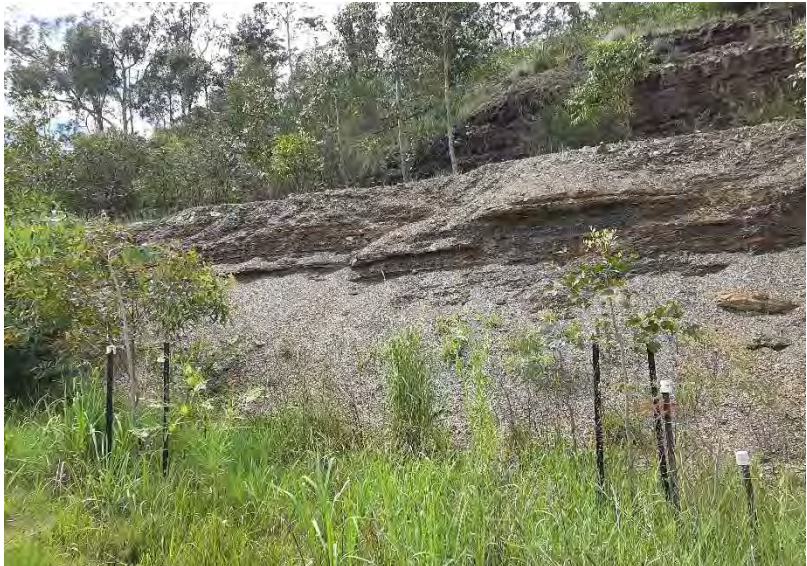
4	Bench #3 rehab' work

N/A	Nil –The Bench #3 rehab' planting is progressing adequately with the annual rehabilitation inspection occurring at the same time as this inspection – Positive observation.	N/A
---	----------------------	--	-----	---	-----

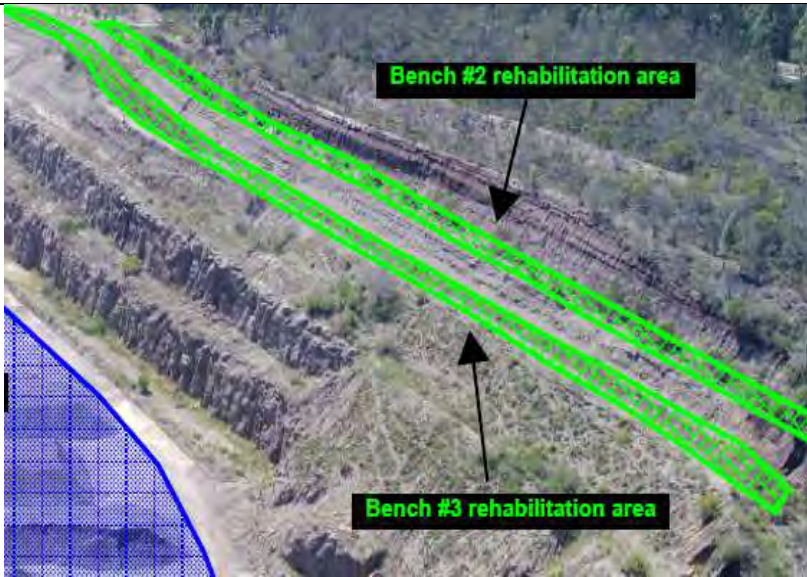
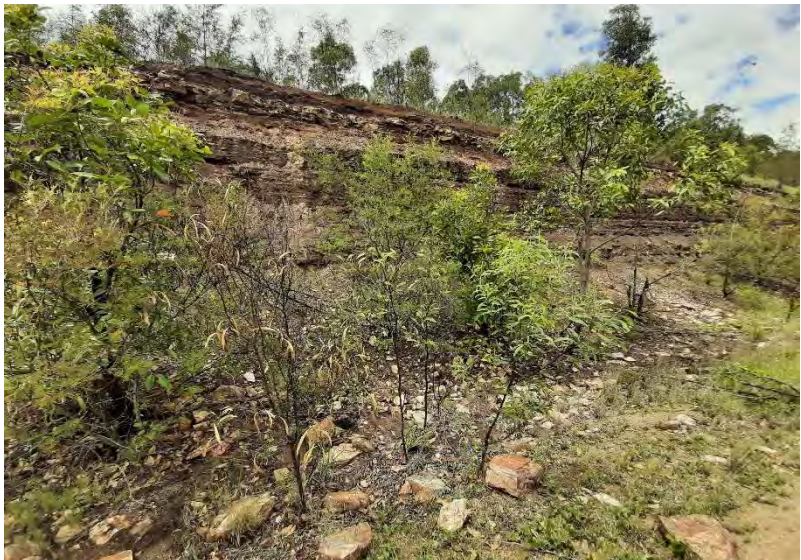
N/A	Nil –The Bench #2 rehab' planting is progressing adequately with the annual rehabilitation inspection occurring at the same time as this inspection – Positive observation.	N/A
---	----------------------	--	-----	---	-----

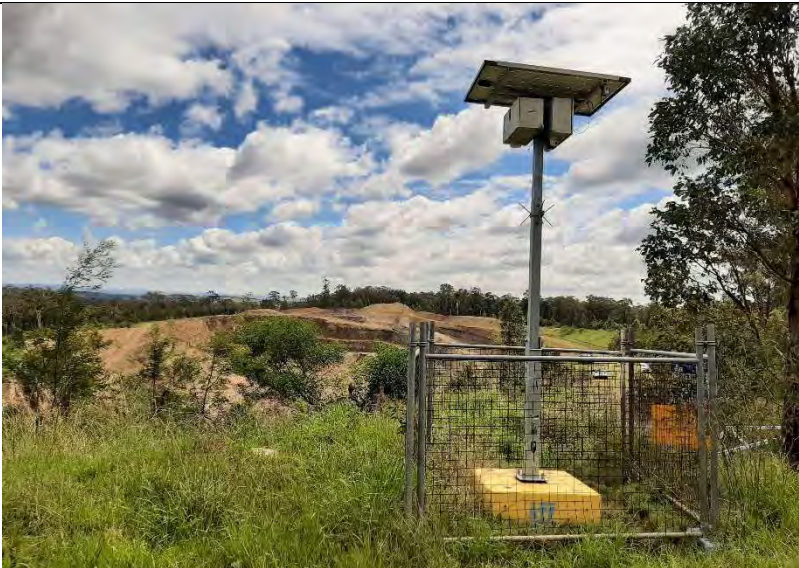
N/A	Nil – A number of remotely activated cameras are installed on site to mitigate unauthorised access – Positive observation.	N/A
7	Departure road adjacent to Dam #1

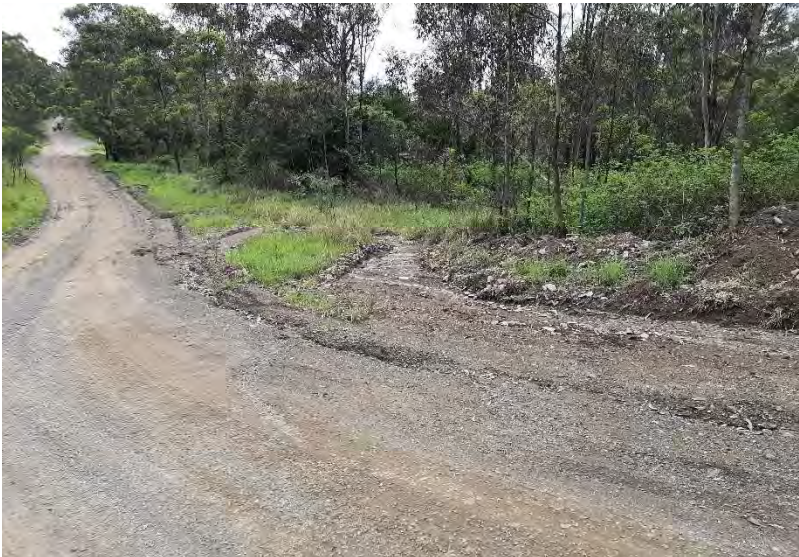
N/A	Nil – Additional catch drains installed to assist with the management of site water – Positive observation.	N/A

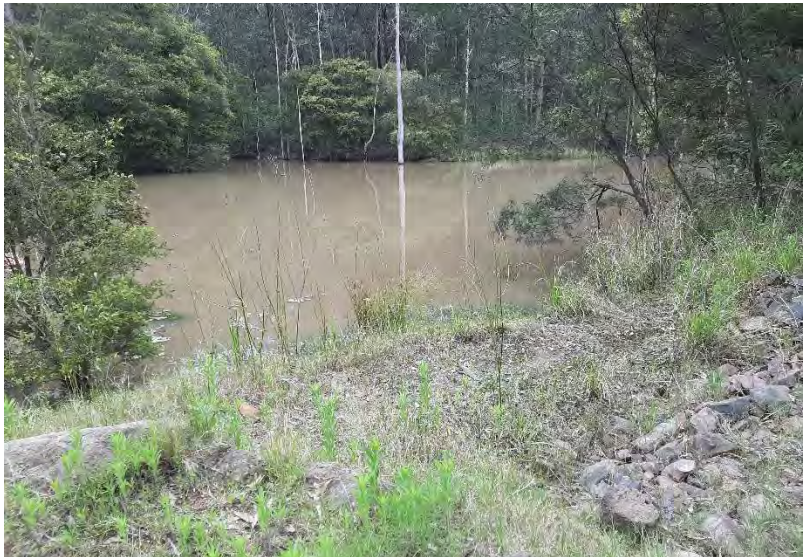
N/A	Nil – Site water is captured and managed appropriately with additional water pumped to the 'western detention basin' as required due to substantial rainfall received— Positive observations.	N/A
---	-------------------------	--	-----	---	-----

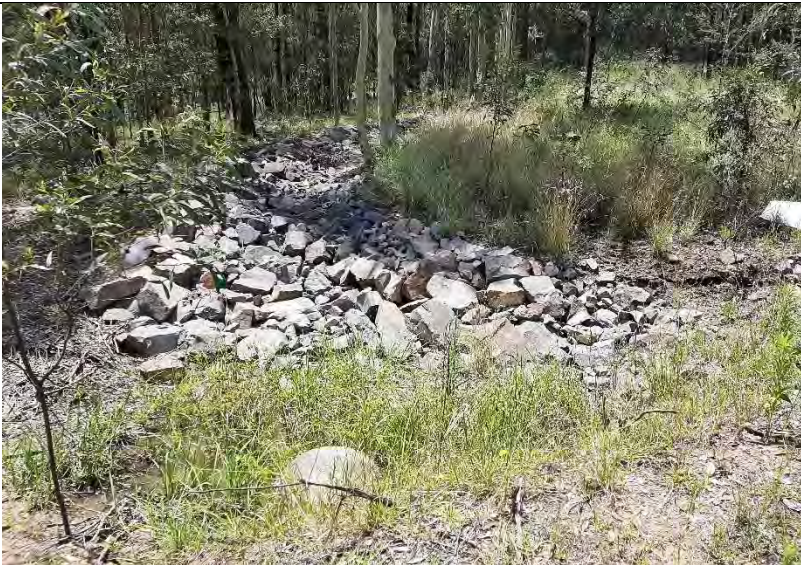
N/A	Nil – Scour protection installed adjacent to the main gate is operating effectively to prevent downstream sedimentation – Positive observation.	N/A
10	Panoramic image of the quarry looking east over the active quarry area

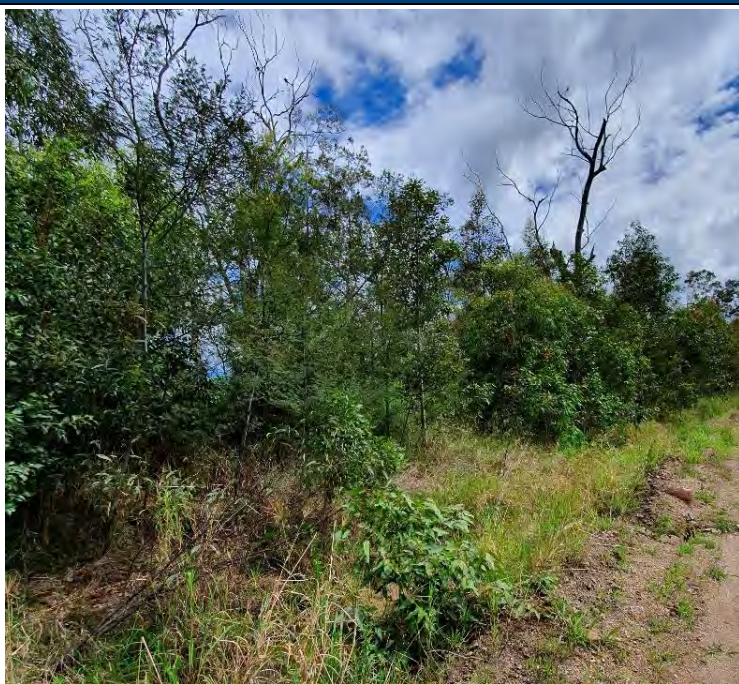
Adjoining Native Vegetation?	Yes, to north and west	
Establishment date	2017	
High Threat Weeds Present	Lantana (<i>Lantana camara</i>) encroaching from adjoining native vegetation.	
Other Exotics	Some fleabane (<i>Conyza</i> sp.) and spear thistle (<i>Cirsium vulgare</i>).	
General Description	Linear area of rehabilitated forest that occurs between access road at the top of quarry, and remnant vegetation. Quarrying is planned to continue to the north-east of this area. This area has regenerated from stripped topsoil and displays high diversity. A few new shrub species were noted during this monitoring event, indicating that individuals are either regenerating from the seedbank or from adjacent remnant vegetation.	
Canopy Description	Height 1 – 7m. Canopy is dense, dominated by spotted gum (<i>Corymbia maculata</i>), with occurrences of grey gum (<i>Eucalyptus punctata</i>), smooth-barked apple (<i>Angophora costata</i>), narrow-leaved ironbark (<i>Eucalyptus crebra</i>) and red ironbark (<i>Eucalyptus fibrosa</i>).

Fauna Utilisation	An array of small woodland birds were seen and heard in the area. Superb fairy-wrens appeared to be nesting in a spotted gum.	
Management Recommendations	Nil for this area. Continue to use stripped topsoil for rehabilitation in the future.

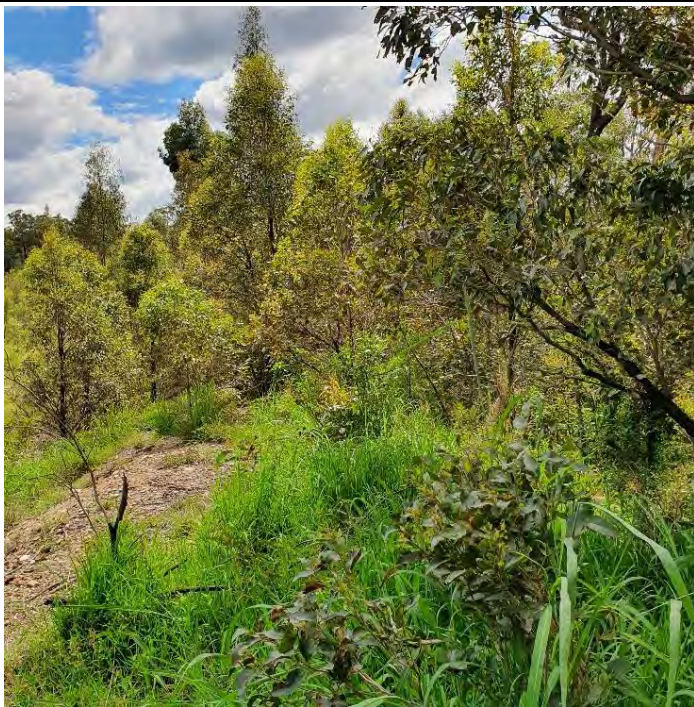
Adjoining Native Vegetation?	Yes, to east	
Establishment date	Prior to 2017	
High Threat Weeds Present	Small amounts of Lantana (<i>Lantana camara</i>) encroaching from adjoining native vegetation, some castor oil plant (<i>Ricinus communis</i>) and pampas grass (<i>Cortaderia selloana</i>).	
Other Exotics	Some fleabane (<i>Conyza</i> sp.) and spear thistle (<i>Cirsium vulgare</i>).	
General Description	Linear area of rehabilitated forest adjoining remnant vegetation at the eastern edge of the quarry. There is a bund that has recently been shaped (2021) that extends into this area. The bund is not yet planted, and there is little topsoil that has been used on it. Exotic species appear to be colonising this area.	
Canopy Description	Height 1 – 6m. Canopy is mid-dense, dominated by grey gum (<i>Eucalyptus punctata</i>), spotted gum (<i>Corymbia maculata</i>) and red ironbark (<i>Eucalyptus fibrosa</i>).

Fauna Utilisation	An array of small woodland birds were seen and heard in the area, along with macropod scats. Large ant nests were recorded, and these will promote bioturbation of the soil.	
Management Recommendations	Pasture species will likely become outcompeted over time as the canopy grows and shades the understorey. Weed spraying is recommended on the exposed bund and seeding with native groundcovers such as kangaroo grass (<i>Themeda triandra</i>) and silvertop wallaby grass (<i>Rytidosperma pallidum</i>) to avoid colonisation by tall, exotic pasture grasses that will outcompete natives.

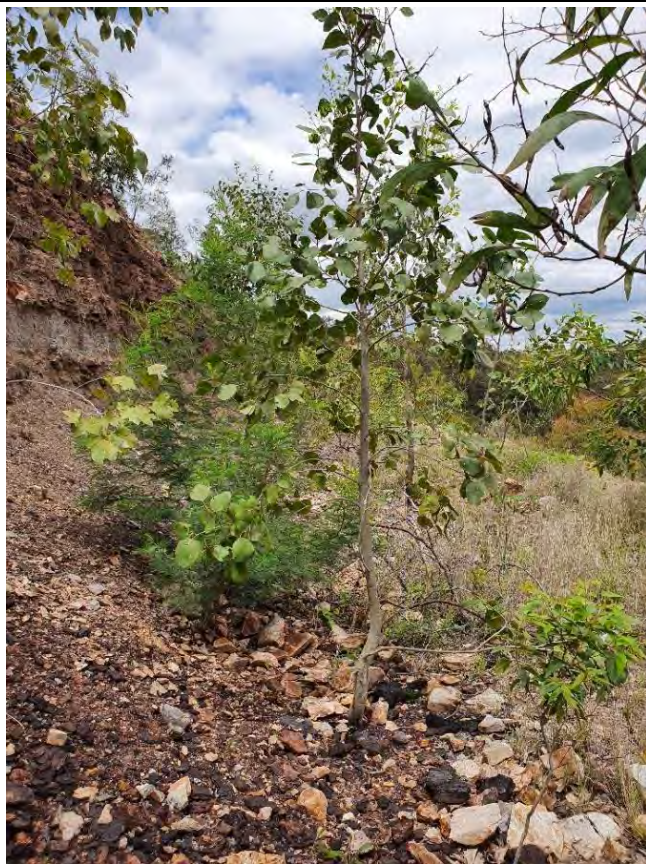
Adjoining Native Vegetation?	No direct adjoining vegetation.	
Establishment date	2013	
High Threat Weeds Present	Castor oil plant (<i>Ricinus communis</i>) colonising lip of bench.	
Other Exotics	Balloon cotton (<i>Gomphocarpus fruticosus</i>) and purpletop (<i>Verbena bonariensis</i>).	
General Description	Strip of planted vegetation along upper bench of southern side of the quarry. Growth pattern is slightly patchy. Bench faces north-west and is very exposed, particularly to mid-afternoon sun.	
Canopy Description	Height 2 – 6m. Canopy is open and is dominated by grey gum (<i>Eucalyptus punctata</i>), spotted gum (<i>Corymbia maculata</i>), forest she-oak (<i>Allocasuarina torulosa</i>) and swamp mahogany (<i>Eucalyptus robusta</i>).	
Mid-storey/Shrub Layer Description	Height 1– 3m. Mid-storey is dominated by Acacias such as green wattle (<i>Acacia decurrens</i>), swamp wattle (<i>Acacia elongata</i>) and sickle wattle (<i>Acacia falcata</i>). Some smaller forest she-oak is present.

Ground Cover Description	Height 0.1 – 1m. Ground cover is sparse, comprising exotic pasture species such as red natal grass (<i>Melinis repens</i>), Rhodes grass (<i>Chloris gayana</i>) and natives such as two-colour panic (<i>Panicum simile</i>).	
Health and Condition	Canopy exhibiting signs of active growth. Some Eucalypts with mistletoes, and a high proportion of the canopy and mid-storey species are flowering and fruiting. Ground texture is extremely rocky, and it is possible that the soil profile may be hindering the growth of the rehabilitation. There is a large and prominent erosion rill at the far west end of the bench, however this is a known issue and it is becoming colonised and stabilised by <i>Acacia</i> species.	
Fauna Utilisation	No obvious signs of fauna utilisation.	
Management Recommendations	Spraying of the castor oil plant along the lip of the bench is recommended. If surplus stripped topsoil is available, it would be worthwhile spreading on some of the sparser areas along Bench #2 to promote growth. Mulch may be another alternative to help retain moisture and build a soil profile.

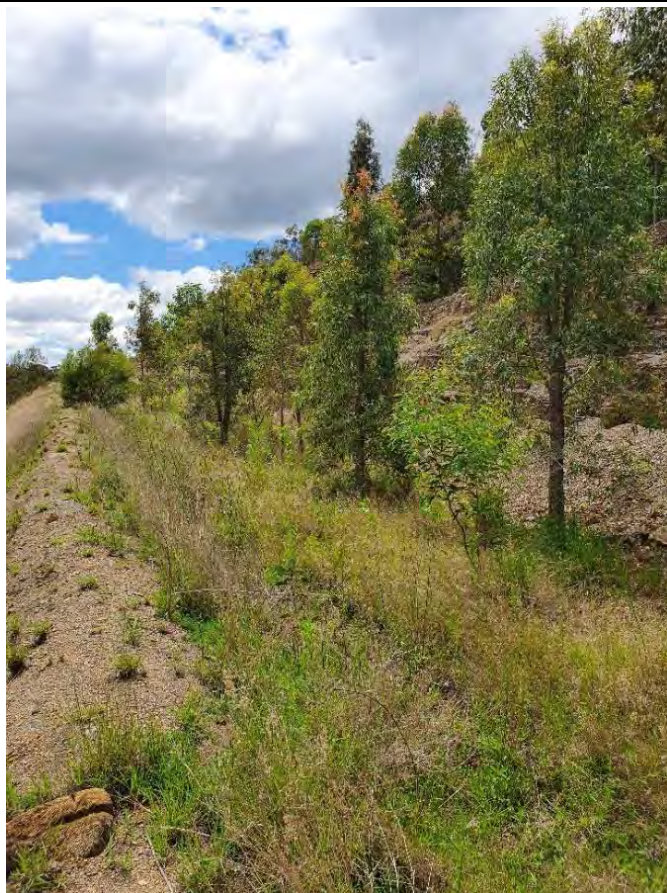
Adjoining Native Vegetation?	No direct adjoining vegetation.	
Establishment date	2015 (additional plantings in 2016, 2018 and 2020).	
High Threat Weeds Present	Castor oil plant (<i>Ricinus communis</i>) colonising lip of bench.	
Other Exotics	Balloon cotton (Gomphocarpus fruticosus) and purpletop (Verbena bonariensis).	
General Description	Strip of planted vegetation along upper bench of southern side of the quarry. Growth pattern is quite patchy. Bench faces north-west and is very exposed, particularly to mid-afternoon sun. Some supplementary plantings were made in 2020, which have mostly survived.	
Canopy Description	Height 1.5 – 5m. Canopy is open and appears to be slightly more stunted than the plantings on Bench #2. The canopy is dominated by grey gum (<i>Eucalyptus punctata</i>), spotted gum (<i>Corymbia maculata</i>), narrow-leaved ironbark (<i>Eucalyptus crebra</i>) and rough-barked apple (<i>Angophora floribunda</i>).

Mid-storey/Shrub Layer Description	Height 1– 2m. Sparse mid-storey dominated with Acacias such as green wattle (<i>Acacia decurrens</i>) and sickle wattle (<i>Acacia falcata</i>), with some hickory wattle (<i>Acacia implexa</i>). A high number of species are regenerating and flowering.	
Ground Cover Description	Height 0.1 – 1m. Ground cover is patchy, with a variety of both native and exotic species. These include Rhodes grass (<i>Chloris gayana</i>), kidney weed (<i>Dichondra repens</i>), Paddys lucerne (<i>Sida rhombifolia</i>) and couch (<i>Cynodon dactylon</i>).	
Health and Condition	Rehabilitation is very patchy and the canopy has some noticeable gaps. Plantings in these gaps have been largely successful, though growth has been slow given the exposed western aspect of the bench. Some mistletoes are present in Eucalypt species.	
Fauna Utilisation	A small woodland bird nest was recorded in a Eucalypt.

Management Recommendations	Spraying of the castor oil plant along the lip of the bench is recommended. If surplus stripped topsoil is available, it would be worthwhile spreading on some of the sparser areas along Bench #3 to promote growth.
