BUTTAI QUARRY

ANNUAL ENVIRONMENTAL MANAGEMENT REPORT (AEMR)

2022

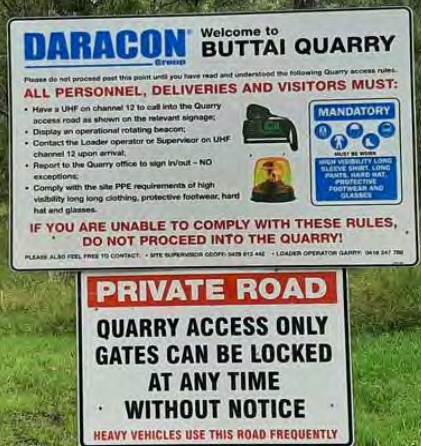
No.	Location (Area / description)	Issue / Comment	Recommended priority	Action	Close out date
1	Buttai Quarry access

N/A	Nil – Appropriate signage installed at the main gate and there was no evidence of dust generation on site during the inspection – Positive observations.	N/A

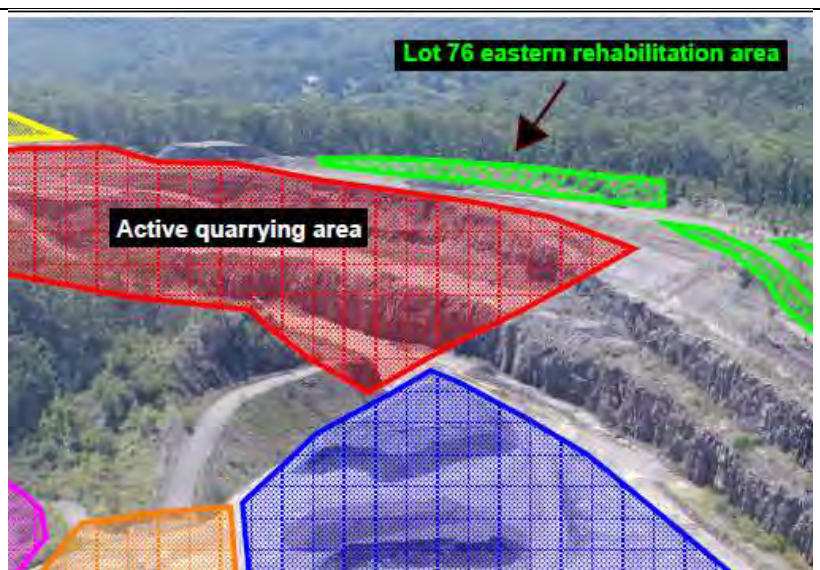
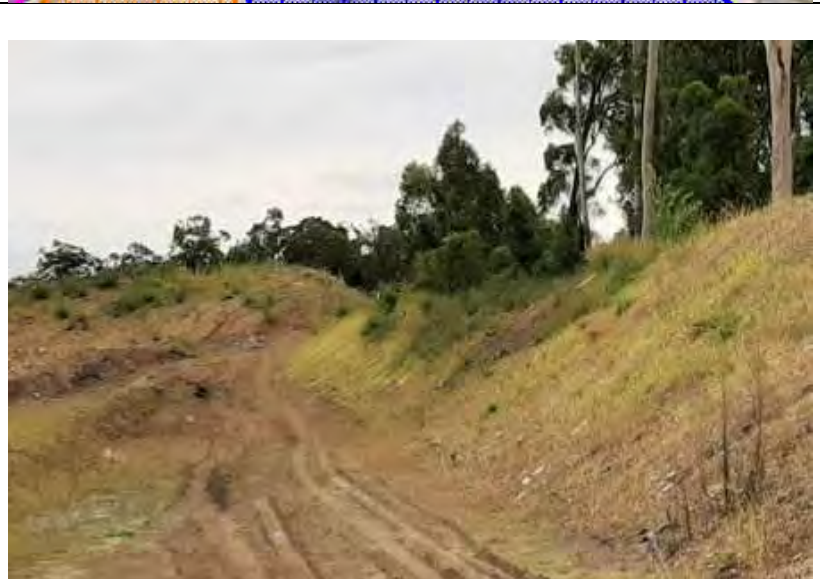
3	Recently re-shaped batter along eastern edge of the quarry pit 'Lot 76' area

N/A	Nil - Following the previous inspection, the eastern batter was seeded in late December 2021. As seen in the image, the batter now has a good vegetation cover which should only increase over time – Positive observation.	N/A
---	---	--	-----	---	-----

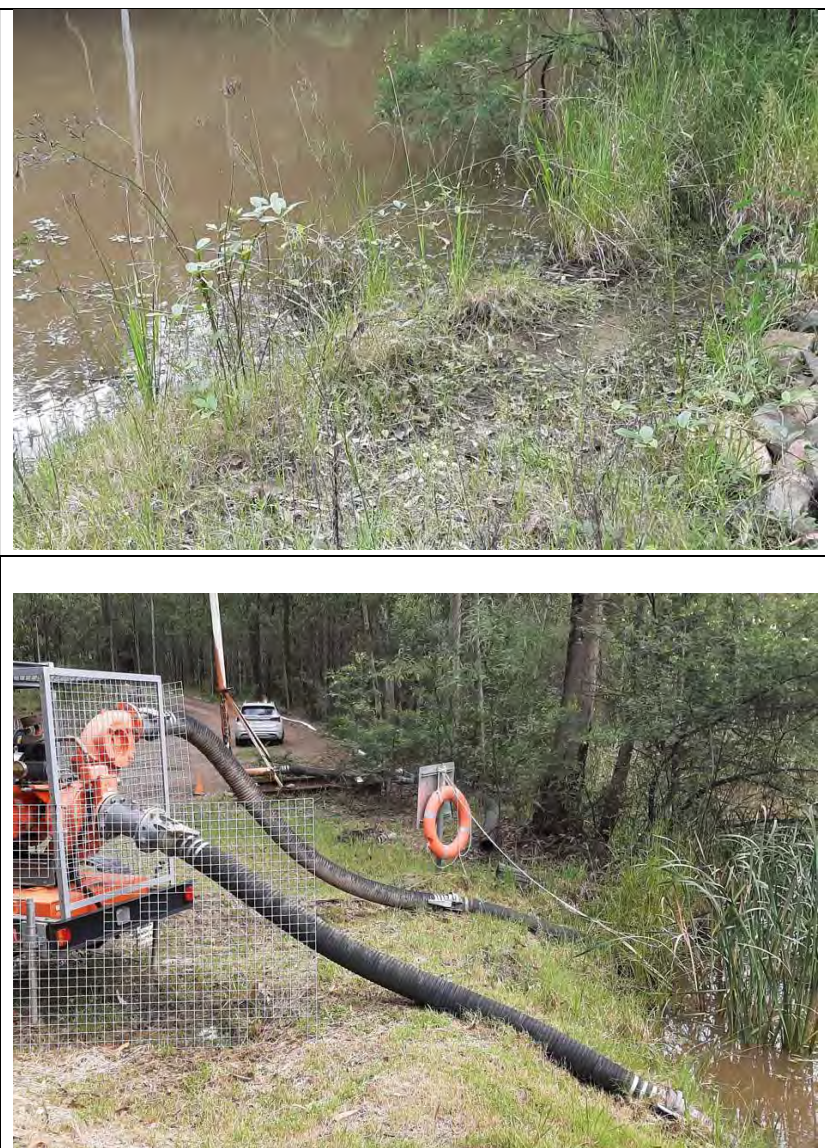
4	Dam 4 water transfer

N/A	Nil – At the time of inspection, site water was being Managed appropriately with additional water pumped from Dam #4 to the ‘western detention basin’ as required due to substantial rainfall received – Positive observation.	N/A
---	----------------------	---	-----	--	-----

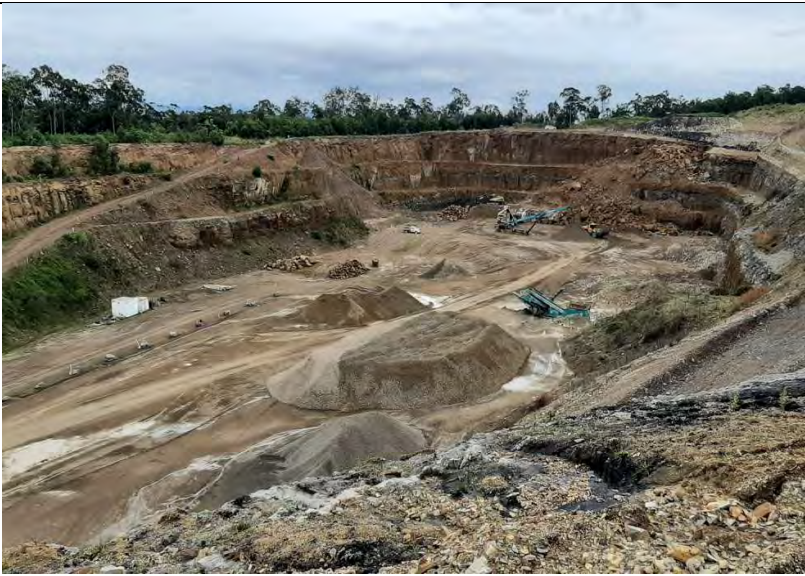
5	Active quarry area

N/A	Nil – The active quarry area was tidy with no evidence of dust generation on site during the inspection – Positive observations.	N/A
6	Sed' controls along access road

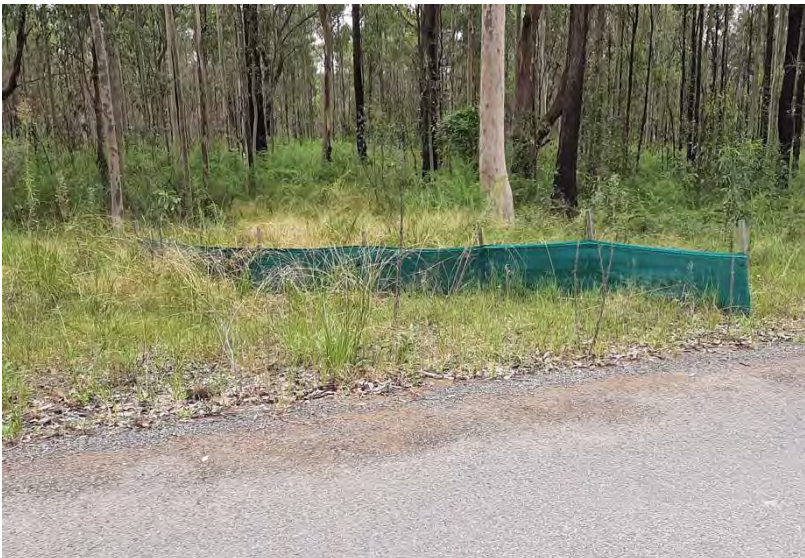
N/A	Nil – The various sedimentation controls installed along the site access road were functional at the time of inspection – Positive observation.	N/A

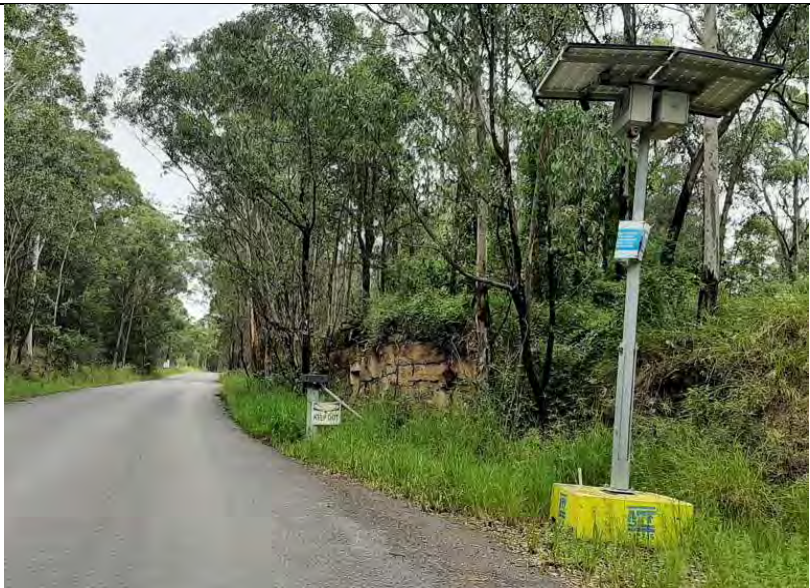
7	Site security

N/A	Nil – A number of remotely activated cameras are installed on site to mitigate unauthorised access – Positive observation.	N/A
8	Bench #2 and #3

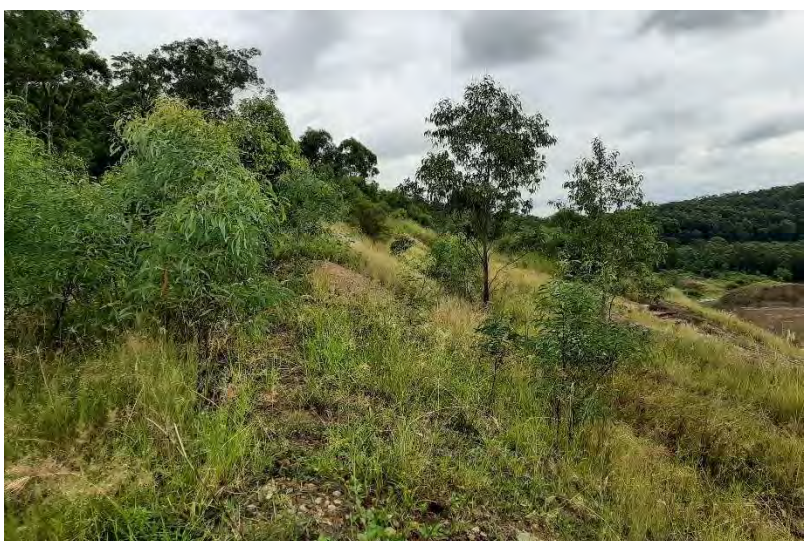
N/A	Nil – Both upper benches rehabilitation areas were progressing appropriately at the time of inspection – Positive observation.	N/A

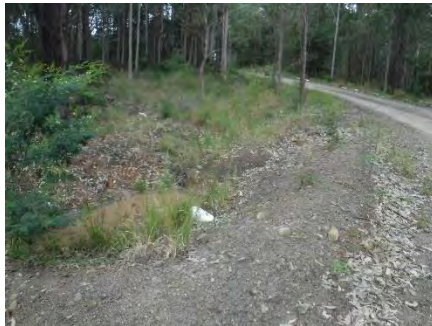
1.	Dam 4.	The area around Dam 4 was inspected. The controls adjacent to the haul road remain in position and functional. Water in Dam 4 continues to be transferred to dams in the upper floor of the quarry.		The controls in the area remain functional and no actions were required.

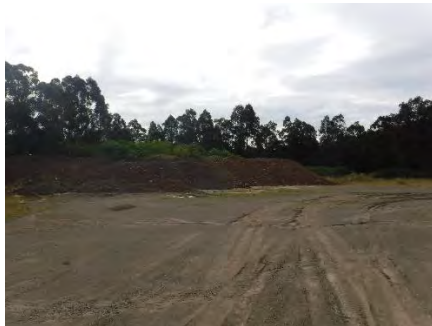
2.	Proposed Resource Recovery Facility (RRF).	The area for the proposed Resource Recovery Facility (RRF) was inspected. Site controllers indicated the planning and approvals process is continuing. We noted a quantity of stockpiled material which is proposed to be utilised to form a noise attenuation bund.		The controls in the area remain functional and no actions were required.

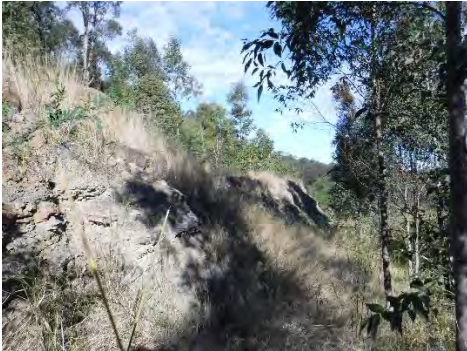
ISSUE NO.	LOCATION	ISSUE/MATTER	RECOMMENDATION/COMMENT	PHOTOGRAPH
4.	Bench 2 and Bench 3 rehabilitation areas.	The revegetation along Bench 2 and Bench 3 was inspected. The rehabilitation plantings are well established in most areas however a few isolated areas remain where the onset of seedlings is impacted due to the aspect and weather impacts.	Site controllers indicated that additional plantings are scheduled in the affected areas and that weed treatment will resume with a return to extended dry conditions.

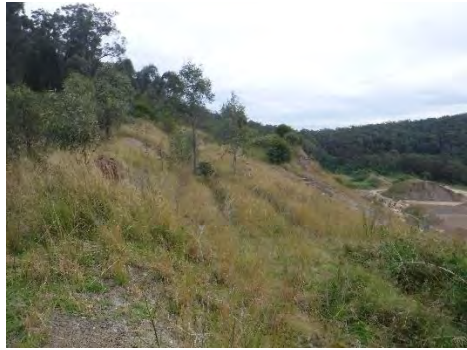
5.	Bench 2 and Bench 3 rehabilitation areas.	As noted above, the bench rehabilitation areas were inspected. The rehabilitation in the area is progressing however, as noted previously, an outbreak of castor oil weed was noted in the northern section of Bench 3.	As discussed, continue to implement the periodic weed suppression, targeting the weed identified on Bench 3.

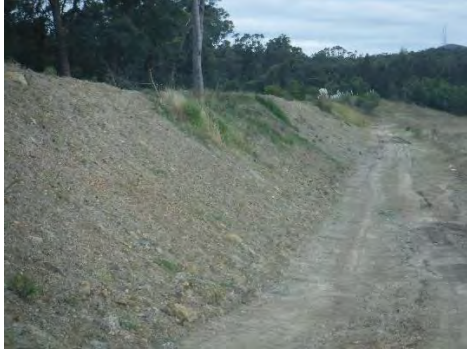
6.	Eastern bund.	The eastern bund rehabilitation area was inspected. The bund has been extended and revegetated. The revegetation on the initial bund is well established, whilst the bund extension section has surface vegetation establishing and native seedlings are evident. Some minor outbreaks of Pampas Grass was noted in one area.	The area remains stable and well vegetated, and no actions are required. As discussed, continue to schedule the area for periodic weed suppression.

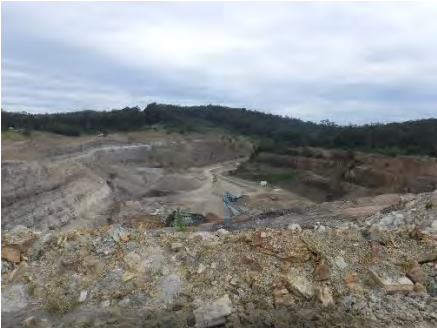
ISSUE NO.	LOCATION	ISSUE/MATTER	RECOMMENDATION/COMMENT	PHOTOGRAPH
7.	Air quality – general.	The inspection occurred during dry conditions with moderate wind conditions present. Dust emissions were visibly minimal within the area of works.	Continue to implement effective dust mitigation management.

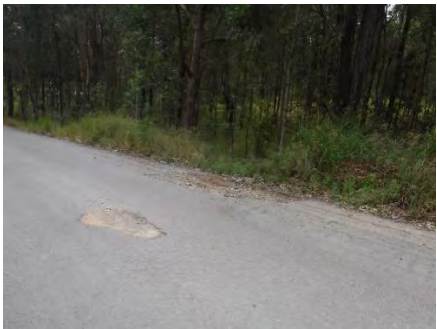
8.	Main access road.	The areas along the main access road were inspected. The road is being well maintained and installed sediment controls are functional and in good condition. Two minor sections of failed chip seal were noted on section of the road a small distance upslope from the entrance gate.	As discussed, continue to monitor, implement, and maintain the drainage controls to minimise erosion and improve runoff water quality. In addition, we recommend temporarily repairing the failed asphalt sections with 'cold mix' bitumen until the asphalt re-sealing works commence.

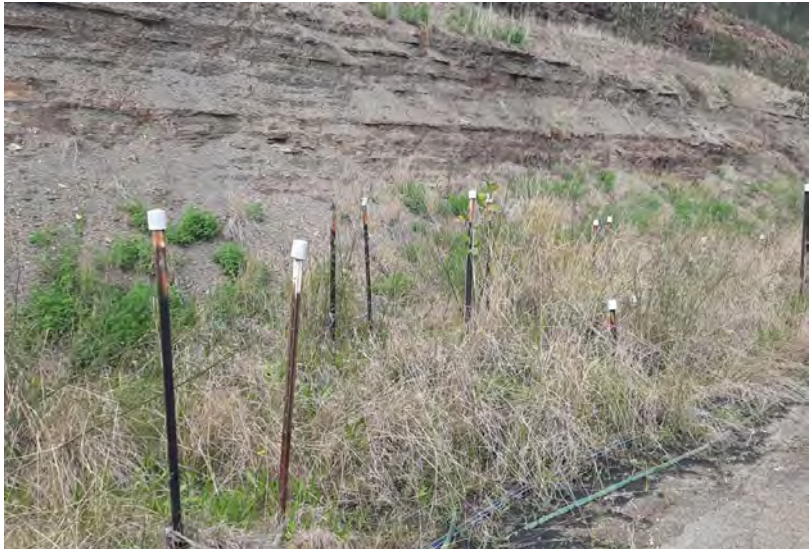
Low	Small areas of delayed rehabilitation on bench #3 mean that we're currently planning to install some additional plants and improved soil amelioration to this area shortly.	Additional maintenance and planting occurred on the 20th September 2022. Ongoing maintenance will occur over the next few months - Ongoing

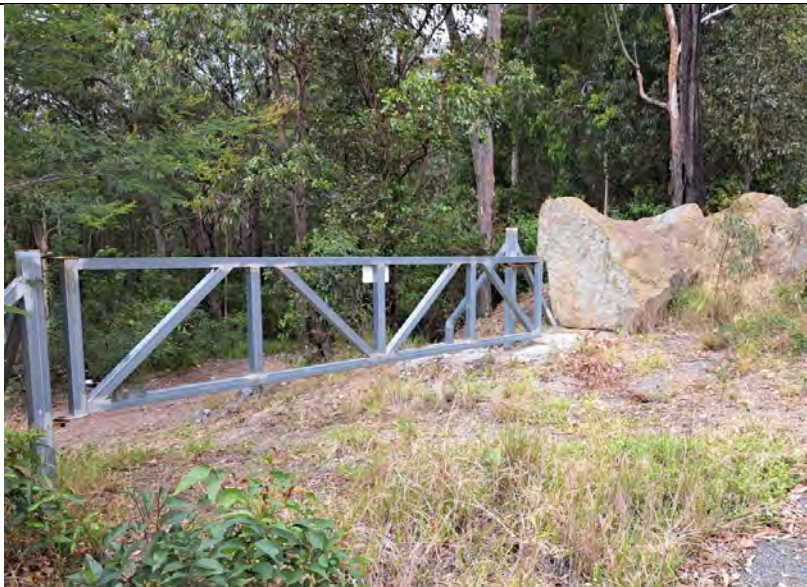
2	Gates at the top of the quarry

N/A	Nil – As shown in the top image, the gates at the top of the quarry were intact, closed and locked – Positive observation.	N/A

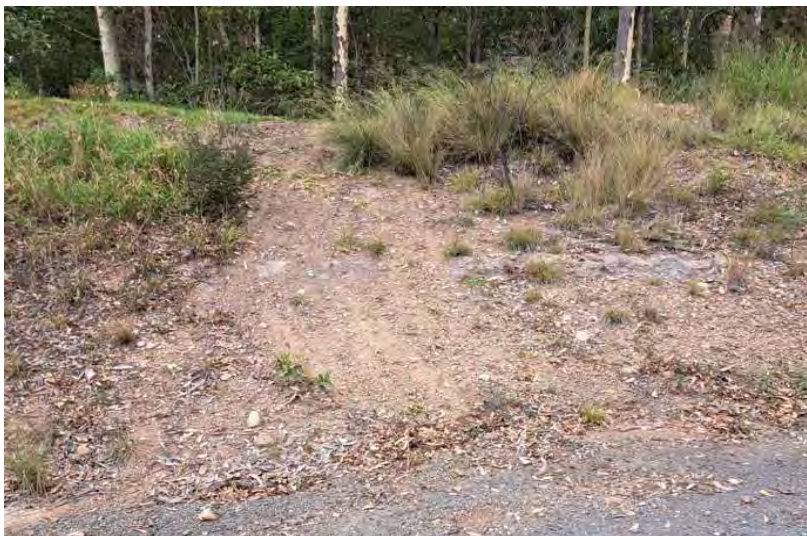
High	Evidence of unauthorised access found adjacent to the top gate. The excavator operator was informed and promptly rectified as shown below

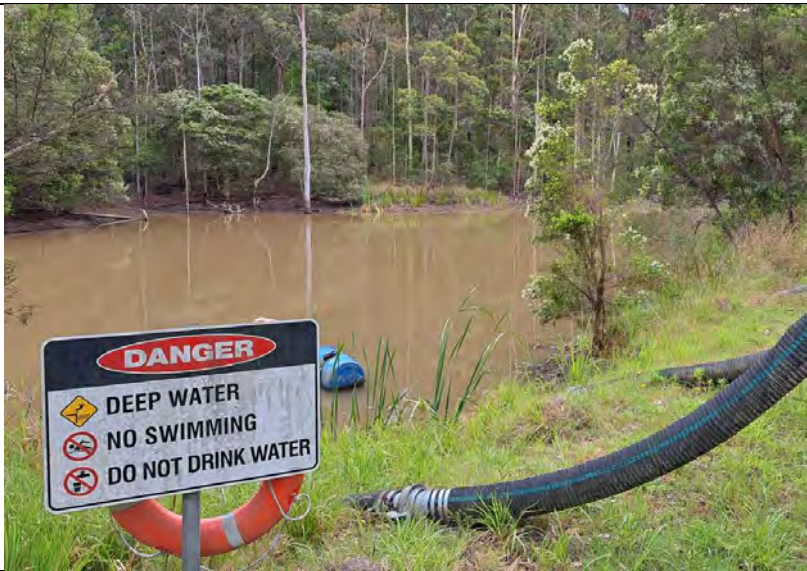
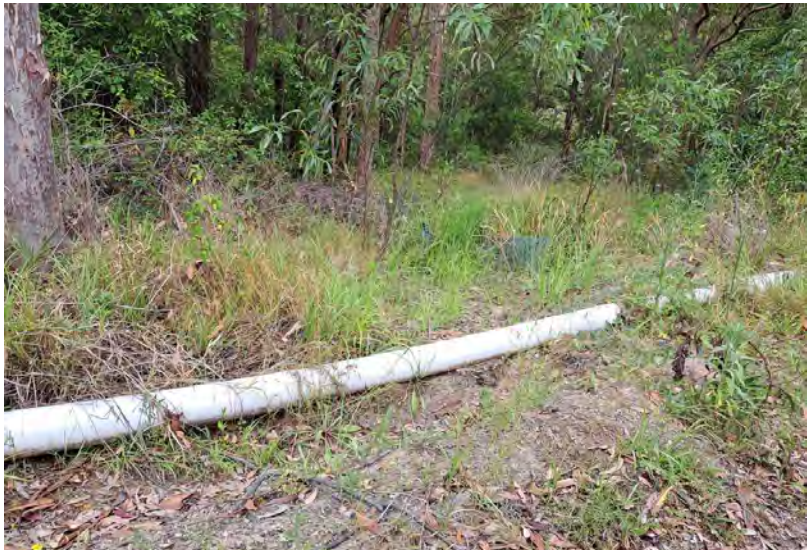
4	Dam #4 and water re-use pipework

N/A	Nil – Dam #4 was holding a moderate amount of water which is actively managed using the ‘re-use pipework’ when required – Positive observation.	N/A
---	----------------------------------	--	-----	---	-----

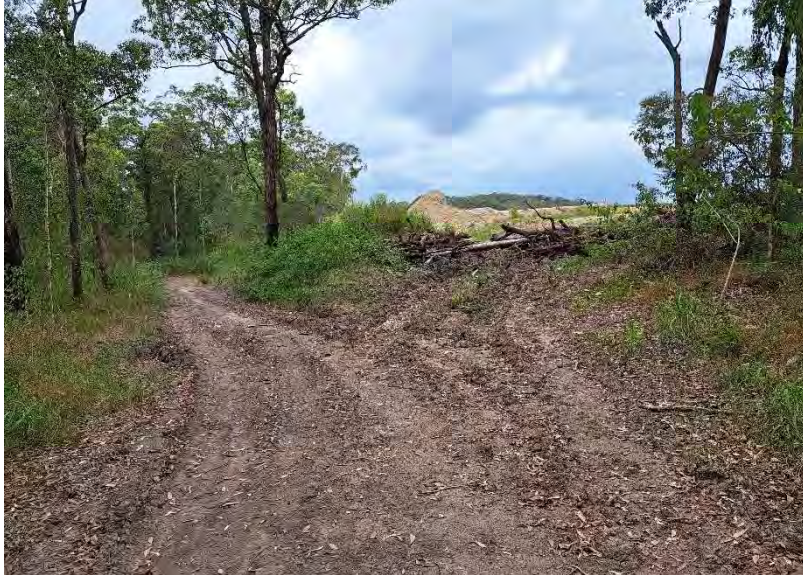
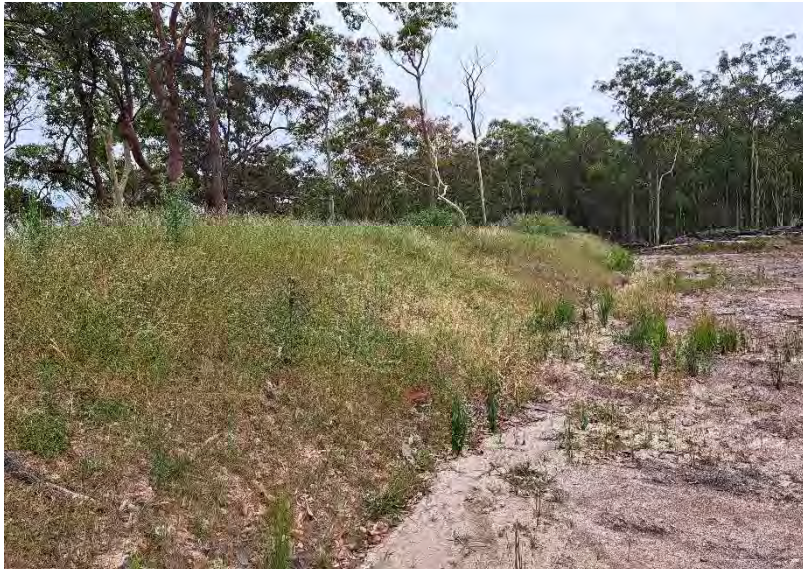
7	Northern pre-strip area

N/A	<p>Nil – The northern pre-strip area is well contained with all runoff directed to a control structure whilst the western bund now has a decent vegetation cover – Positive observations.</p>	N/A
---	-------------------------	--	-----	---	-----

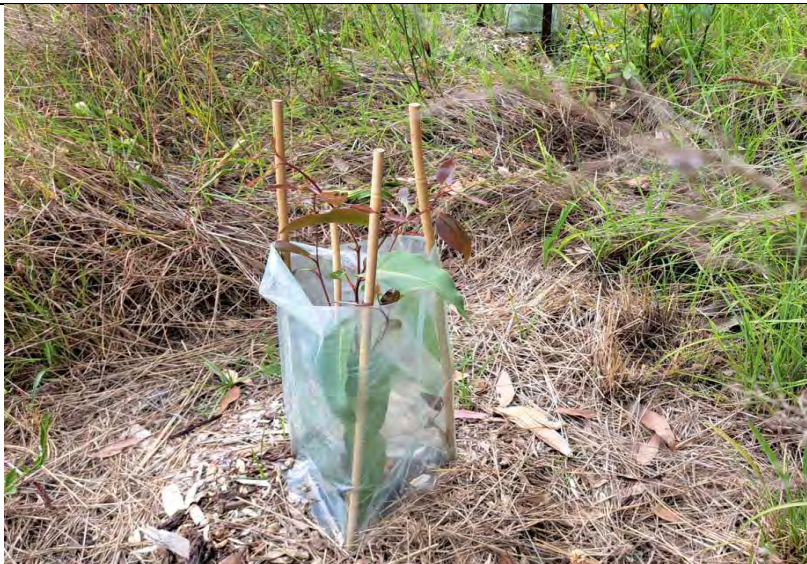
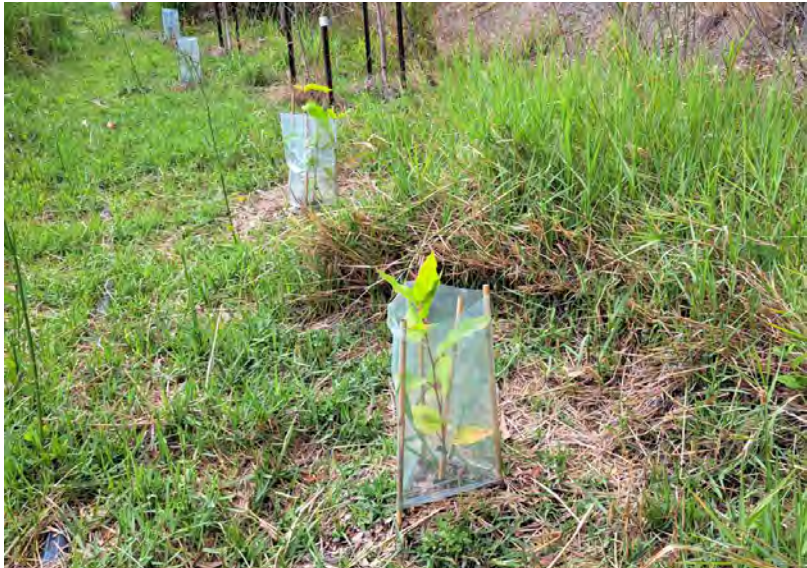
8	Bench #3

Low	<p>Despite the fact we recently planted more tube stock onto Bench #3, it was recently suggested that we could consider 'top-down planting' by the CCC during the recent site inspection. This will be further investigated over the next few weeks and additional plants installed if deemed feasible – Positive observation.</p>	<p>N/A</p> <p>Ongoing into 2023 - LR</p>
---	----------	--	-----	--	--

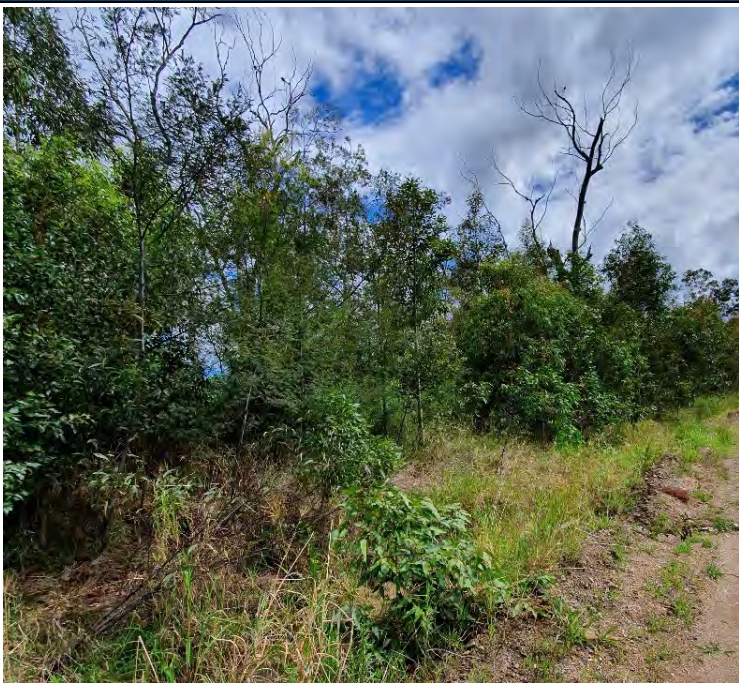
Site Name	Lot 76 Western Rehabilitation (South End)	
Form	Linear strip on bund

Adjoining Native Vegetation?	Yes, to west	
Establishment Date	2017	
Monitoring Point Co-ordinates	365151, 6365644	
High Threat Weeds Present	Lantana (<i>Lantana camara</i>) encroaching from adjoining native vegetation.	
Other Exotics	Some fleabane (<i>Conyza</i> sp.) and spear thistle (<i>Cirsium vulgare</i>).	
General Description	Linear area of rehabilitated forest that occurs between access road at the top of quarry, and remnant vegetation. Quarrying is planned to continue to the north-east of this area and the bund has been extended to the north (see following table). This area has regenerated from stripped topsoil and displays high diversity.	
Canopy Description	Height 1.5 – 7.5m. Canopy is dense, dominated by spotted gum (<i>Corymbia maculata</i>), with occurrences of grey gum (<i>Eucalyptus punctata</i>), smooth-barked apple (<i>Angophora costata</i>), narrow-leaved ironbark (<i>Eucalyptus crebra</i>) and red ironbark (<i>Eucalyptus fibrosa</i>).

Management Recommendations	Continue to use stripped topsoil for rehabilitation in the future. Continue to monitor canopy species that have fallen over.

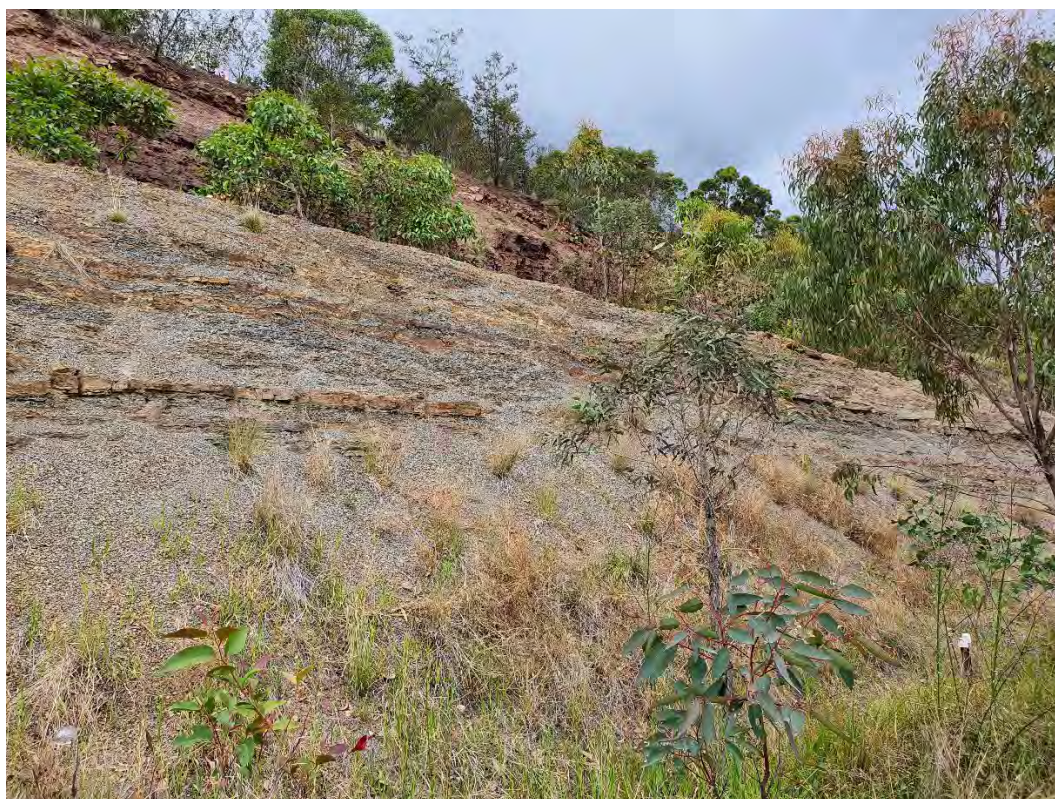
The planting of native scrambling plants to cover the exposed rocky slope is a potential mitigation measure for this issue, however the success of this strategy cannot be predicted. There are existing plants on this site that have been observed colonising rocky slopes (see **Photo 3.2** for example), such as purple coral pea (*Hardenbergia violacea*), dusky coral pea (*Kennedia rubicunda*) and variable glycine (*Glycine tabacina*), however these were observed on slopes that had more shade and protected than that found at Bench #3. It is unknown how these plants would fare in the proposed location. If this mitigation measure is chosen, planting the tubestock with mulch and/or topsoil will increase chances of survival.

Photo 3.1 Exposed rocky slope behind plantings on Bench #3 (seen in foreground)
