BUTTAI FACILITY

ANNUAL ENVIRONMENTAL MANAGEMENT REPORT (AEMR)

2023

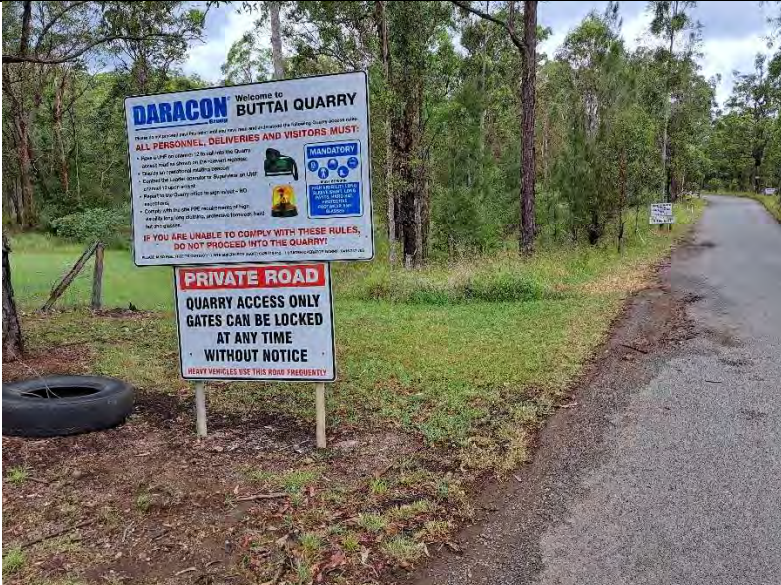
<input checked="" type="checkbox"/> Low </div>	
No.	Location (Area / description)	Issue / Comment	Recommended priority	Action	Close out date		
1	Buttai Quarry main access

N/A	Nil – There was no evidence of dust generation on site and appropriate signage installed at the main gate – Positive observations.	N/A

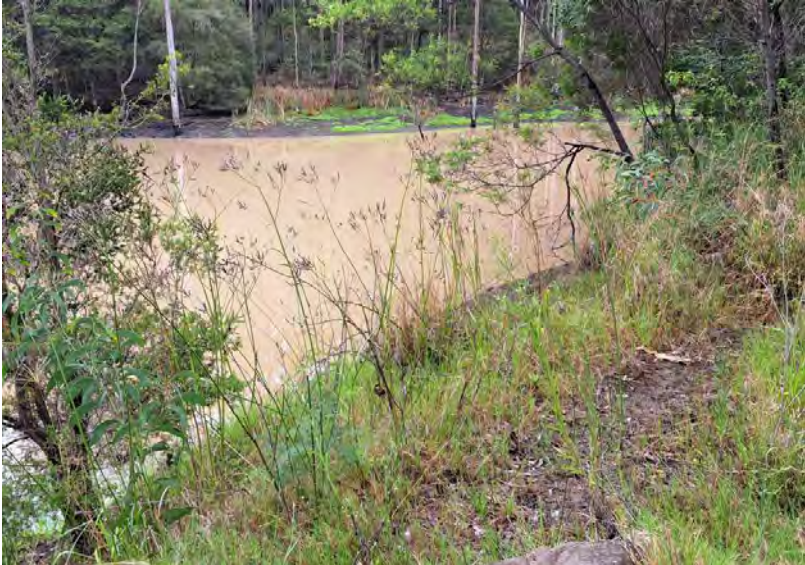
4	Dam #4

N/A	<p>Nil – Dam #4 was holding a small amount of water with the overhead watercart standpipe moved to Dam #1 due to the low volume of water present in Dam #4 – Positive observation.</p>	N/A
---	--------	--	-----	--	-----

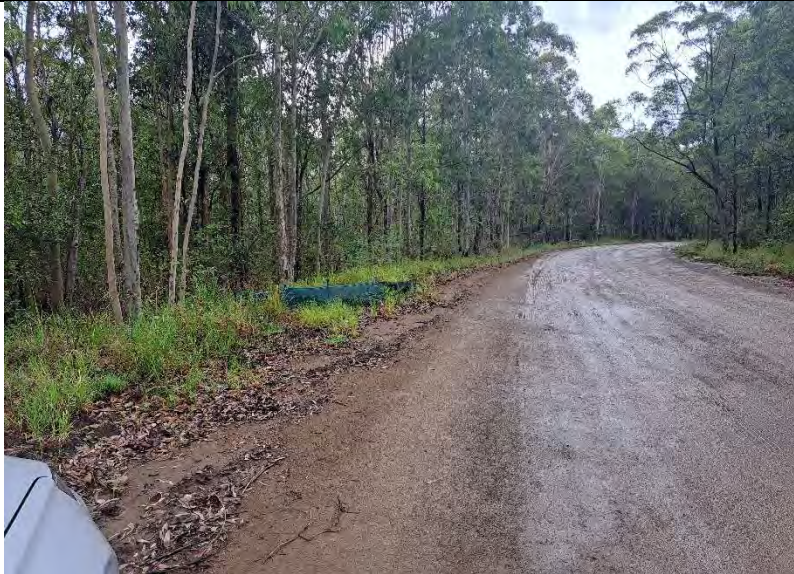
5	Sed' controls along access road

Low	A few of the sed' control structures along the access road have small windrows in front of that need to be removed to prevent water bypassing the sed' control structures.	Complete 20/03/23
6	Rock lined drain at main entrance

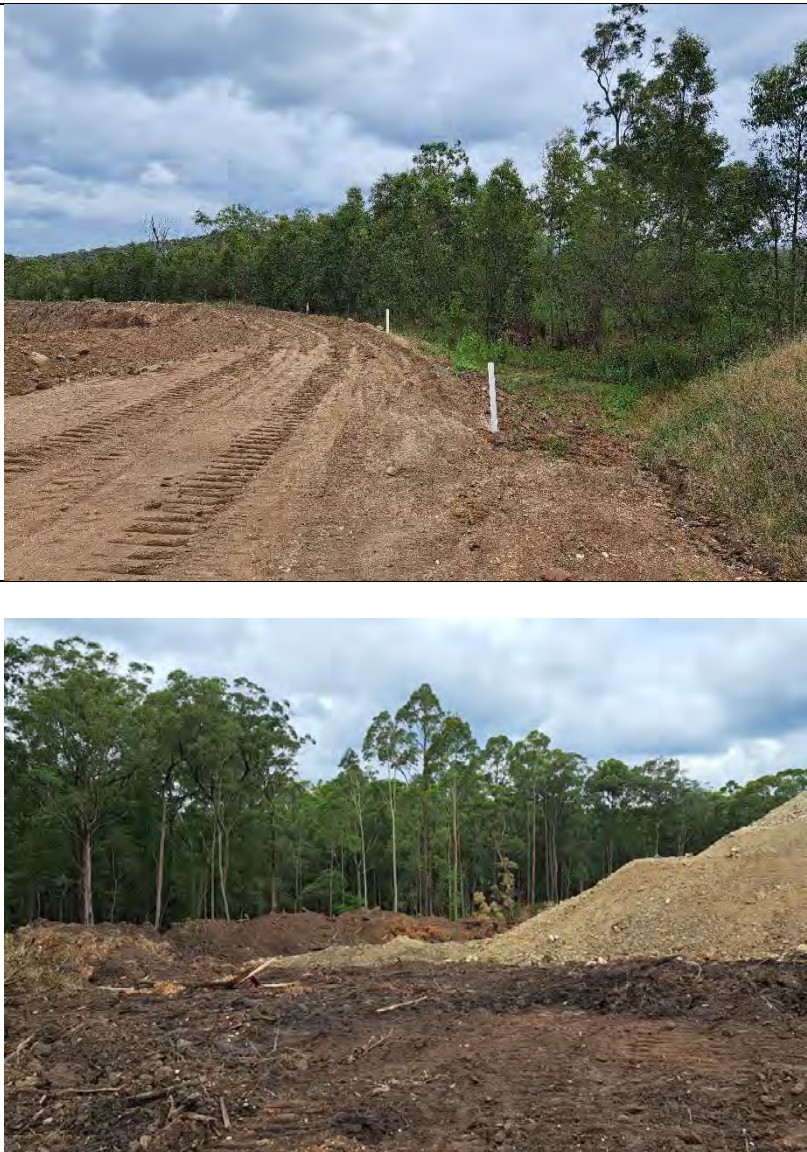
7	Northern pre-strip area

N/A	<p>Nil – The bund on the western section of the northern pre-strip area continues to show a good level of revegetation, whilst the northern stripped area continues to be well contained with all runoff directed to temporary water quality control structures – Positive observations.</p>	N/A
---	-------------------------	---	-----	--	-----

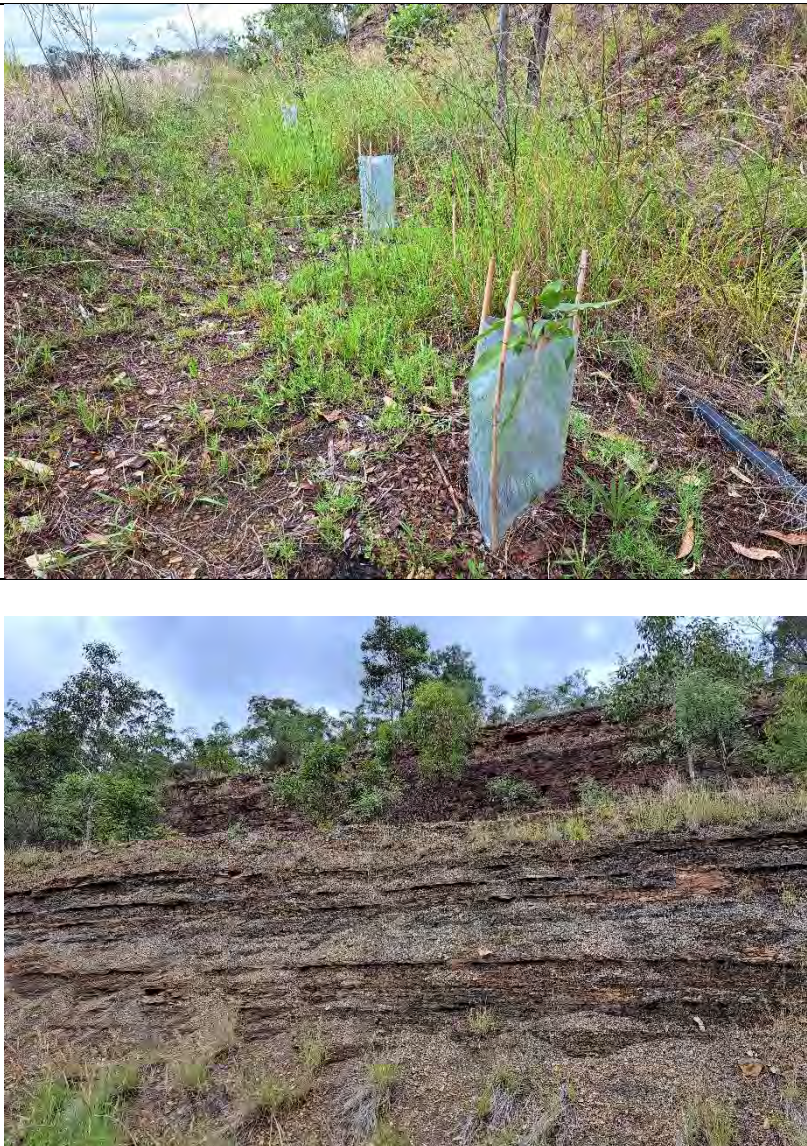
8	Bench #2 and #3

Low	<p>Despite the fact we recently planted more tube stock onto Bench #3 and following the recent suggestion from the CCC that we consider 'top-down planting', the Daracon Landscapers are planning to install some 'ground cover' species to the interface between Bench #2 AND Bench #3 (bottom image) shortly – Positive observation.</p>	<p>N/A</p> <p>Complete 22/03/23</p>
---	-----------------	---	-----	--	---

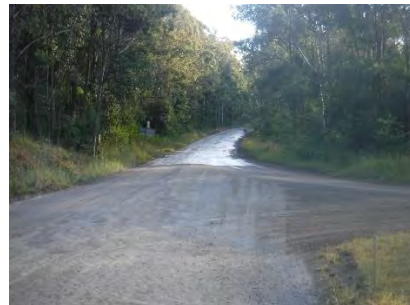
1.	Access road – dust control.	On approach to the main quarry office, we noted the site water cart was watering the unsealed portion of the quarry access track.		As discussed, continue to implement effective dust control measures as required.

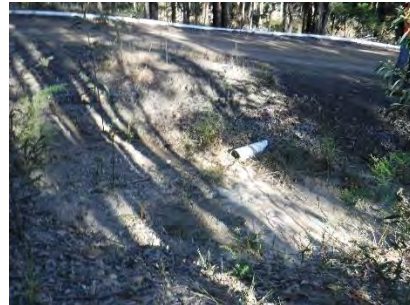
2.	Dam 4 – lower water quality basin.	Dam 4 and the adjacent watering fill point was inspected. Site controllers indicated that the water volumes in the dam are managed by pumping up to Dam 2. The spillway was inspected, and it was noted that it appears that no spill event has occurred in the time since the previous inspection. We noted the upslope sump and transfer pipe has accumulated sediment, with the pipe now being partially obstructed.		As discussed, we recommend desilting the sump to restore capacity.

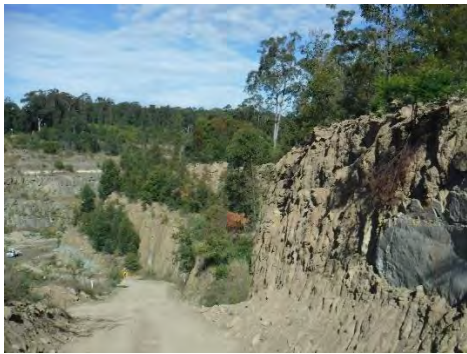
ISSUE NO.	LOCATION	ISSUE/MATTER	RECOMMENDATION/COMMENT	PHOTOGRAPH
4.	Northern bund on the northern access ramp.	The northern ramp and the adjacent bund was inspected. The vegetation on the bund has progressed well, with trees now exceeding six metres (6m) in height in many locations. The associated drainage line is colonised with vegetation and coarse sediment migration is minimised. Vegetation is also well established on the adjacent benches above the ramp.	No actions were required in the area.

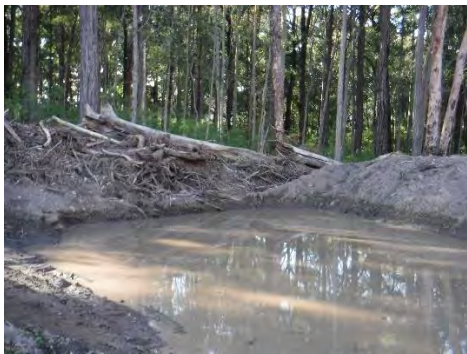
5.	Northern extension area.	The area of the northern quarry extension was inspected. The clearing works in the area have incorporated windrowed timber on the boundary of works, controlled with a topsoil berm formed immediately upslope. We noted the berm at the northeastern extent intersects with windrowed vegetation and a quantity of water is ponding in the area.	As discussed, we recommend the area is monitored following significant rainfall events to ensure that the spill path for the flows from the area remains stable.

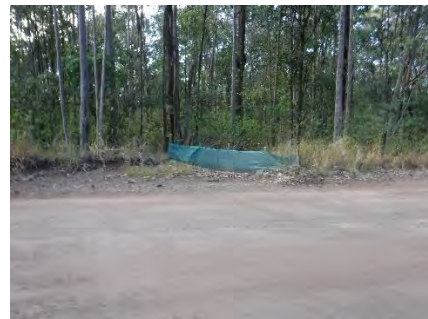
ISSUE NO.	LOCATION	ISSUE/MATTER	RECOMMENDATION/COMMENT	PHOTOGRAPH
7.	Main access track – sediment controls.	The sediment fence controls installed in the mitre drains along the access track were inspected. In general, the sediment fences remain functional and in position however a few installations were noted to require additional pinning.	As discussed, continue to monitor, maintain, and reinstate the sediment fence installations as required.

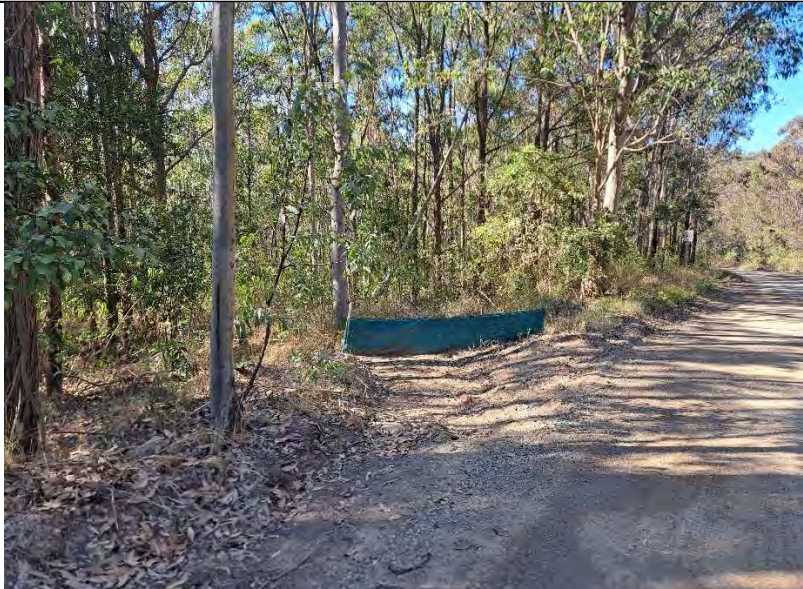
No.	Location (Area / description)	Issue / Comment	Recommended priority	Action	Close out date		
1	Buttai Quarry main access

N/A	Nil – There was no evidence of dust generation on site and silt fences along the haul road were intact – Positive observations.	N/A

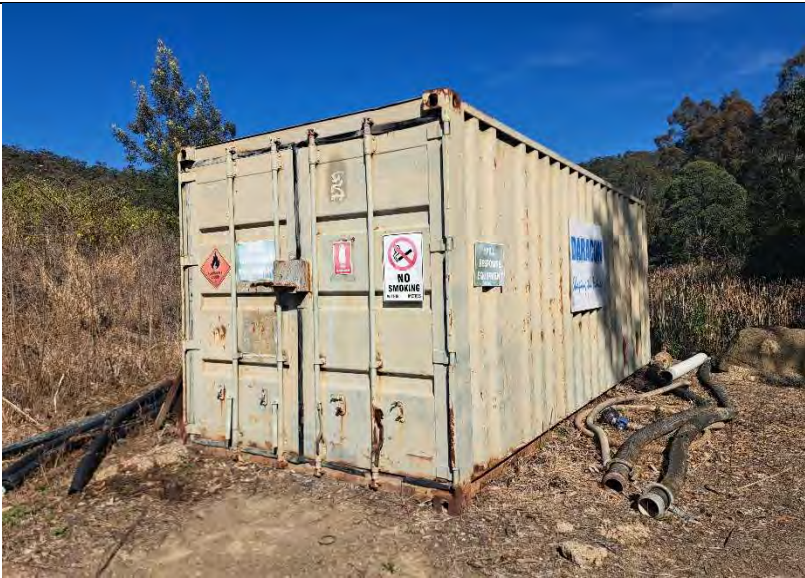
5	Storage container

N/A	Nil – The container had appropriate signage installed and chemicals stored in banded areas – Positive observations.	N/A
6	Gate to fire road at top of quarry

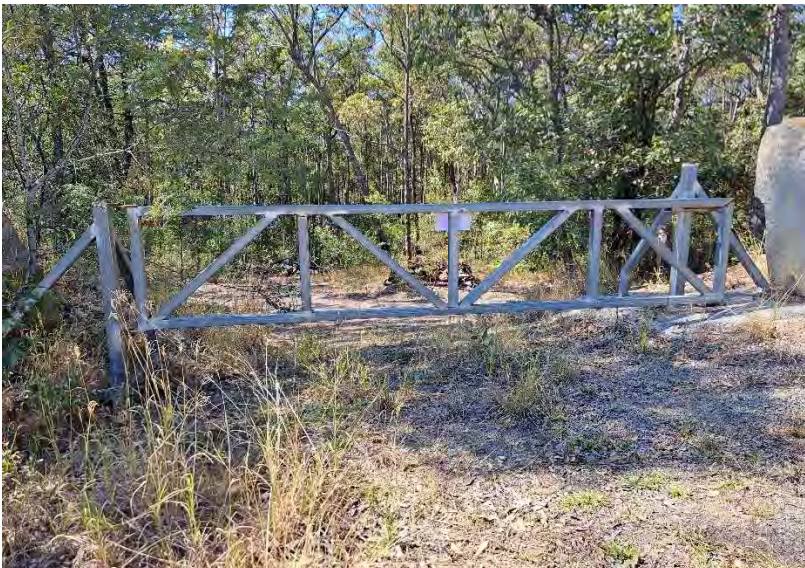
N/A	Nil – The gate was intact with no evidence of trespass – Positive observation.	N/A

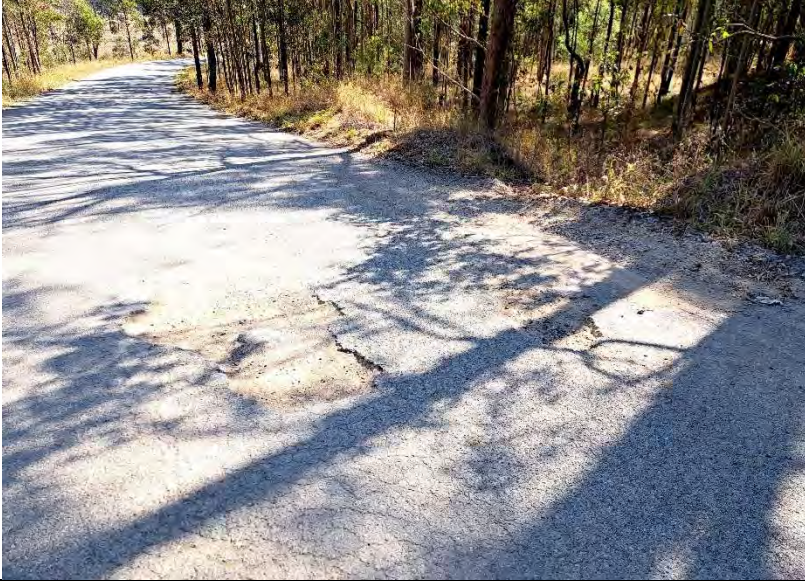
7	Main access road

Low	Potholes on the bitumen sealed access road need repairing.	Complete in January 2024
8	Security camera at top of quarry

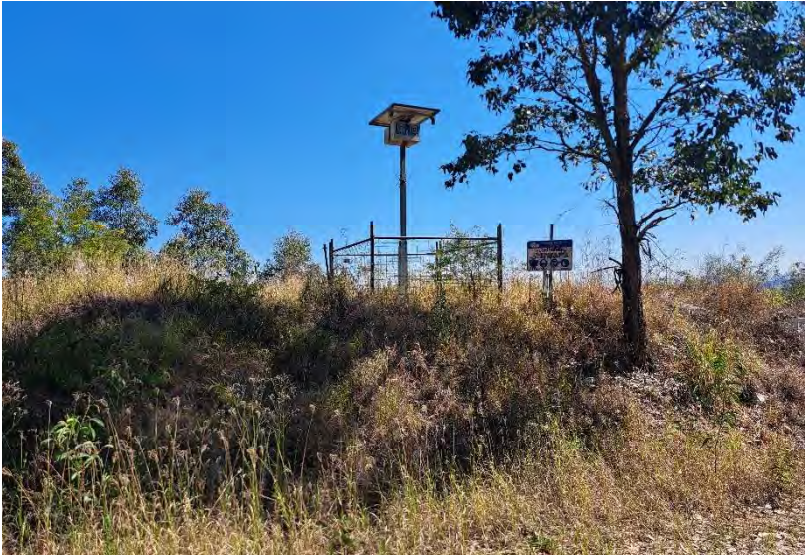
N/A	Nil – The security camera located at the top of the quarry is operating effectively – Positive observation.	N/A

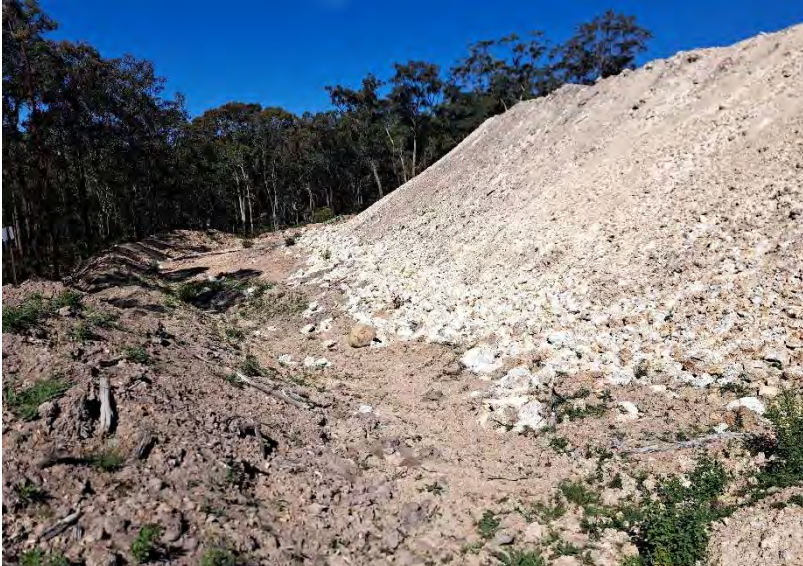
9	Northern pre-strip area

N/A	<p>Nil – The bund on the western section of the northern pre-strip area continues to show a good level of revegetation, whilst the northern stripped area continues to be well contained with all runoff directed to temporary water quality control structures – Positive observations.</p>	N/A
---	-------------------------	--	-----	--	-----

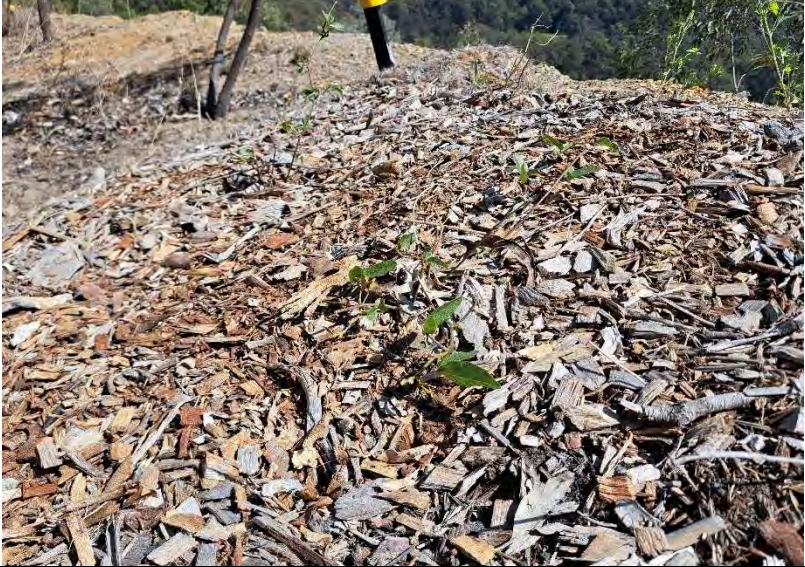
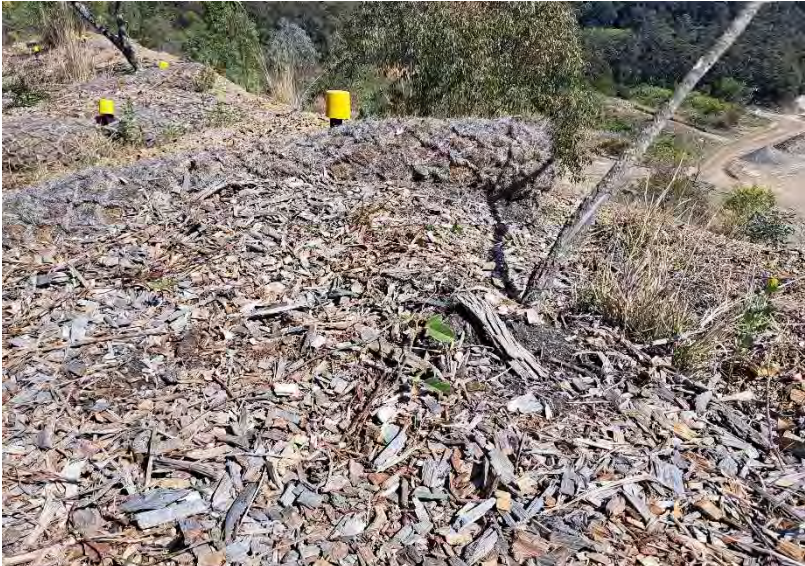
10	Bench #2 and #3

N/A	<p>Nil - The 'top-down plantings' installed earlier this year are still present and alive. This should hopefully provide additional 'ground cover' to the interface between Bench #2 and Bench #3 shortly – Positive observation.</p>	N/A
----	-----------------	--	-----	---	-----

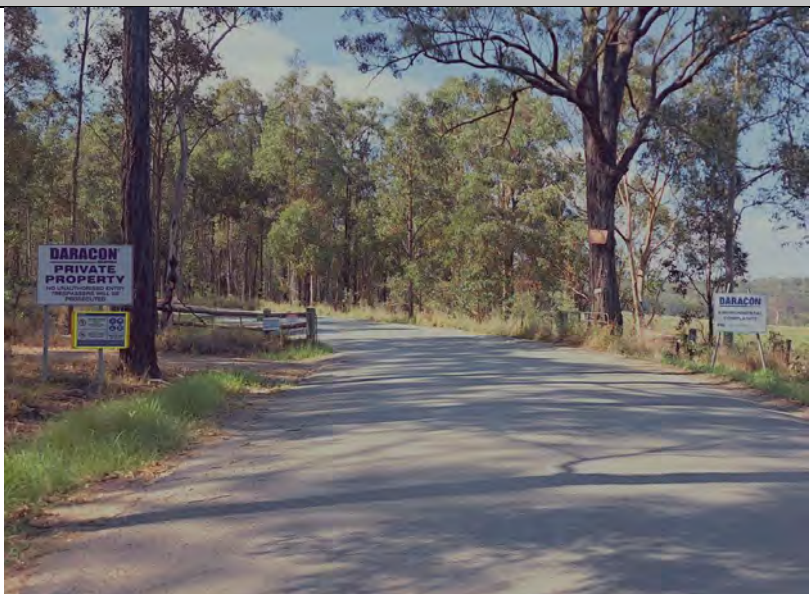
No.	Location (Area / description)	Issue / Comment	Recommended priority	Action	Close out date	
1	Buttai Quarry main access

N/A	Nil – All appropriate site access signage was installed and functional at the main gate – Positive observation.	N/A

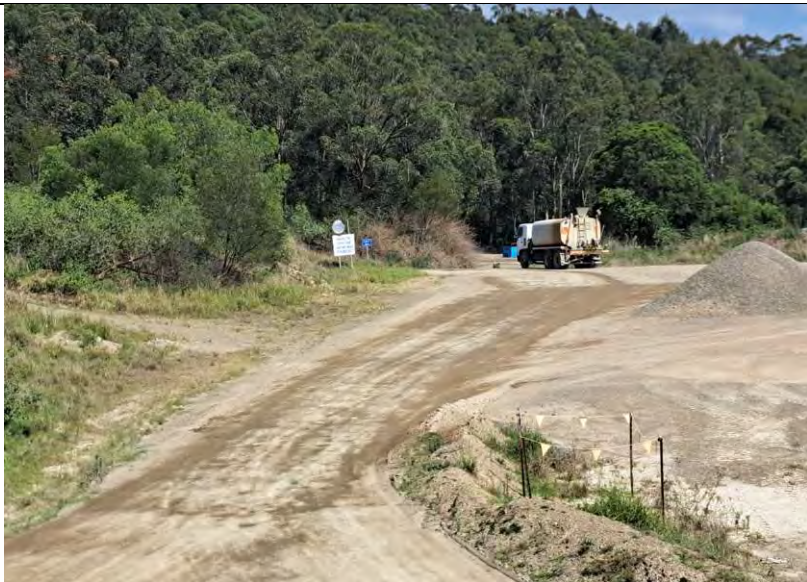
2	Dust control on site

N/A	<p>Nil – At the time of the inspection, there were two watercarts operating due to the extremely low quantity of site water available from the site dams. No evidence of dust generation – Positive observations.</p>	N/A
---	----------------------	--	-----	---	-----

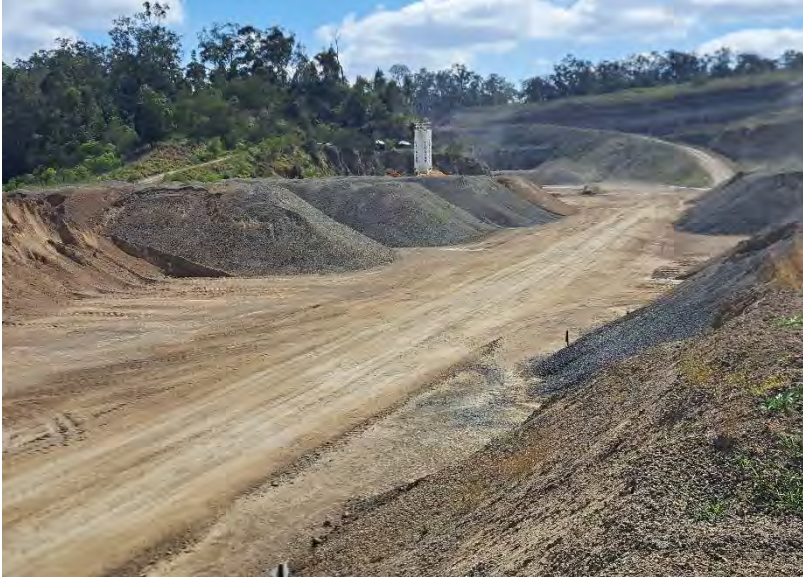
3	Active quarry and stockpile areas

N/A	Nil – No issues were identified within the active quarry face and stockpile areas of the site – Positive observations.	N/A
---	-----------------------------------	--	-----	--	-----

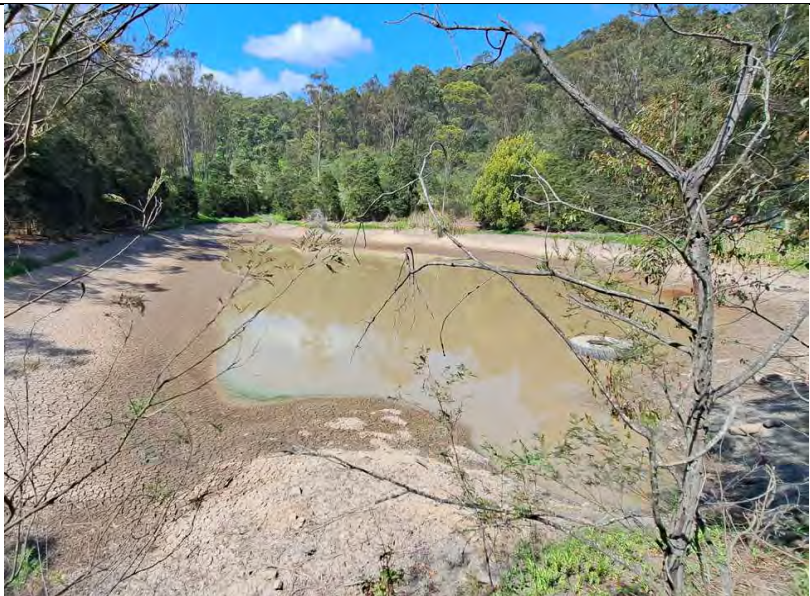
4	Dam 1

Consider	At the time of inspection, Dam 1 was almost completely empty. It may be worth considering de-silting activities in the near future.	
5	Dam 2

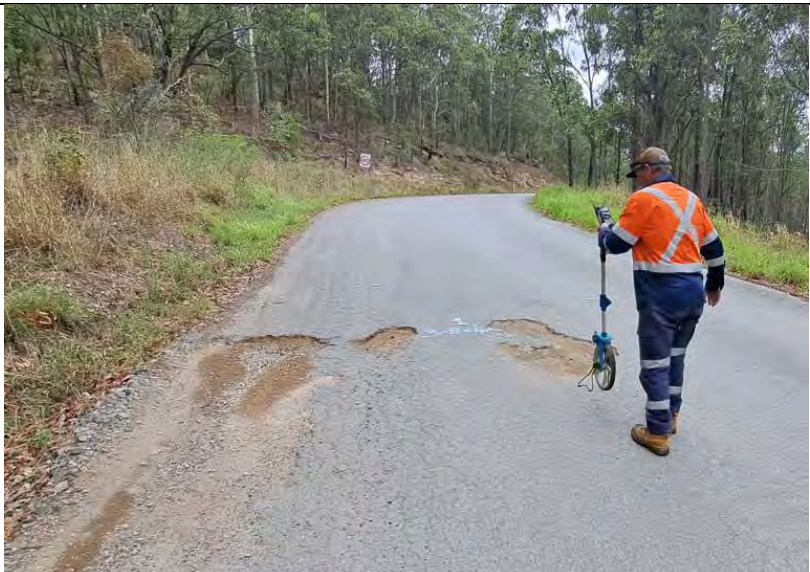
8	Main access road pothole repairs

N/A	Pending - Ian Rich Asphalt have been engaged to repair the potholes in the access road with the work scheduled for early 2024 – Positive observation.	N/A
9	Security cameras on site	 	N/A	Nil – There are a few security cameras operating on site and they appear to be functioning effectively – Positive observation.	N/A

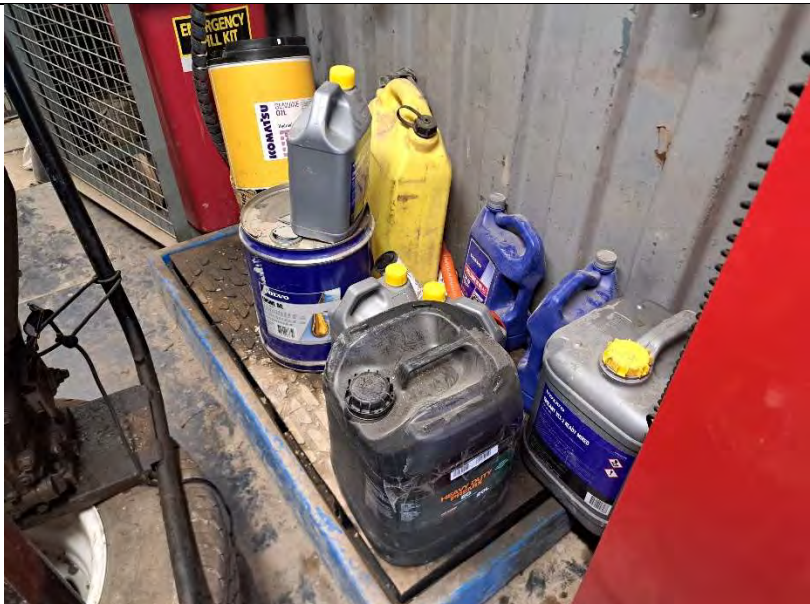
10	Chemical storage

N/A	Nil – Chemicals were stored in a bunded tray – Positive observations.	N/A
11	Silt fences

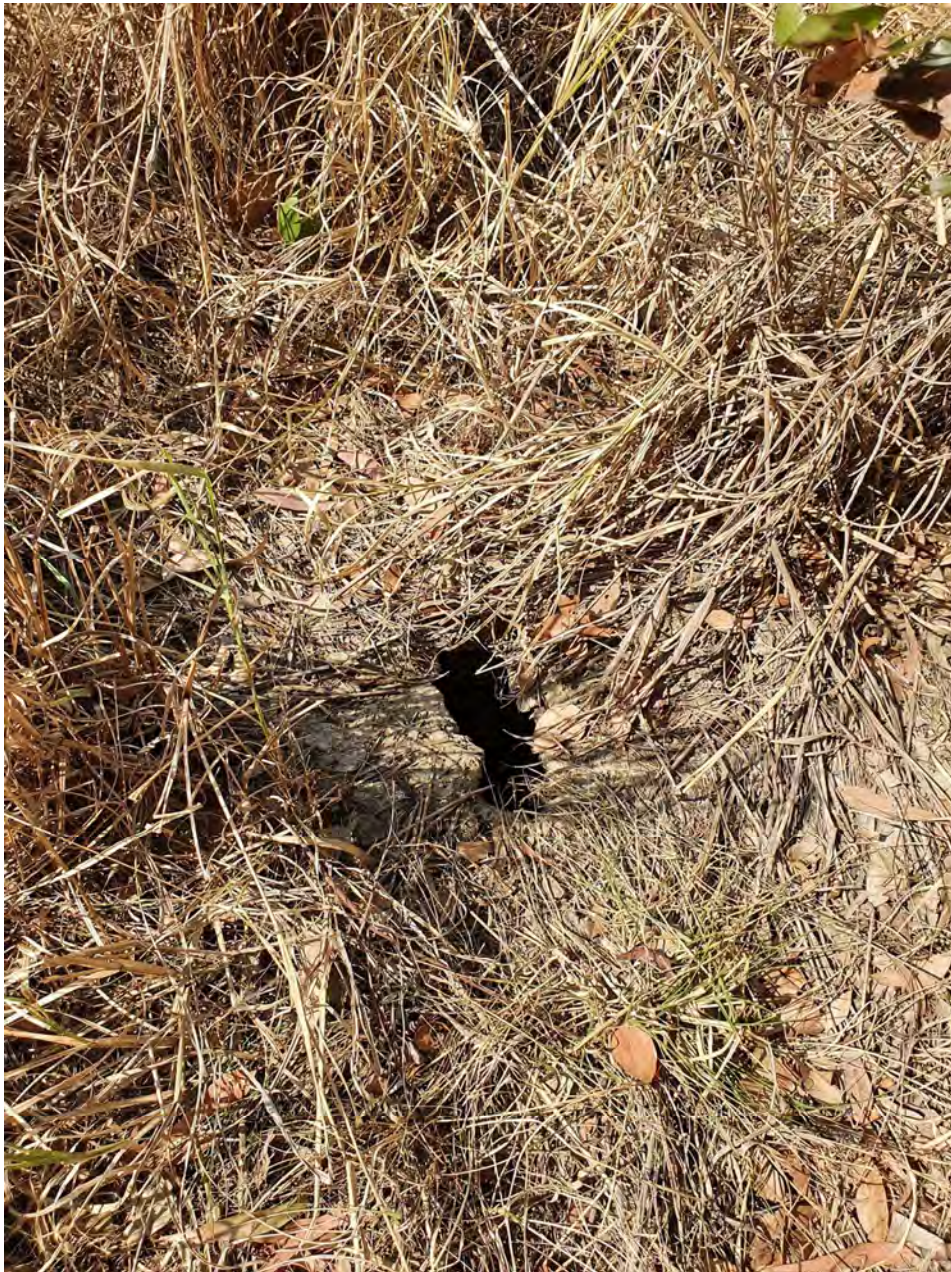
Site Name	Lot 76 Western Rehabilitation (South End)
	substantial erosion was noted in this area, however a small sinkhole (approximately 1-2m depth, seen in Photo 2.1) was found close to the access road (at co-ordinates 365169, 6365633).
Fauna Utilisation	An array of small woodland birds were seen and heard in the area. A silvereye (<i>Zosterops lateralis</i>) nest and macropod scats were observed.
Management Recommendations	Continue to use stripped topsoil for rehabilitation in the future. Sinkhole hazard should be marked so it can be avoided.

Photo 2.1 Sinkhole at Lot 76 Western Rehabilitation (South End)
