ARDGLEN QUARRY

2020 Annual Environmental Management Report (AEMR)

PROJECT APPROVAL MP 06_0264

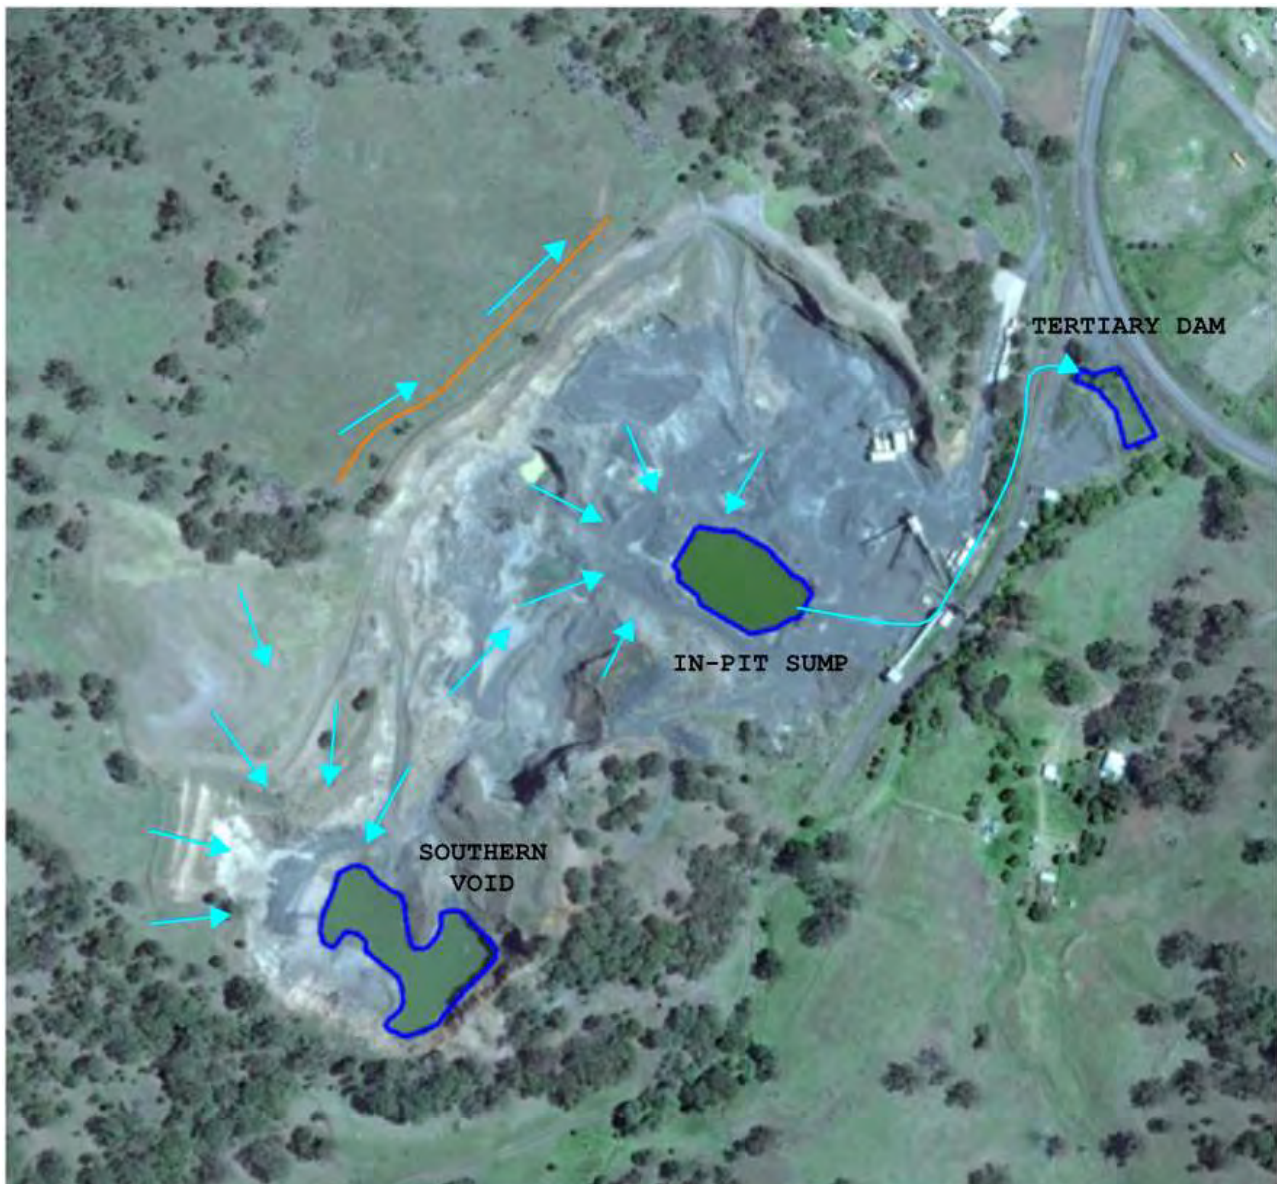
Figure 2: Water Management

A revised Water Management Plan, including the following, is included as part of the proposed consent modification. Subject to approval, this will be enacted prior to commencing work in the Extension Area.

- An assessment of basin volumes is included as part of the proposed consent modification;
- An assessment of the reliability of the water supply to the operation is included as part of the proposed consent modification;
- Operational and maintenance activities that could cause soil erosion and sediment generation will be identified and described;
- Procedures to manage unforeseen water quality impacts;
- Water treatment processes to enable discharge as required (subject to the approval of a variation to the site EPL);

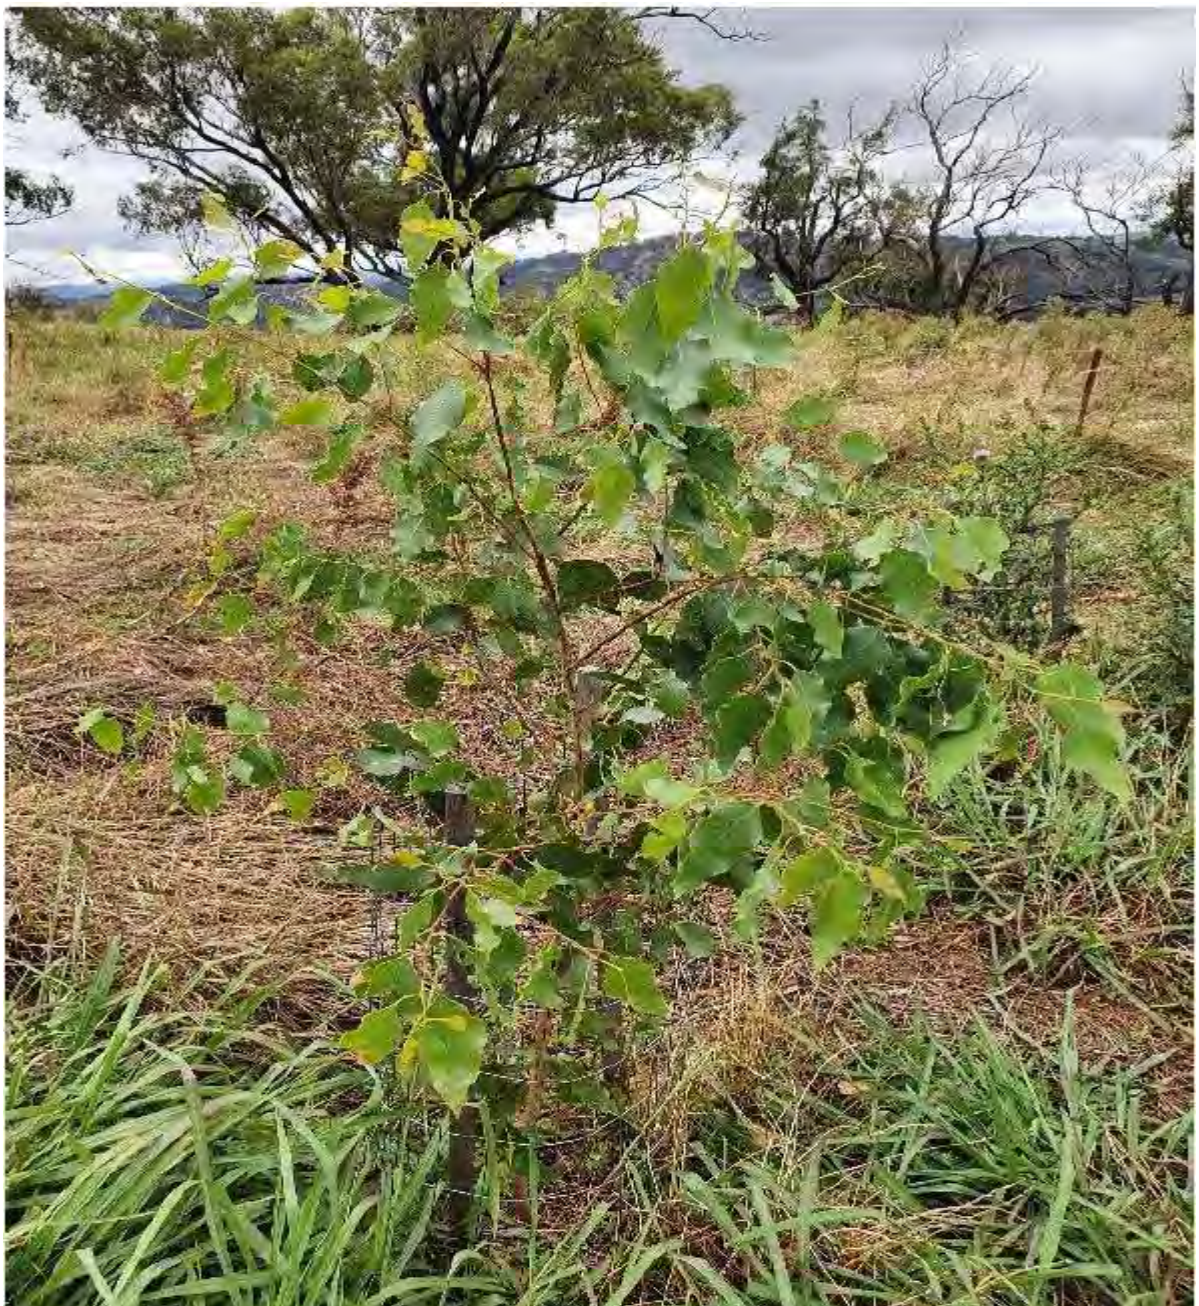
Photo 1: Rehabilitation planting on the western edge

In the Western Boundary (Top of Pit plantings), a dense exotic understorey was present. Weed management is not recommended in this area as the thick groundcover is acting to shield the smaller saplings from herbivory, and provide shelter from the elements. The plant guards in this area seemed mostly intact, and plant heights ranged from 0.2 to 1.7 metres in height, the upper end of which is shown in Photo 1 below. Given the timing of plantings in this area in the height of intense drought, the survival rate and condition of these plantings is very high. The watering protocol undertaken for these plantings has resulted in successful outcomes for this rehabilitated area.

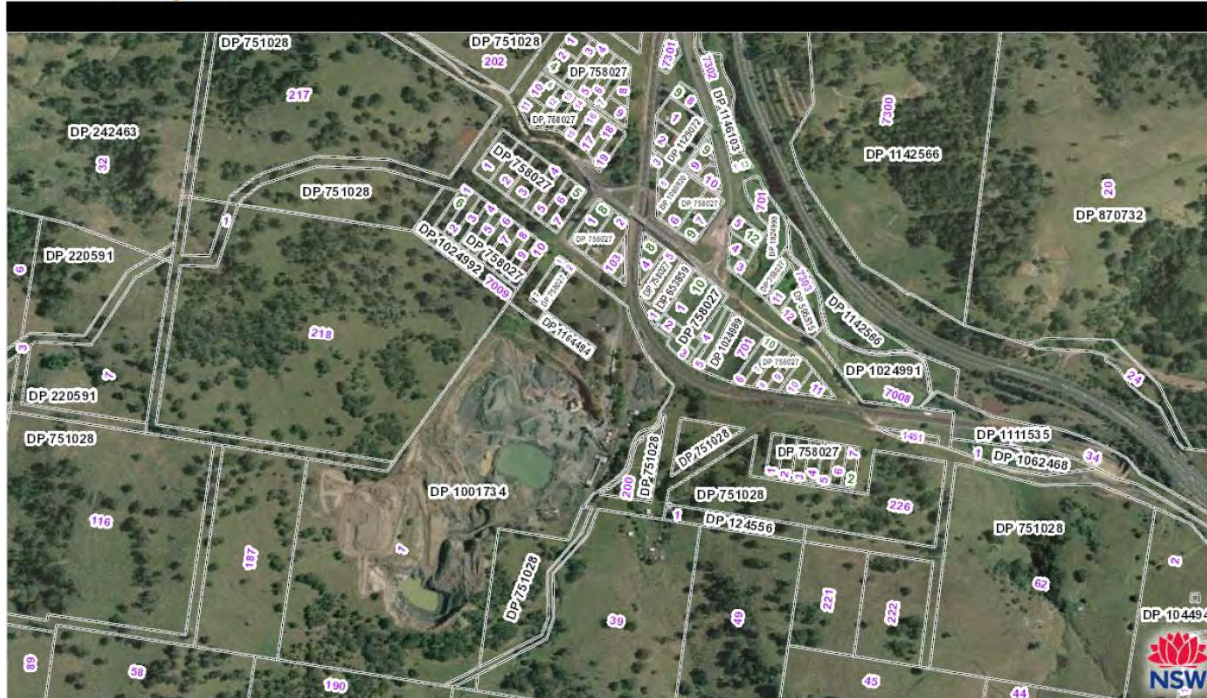
Figure 4: Land Ownership and Residents

Figure 4 displays the land ownership and residence surrounding the quarry. During the reporting period, it is understood that there were no changes to the land ownership within the area. Informal discussions have occurred with a number of residents in the area during the reporting period.

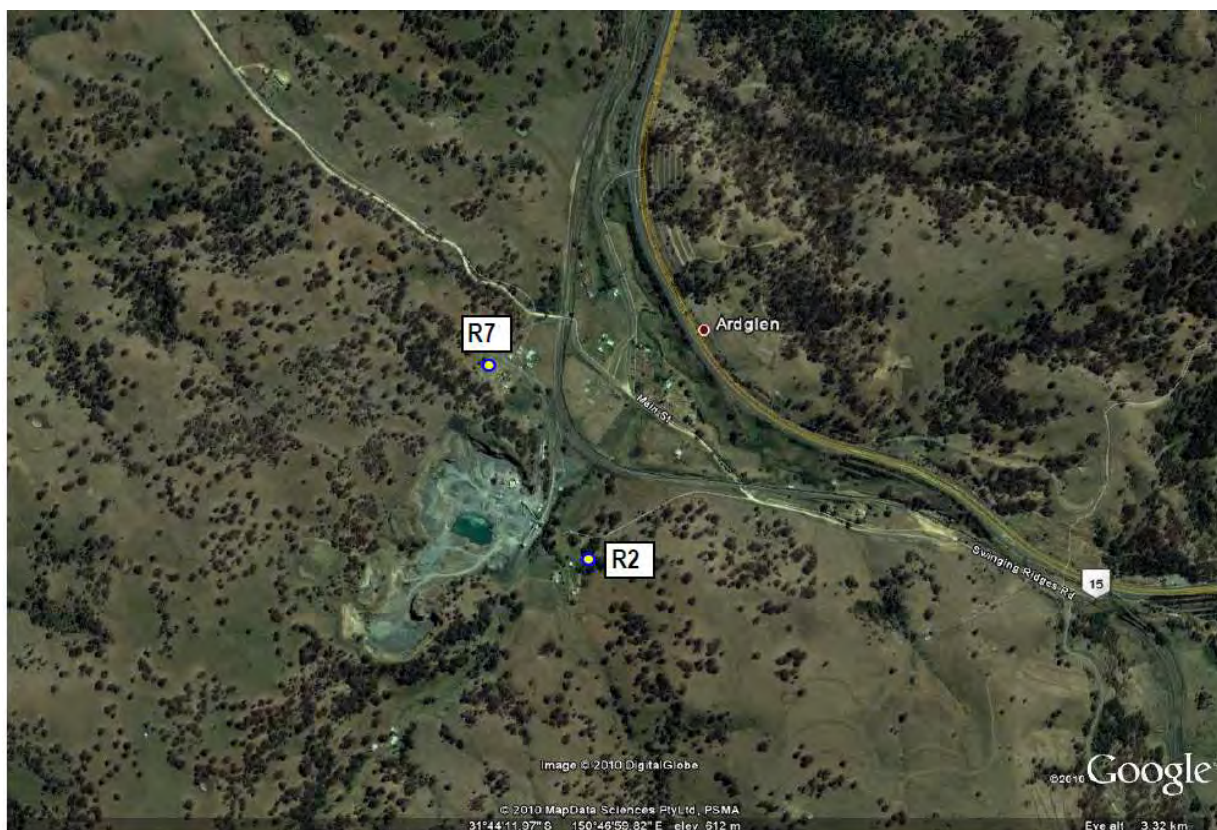
Figure 5: Blast Monitoring Locations

The Blast Monitoring program requires monitoring to take place at specified locations as shown in **Figure 5**. The Noise Monitoring Plan calls for quarterly attended noise monitoring to be completed and take place at specified noise monitoring locations as shown in **Figure 6**.

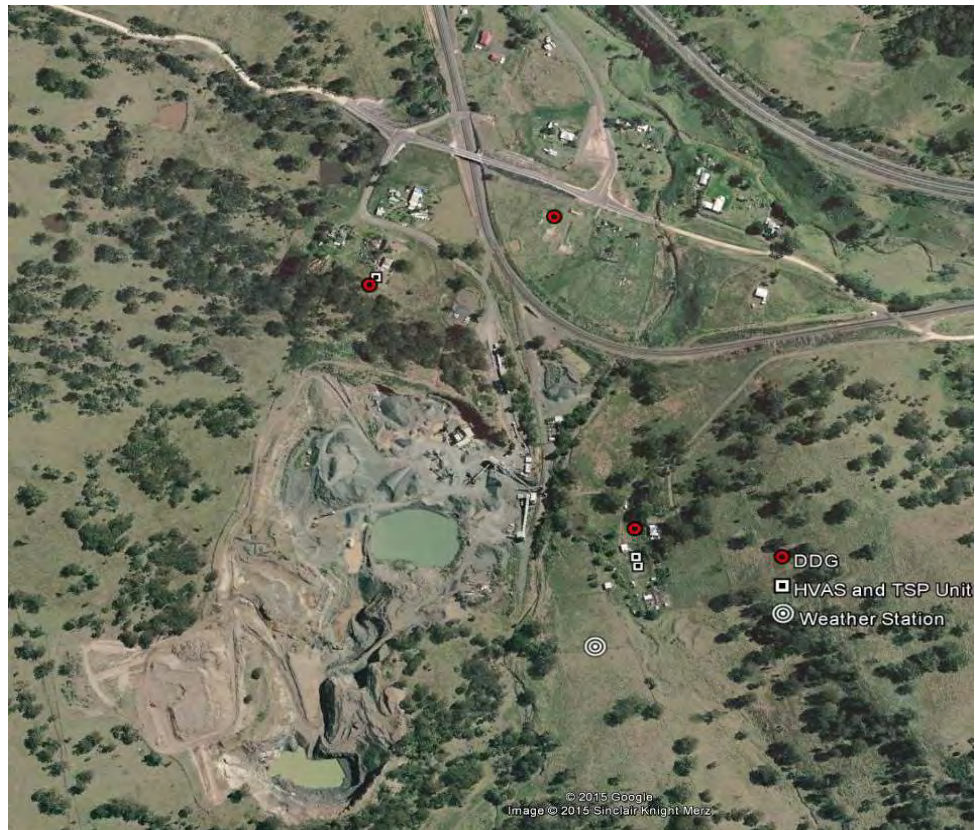
Figure 7: Air Quality Monitoring and Weather Station Locations

Condition 18 (32) requires that a meteorological station to operate in the vicinity of the project site for the life of the project. Daracon has installed a meteorological station (Figure 7), ensuring that the meteorological station complies with the requirements in the "Approved Methods for Sampling of Air Pollutants in New South Wales Guideline".

The current air quality monitoring network consists of three deposited dust gauges (DDG), two HVAS units and one TSP unit (see **Figure 7**).

The location of the air quality monitoring equipment (primarily to the North-East and East of the Quarry) was deduced from the location of the surrounding residences.

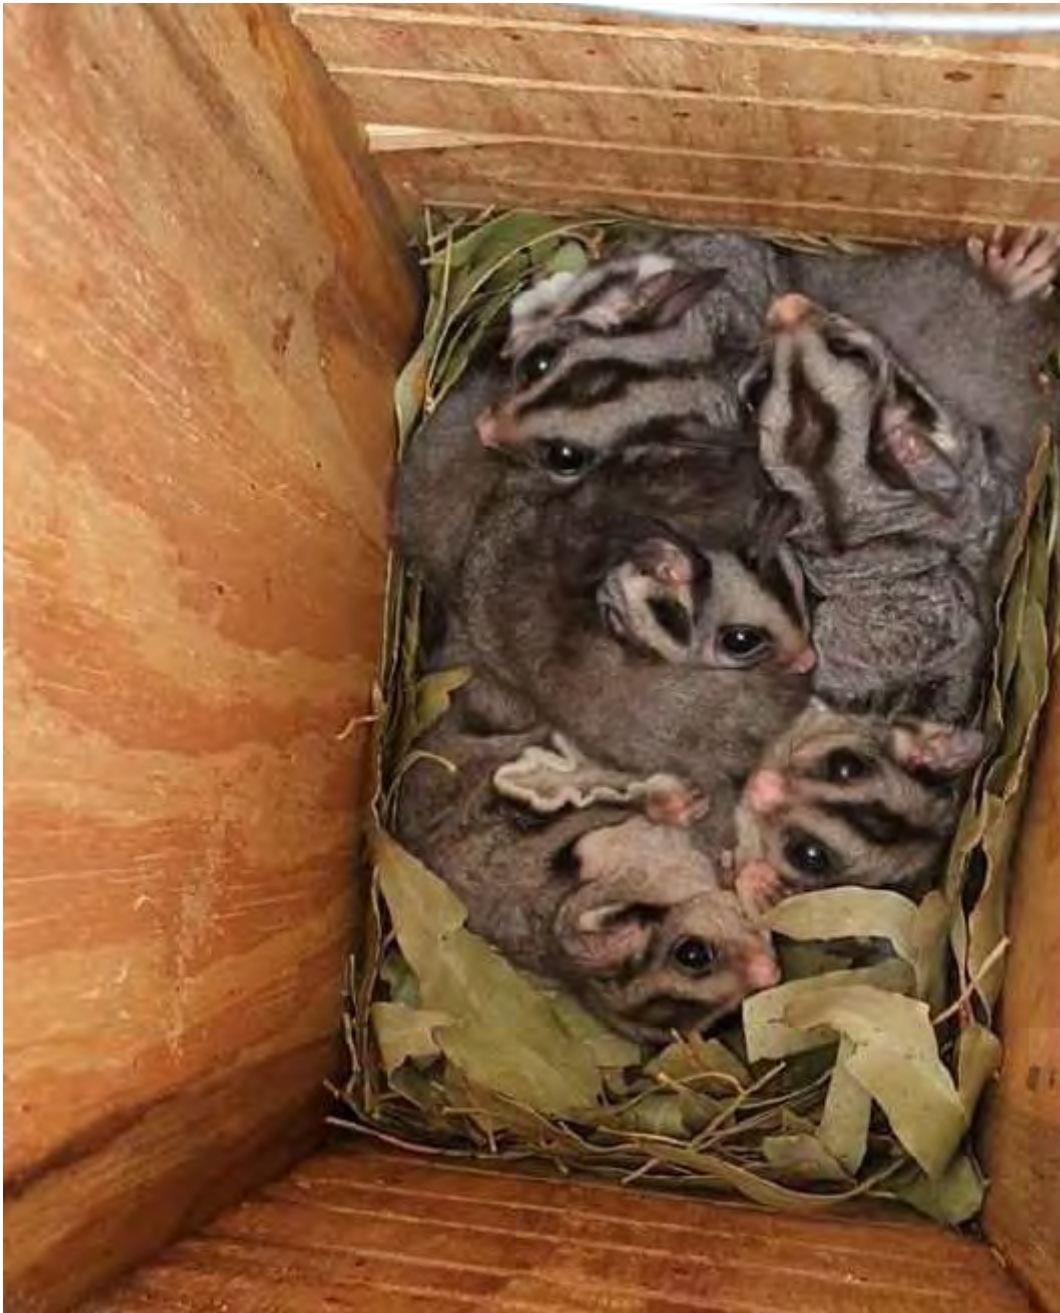
Photo 2: Nest box usage

- It is recommended that the ply stuck to the upper part of Nest Box 17 (TT158) is removed to better facilitate monitoring of the box, however this is a low priority as access to the box by animals does not appear to be impeded – **Daracon will monitor this matter and remove the errant material if we consider it impedes the use of the nest box;**

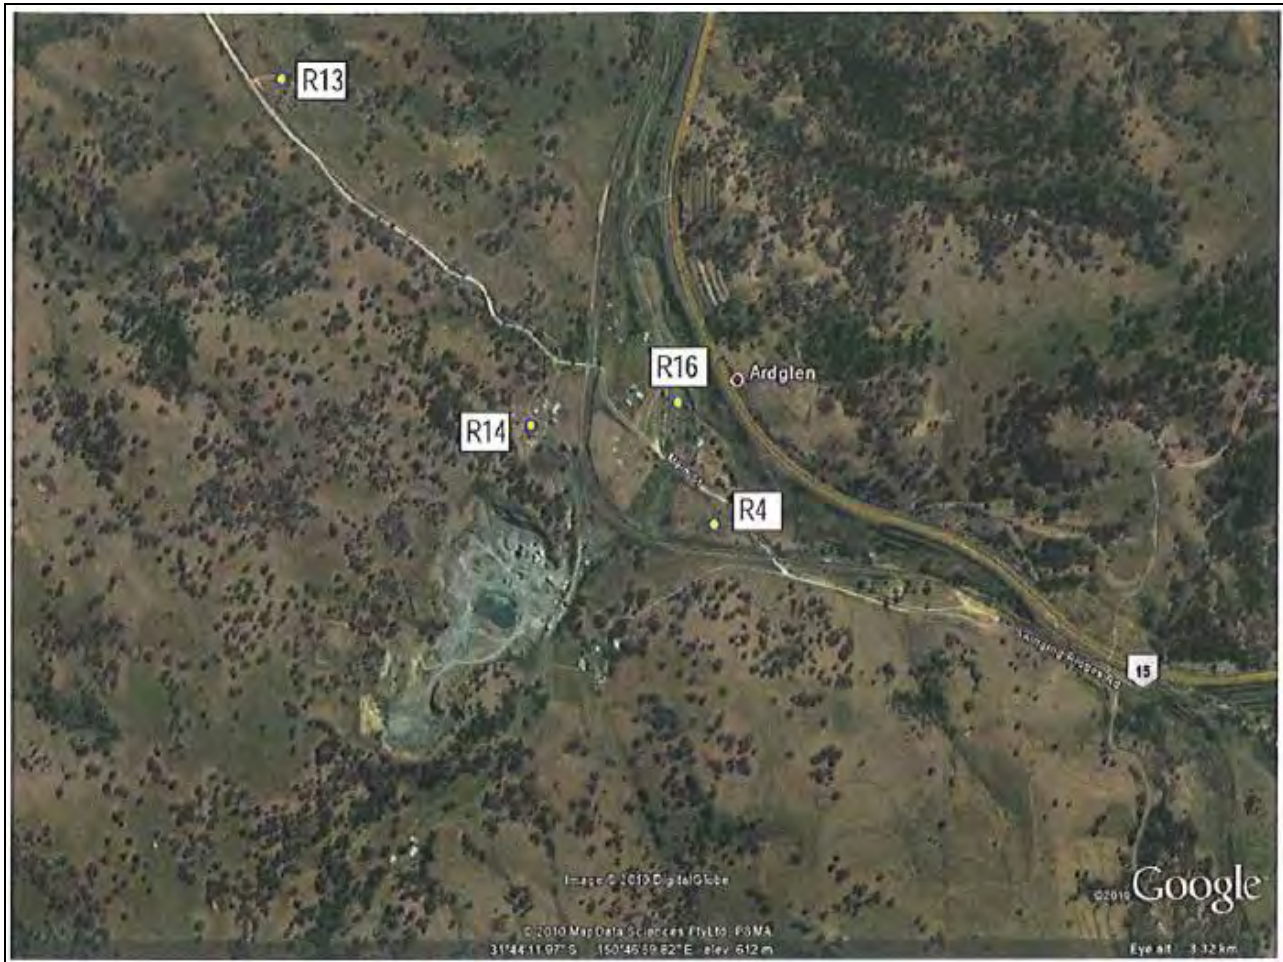
Figure 1 – Attended Noise Monitoring Locations

Noise measurement locations for the attended noise survey are listed below and shown in the accompanying **Figure 1**:

Location 4: C M Thompson
Location 13: McGhie
Location 14: Purtell
Location 16: Bojba

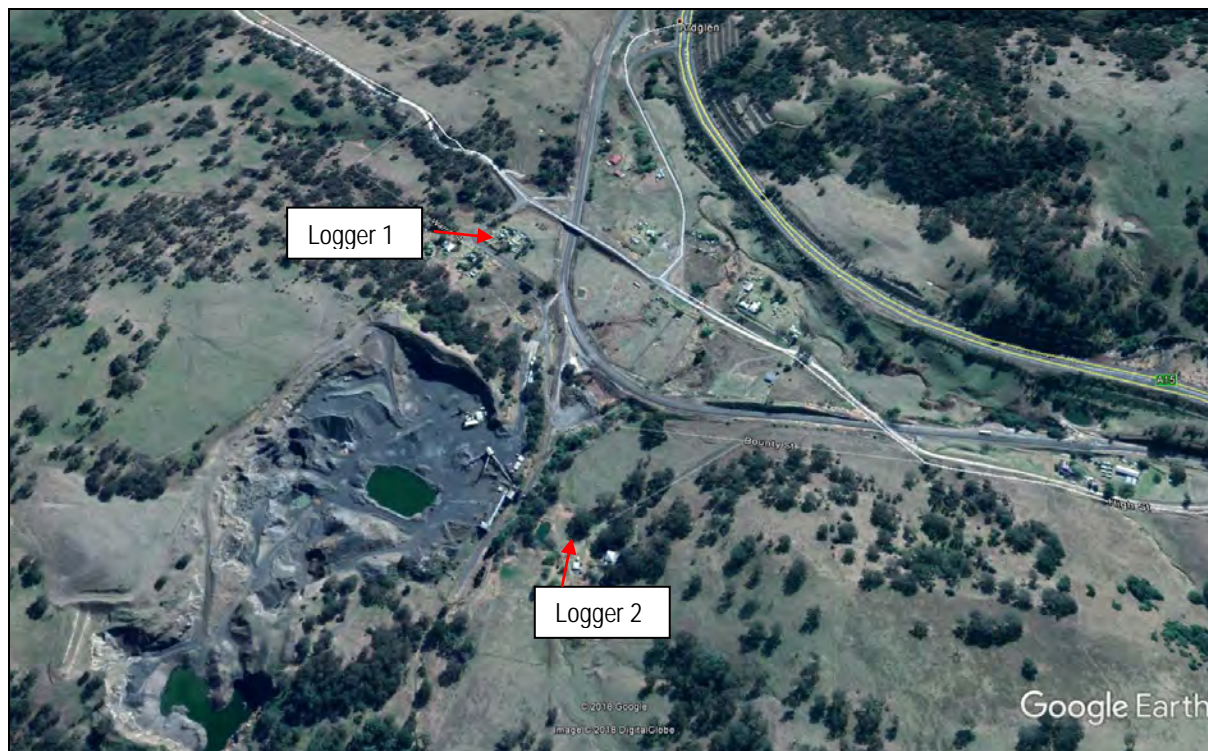
Figure 2 – Unattended Noise Monitoring Locations

To measure the acoustic environment Rion NL-42 sound level meters, set up as environmental noise loggers, were located as shown in Figure 2 from 15th to 22nd November, 2019. **Table 3** shows a summary of the relevant measured data from the loggers which is also shown graphically in **Appendix I**.

The logger locations were chosen to be representative of the acoustic environment of the closest residences to the quarry and for security reasons.

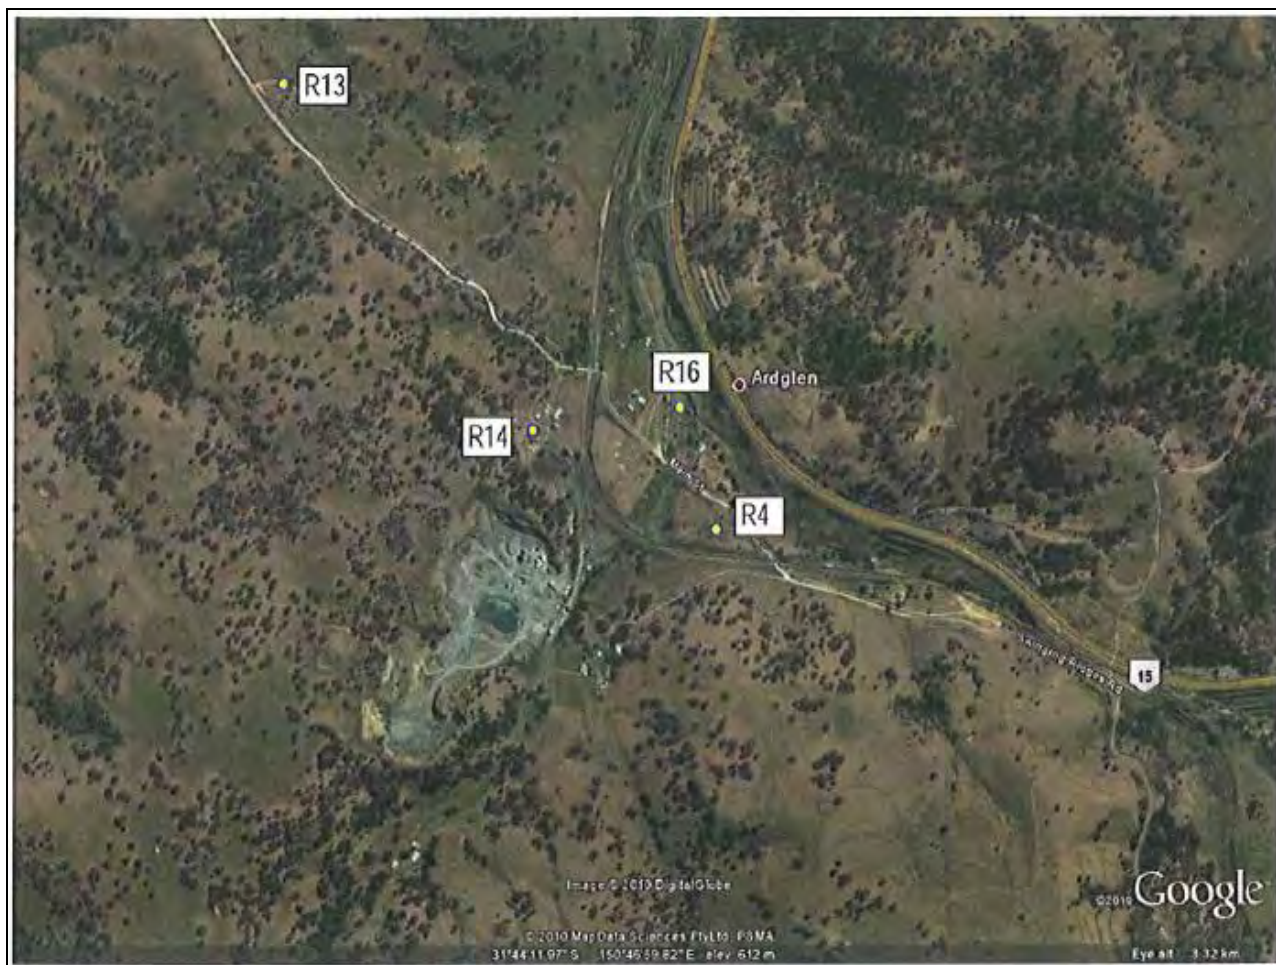
Figure 1 – Attended Noise Monitoring Locations

Noise measurement locations for the attended noise survey are listed below and shown in the accompanying **Figure 1**:

Location 4: C M Thompson
Location 13: McGhie
Location 14: Purtell
Location 16: Bojba

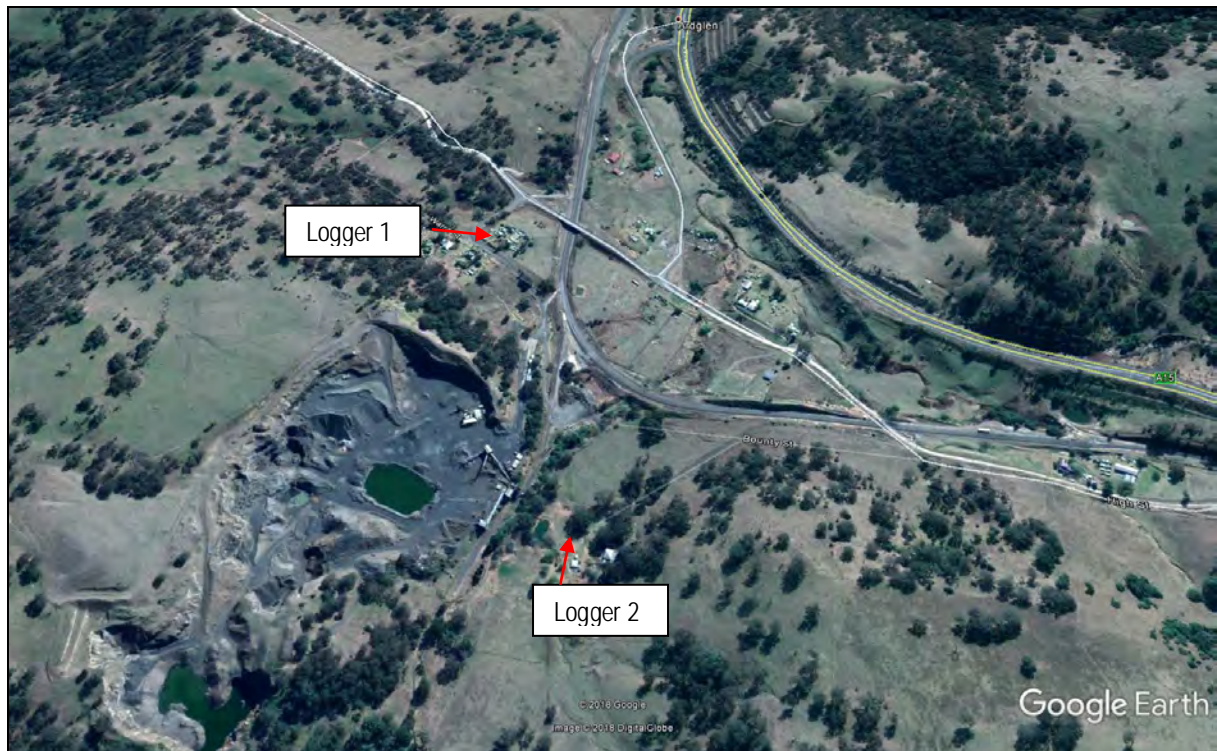
Figure 2 – Unattended Noise Monitoring Locations

To measure the acoustic environment two x ARL EL-315 environmental noise loggers, were located as shown in Figure 2 from 18th to 25th November, 2020. **Table 3** shows a summary of the relevant measured data from the loggers which is also shown graphically in **Appendix I**.

The logger locations were chosen to be representative of the acoustic environment of the closest residences to the quarry and for security reasons.

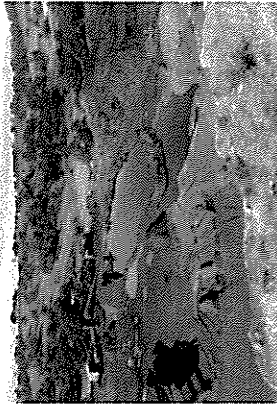
1.	Main central dam.	The main dam on the quarry floor was nearing capacity from recent ongoing rain events. The water clarity was good with very low turbidity indicating low levels of erosion in the catchment.	Continue to monitor the dam, drainage lines and contributing catchment. ✓ Ongoing R

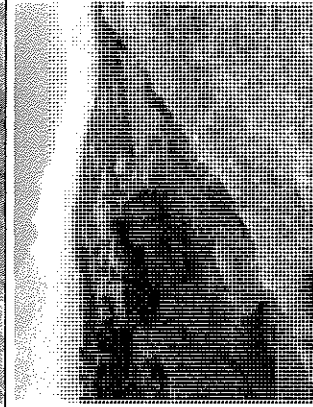
2.	Quarry slopes and floor.	The inspection around the quarry floor confirmed runoff was directed to the central dam. No significant outbreaks of weed have established, and in general terms, weed infestation control is good.	As recommended previously, ensure regular weed control continues with a focus on noxious weeds on boundary areas. ✓ Regular weed spraying continues to occur R.

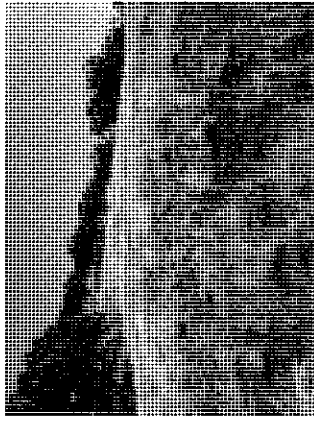
PROJECT:	Ardglen Quarry	INSPECTION REPORT NO.	4	INSPECTION DATE	29 th May 2020
ISSUE NO.	LOCATION	ISSUE/MATTER	RECOMMENDATION/COMMENT	PHOTOGRAPH	
4.	Rehabilitation of offset areas.	As noted above, an extensive tree-planting program has commenced in several areas surrounding the quarry.	We inspected the plantings on the northern escarpment. The majority of seedlings have survived summer growing conditions, are where specimens have perished, replacement tube stock have been replanted in recent months.

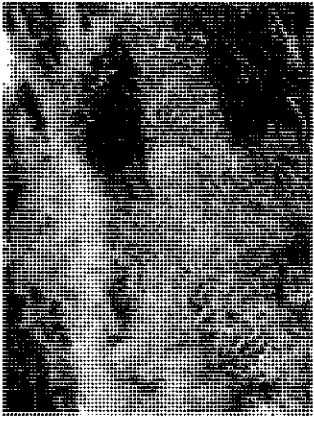
5.	Weed control – main quarry	As noted above, weed suppression has been effective across most areas, with no significant outbreaks noted in the main quarry floor and surrounds. A small outbreak of 'Paterson's Curse' was noted around the quarry entrance and site sheds. Evidence of die back of previously treated areas was noted in several areas.	Continue to monitor the workings and perimeter areas and implement periodic weed control as required. <i>✓ Regular weed spraying occurring</i>

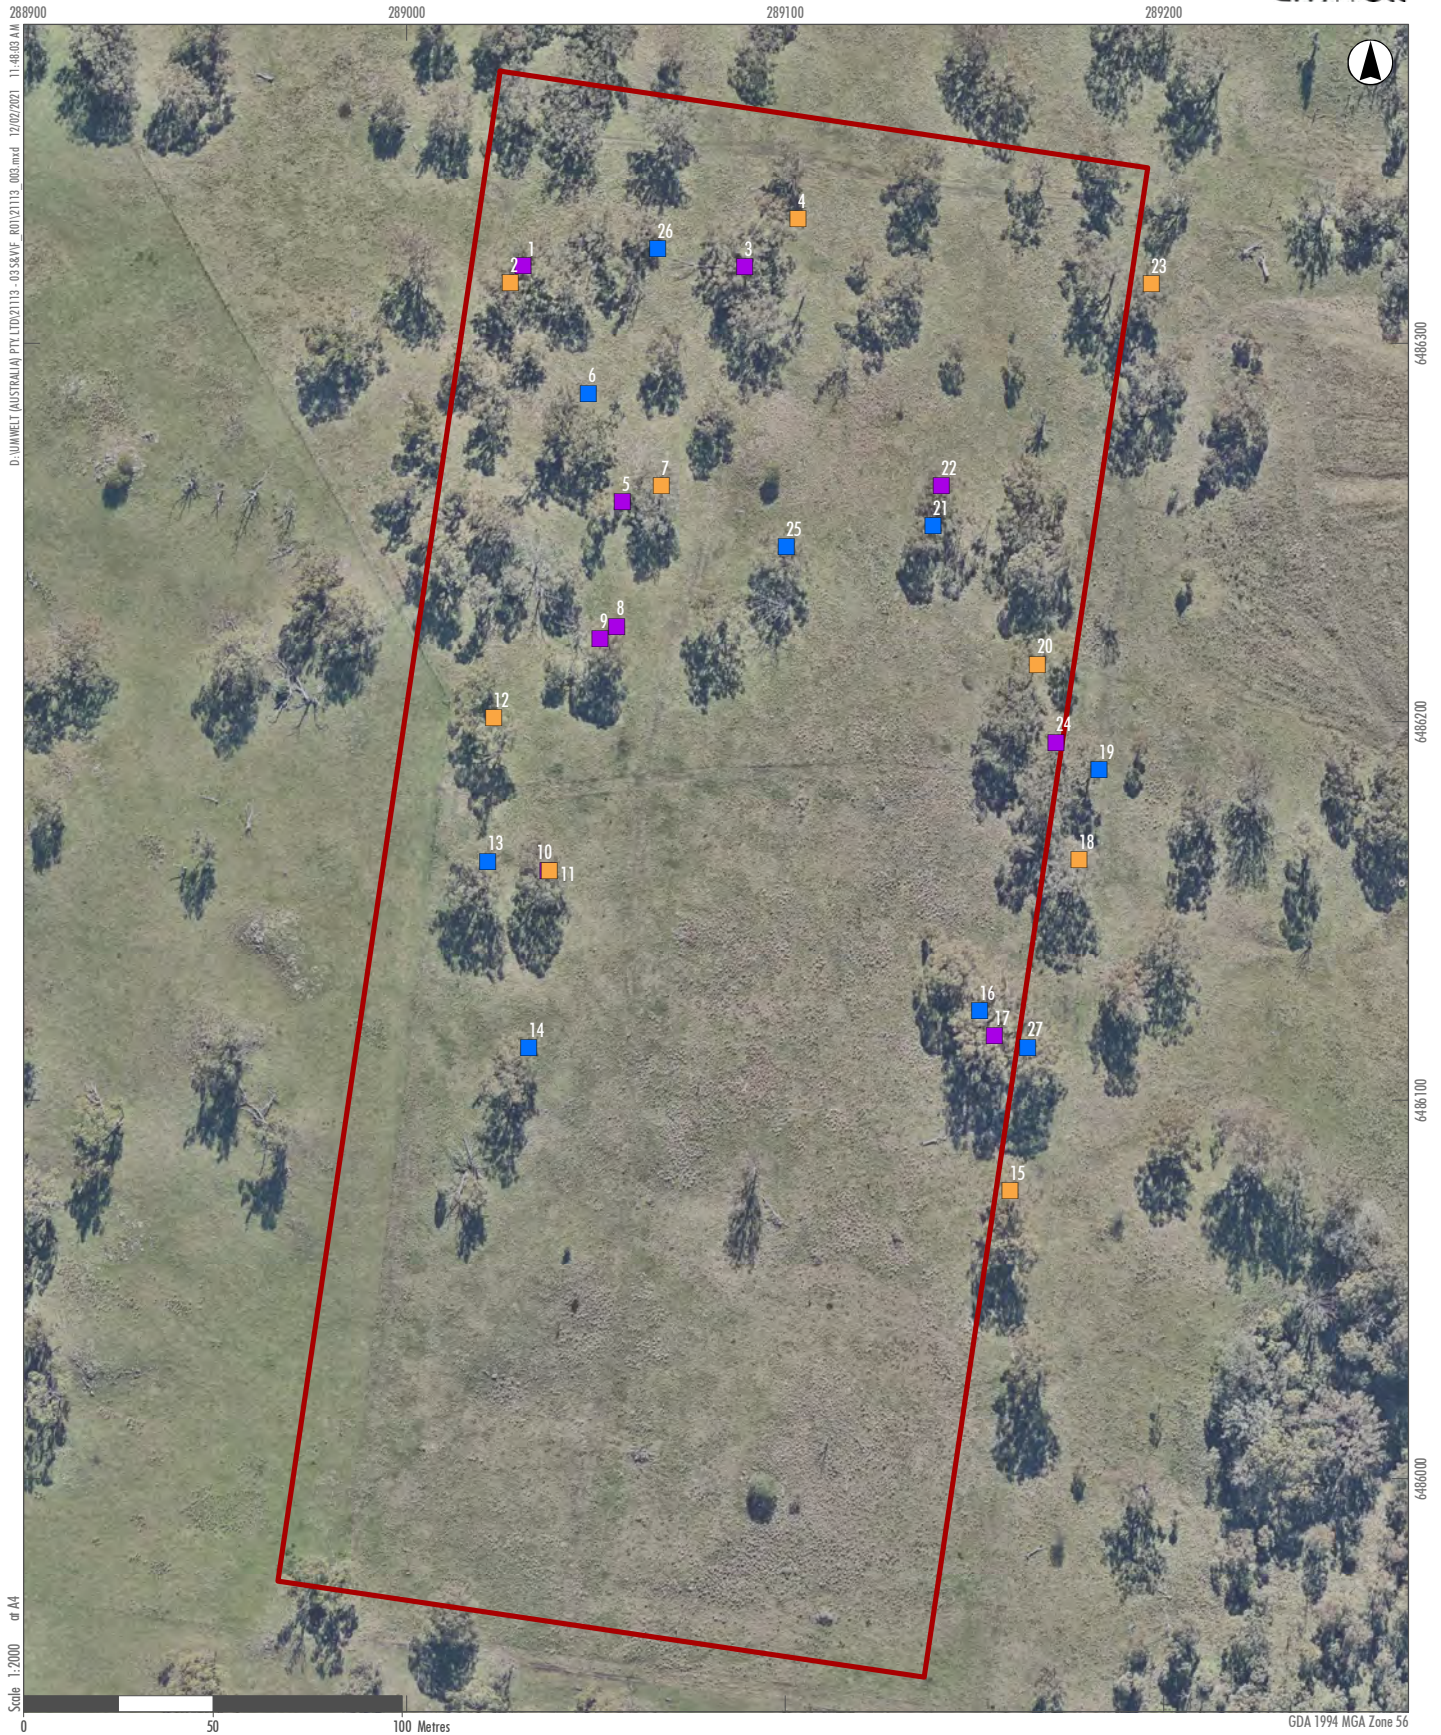
FIGURE 2.2
Nest Box Locations

Nest box monitoring was undertaken for 27 nest boxes installed in Offset A (Lot 187 DP 751028) which are shown in **Figure 2.2**. These boxes were comprised of:

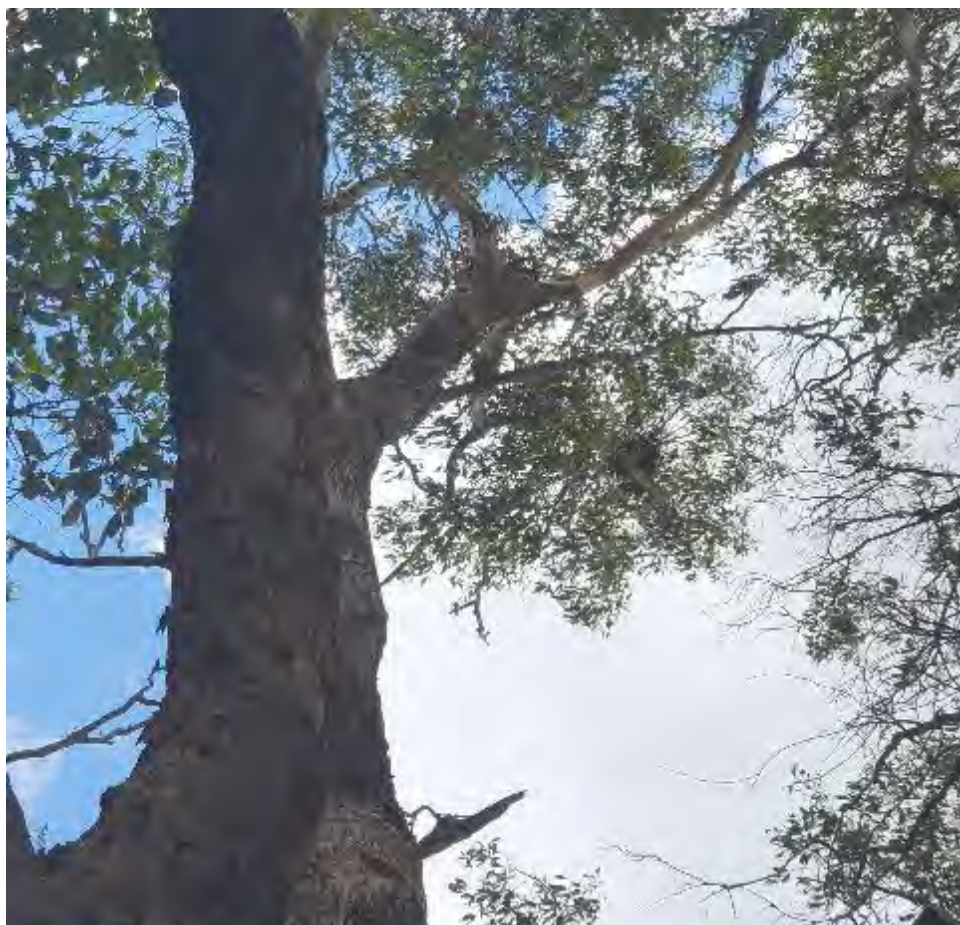
Table 11: Noise monitoring 28th February 2020

No targeted threatened species searches were undertaken as part of this monitoring, however the little lorikeet (*Glossopsitta pusilla*) was again identified in the offset areas in 2020 during the walkover. It is suspected that a nest discovered in Offset A may have been made by little lorikeets, which is a positive sign of continued use of the habitat in the BOAs by this species (see **Plate 4.1**).

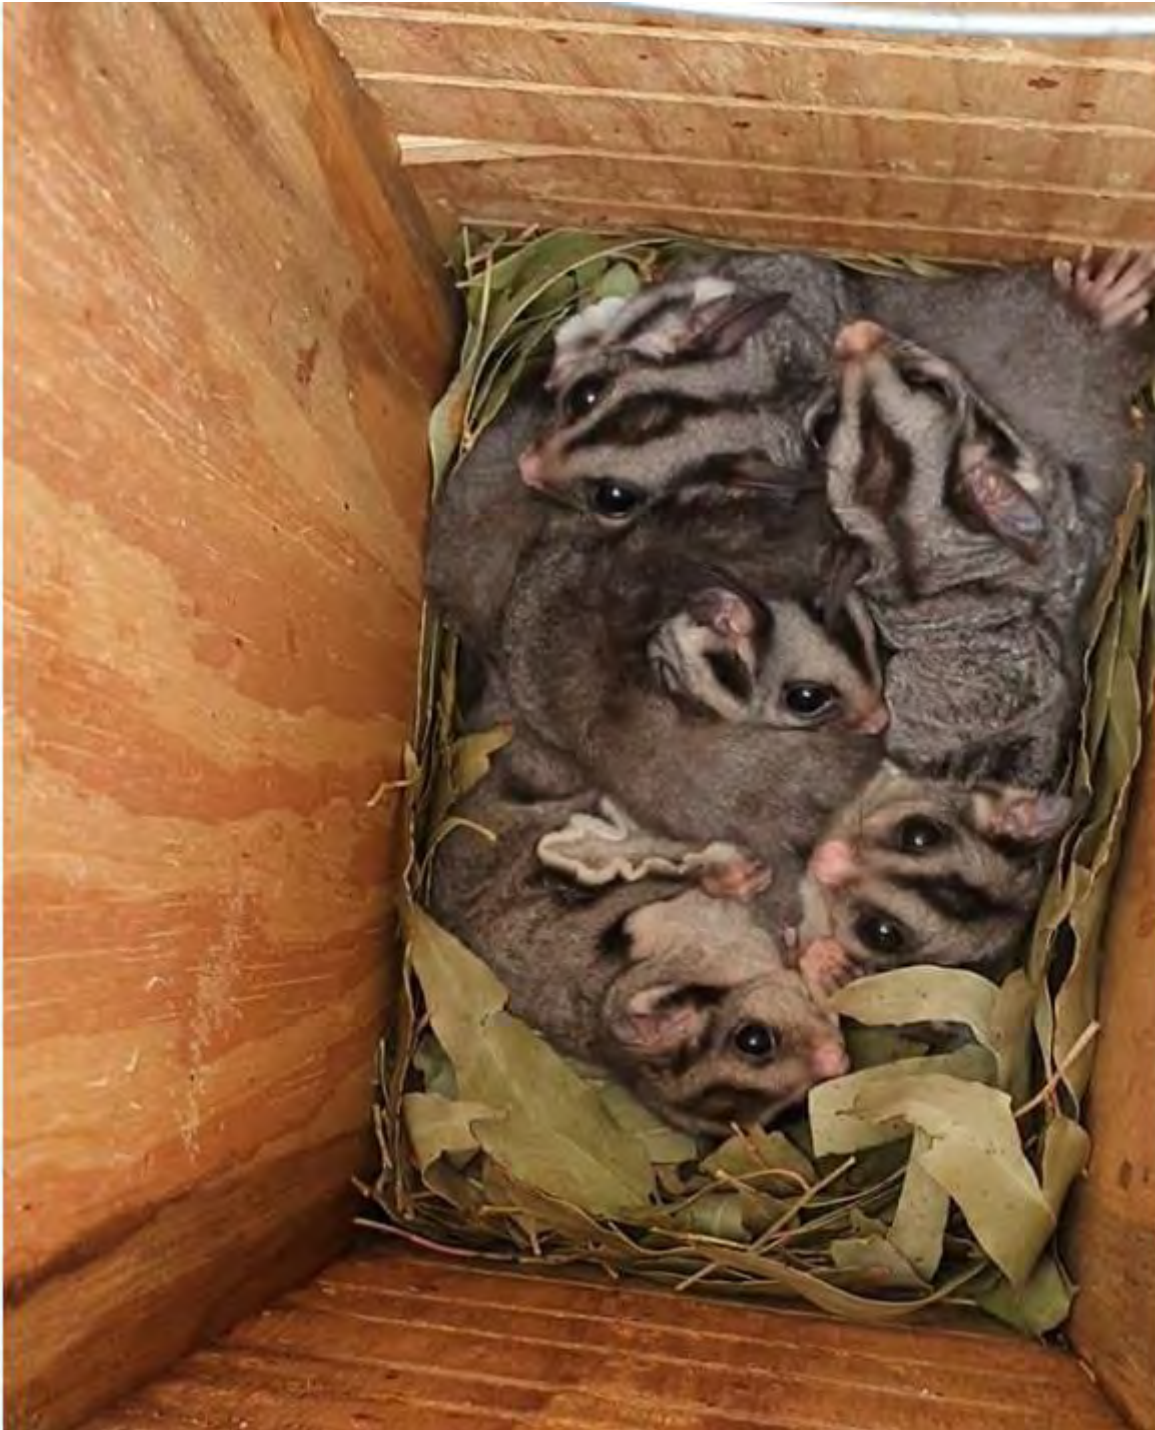
Plate 4.2 Gliders (sugar or squirrel, indeterminate) in NB22/TT112

This year's monitoring period showed greater usage of nest boxes by vertebrate fauna, with target glider species utilising four nest boxes (14.5%), and bird species utilising 7 boxes (25.9%) as shown in **Plate 4.2** and **Plate 4.3**. An eggshell was found in NB24/TT115, which is an excellent sign that the nest boxes are being utilised for breeding. There were positive signs of use of a high percentage of boxes (79.3%), which is lower than last year, however this year's monitoring event produced stronger signs of occupation. Two boxes were found to contain glider species in their characteristic nests, though the exact species (sugar glider *Petaurus breviceps* or squirrel glider *Petaurus norfolcensis*) could not be determined from the footage.

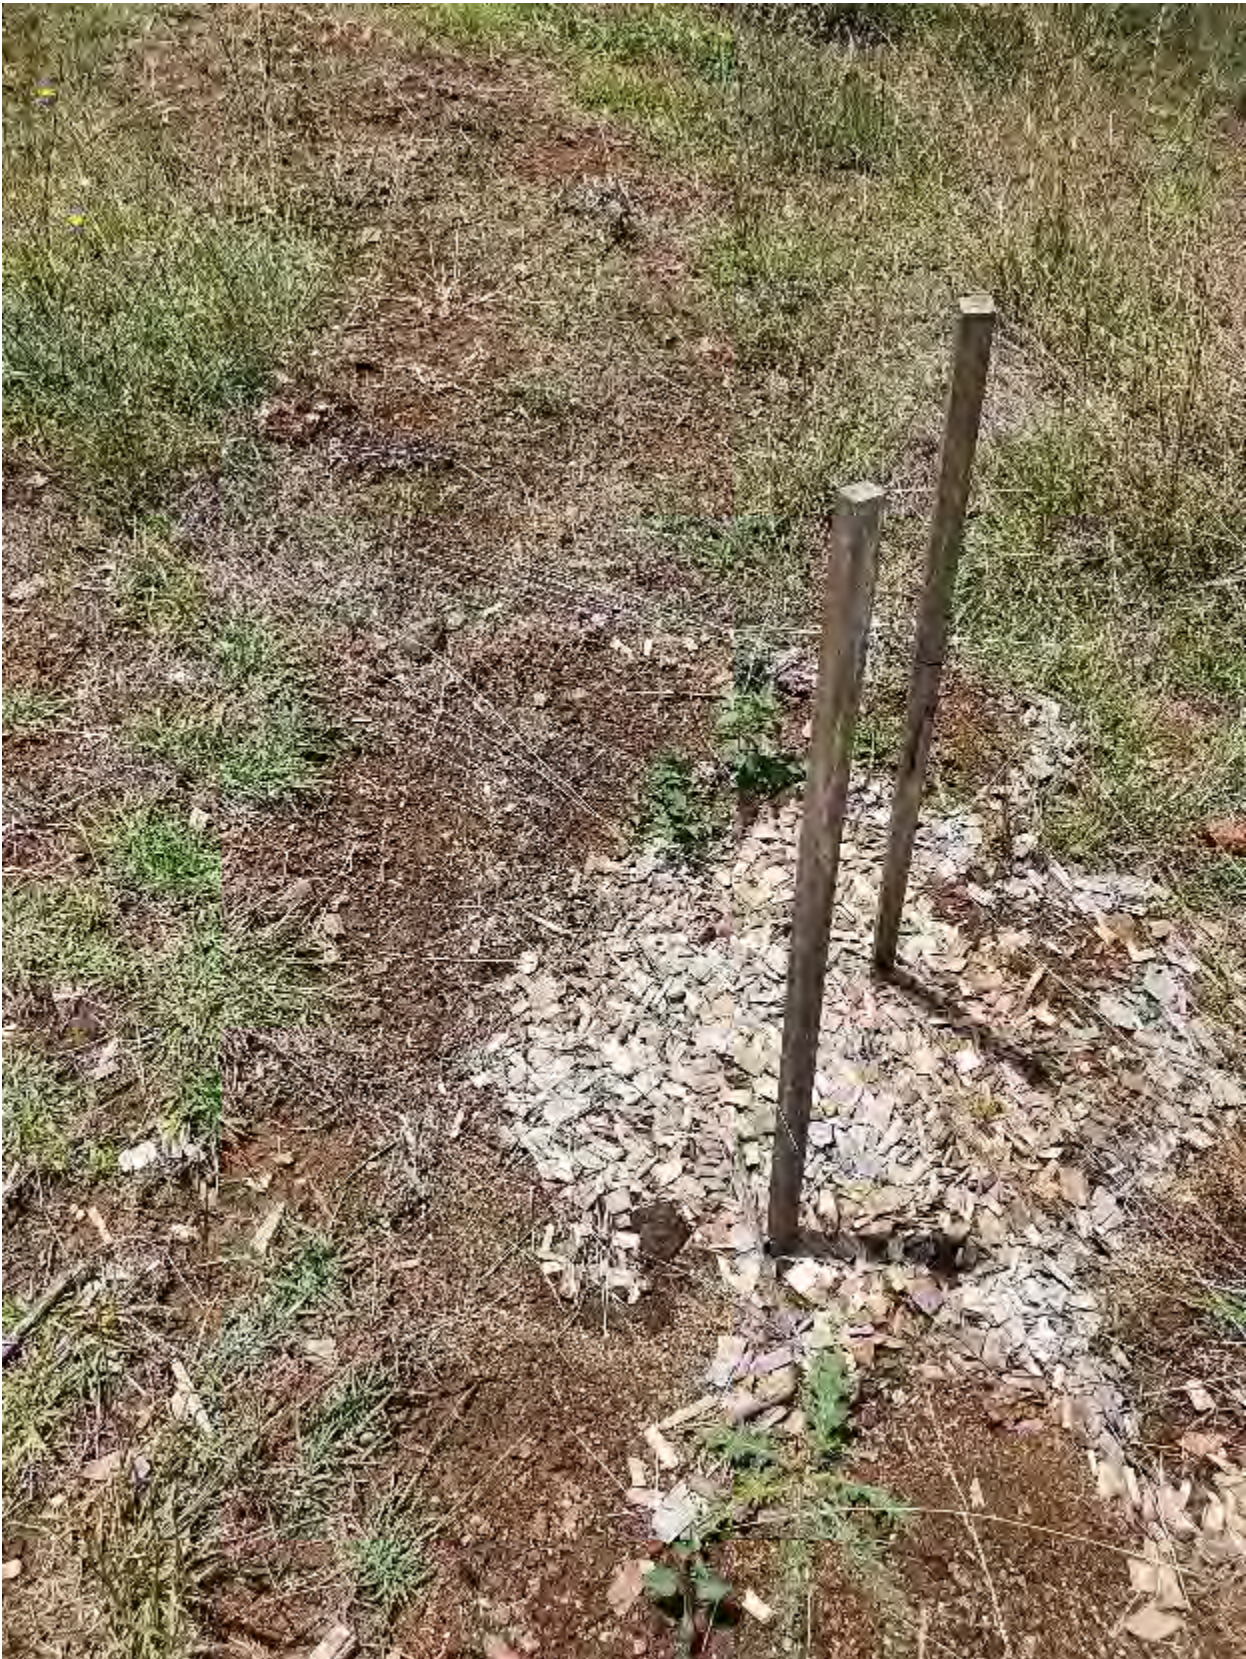
Plate 4.5 Destroyed wire mesh guard and browsed plant in Southern Rehabilitation

In the Southern Rehabilitation area, the survival rate is slightly lower than that of the plantings further up the slope in the Western Rehabilitation. This is likely because the plantings are in a more open, easterly facing setting at the edge of the quarry face, with less surrounding canopy cover and lower groundcover height. Its more exposed setting has also likely contributed to the slower apparent growth rate of the plantings and lower plant heights (0.1 to 1 metre). Despite this, there was a high success rate, which is a testament to the watering protocol Daracon have committed to over the last monitoring period. Herbivory also appears to be a higher risk in this area, with some of the wire mesh plant guards having been destroyed by macropods or feral grazing animals (deer seen in the vicinity) as shown in **Plate 4.5**. It is recommended that these destroyed wire mesh guards are replaced with the plastic mesh guards, which look to be of a sturdier construction.

- It is recommended that where metal mesh plant guards have been destroyed by grazers, these are replaced with plastic mesh plant guards as they are less likely to be dismantled – **In recent times, Daracon has utilised many different types of plant guards and also replaced those damaged as required. Daracon will monitor this matter and adjust the plant guards if deemed necessary;**

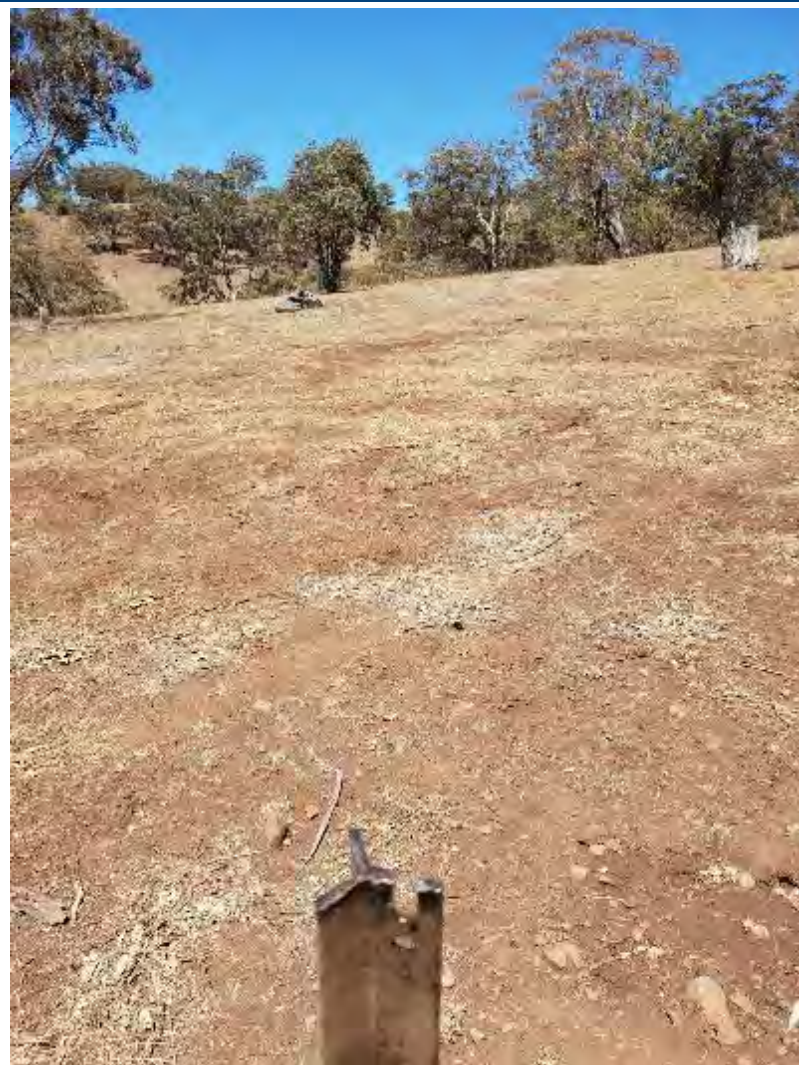
East 2019

Plot Q03: White Box (*Eucalyptus albens*) and Rough barked Apple (*Angophora floribunda*) Dry Sclerophyll Grassy Woodland
