ARDGLEN QUARRY

2020 Annual Environmental Management Report (AEMR)

PROJECT APPROVAL MP 06_0264

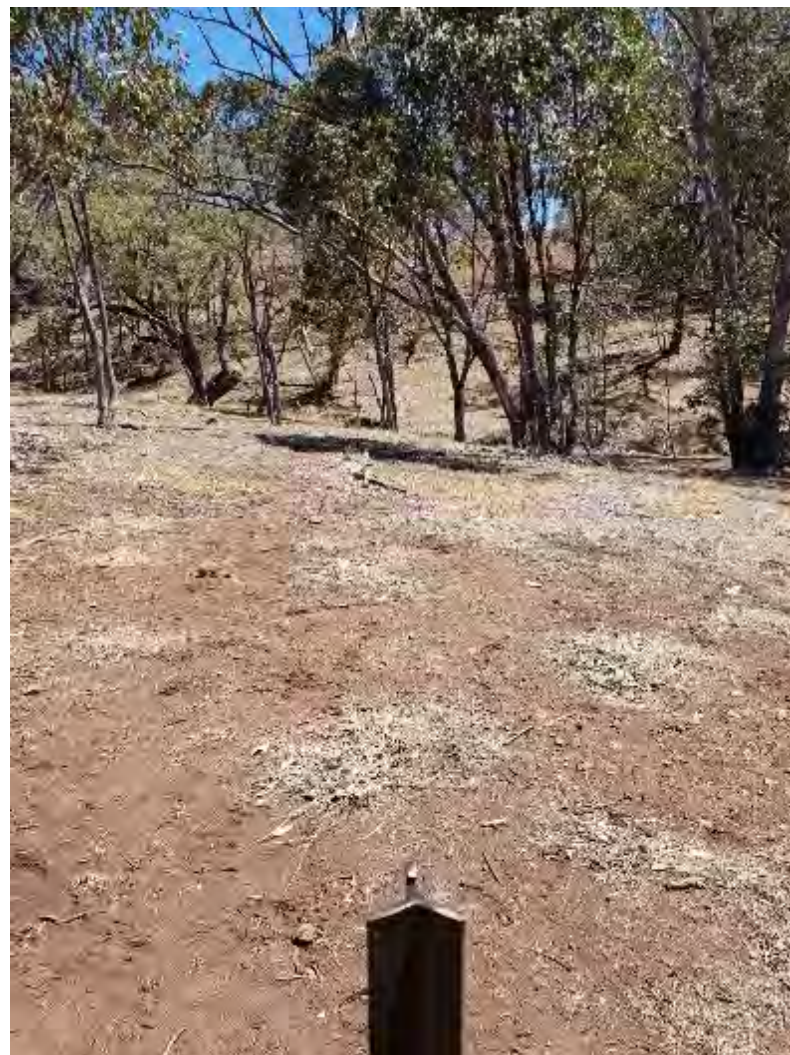
South 2019

Plot Q03: White Box (*Eucalyptus albens*) and Rough barked Apple (*Angophora floribunda*) Dry Sclerophyll Grassy Woodland

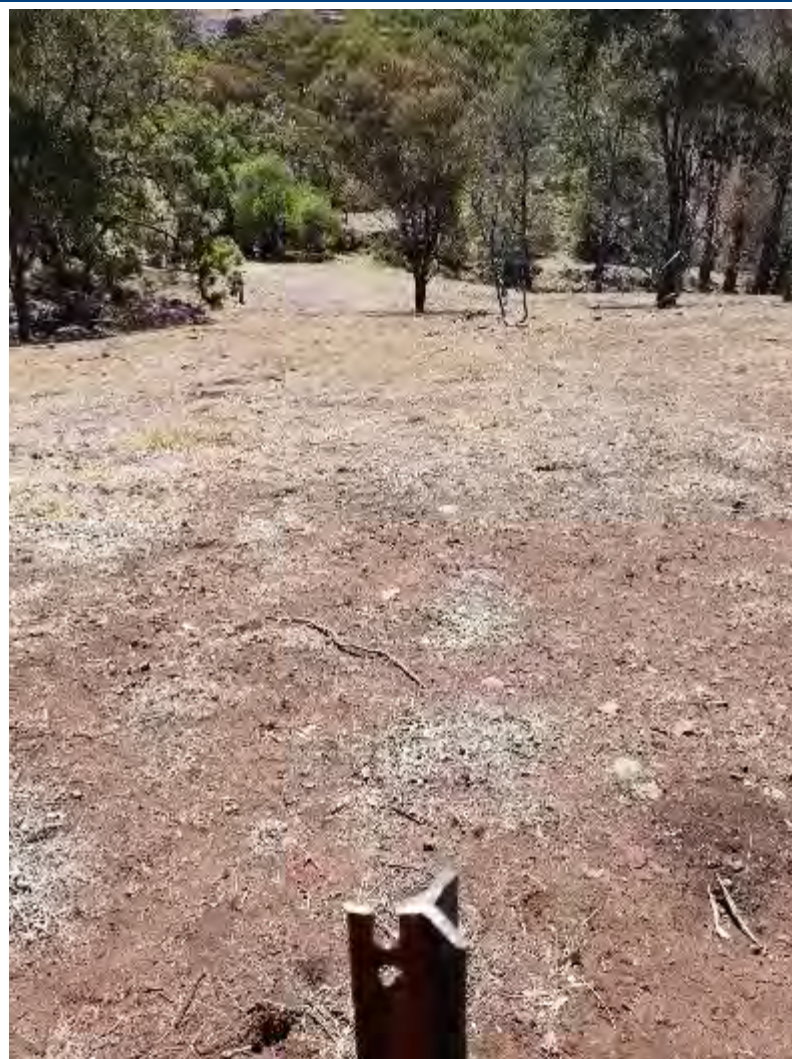
West 2019

Plot Q03: White Box (*Eucalyptus albens*) and Rough barked Apple (*Angophora floribunda*) Dry Sclerophyll Grassy Woodland

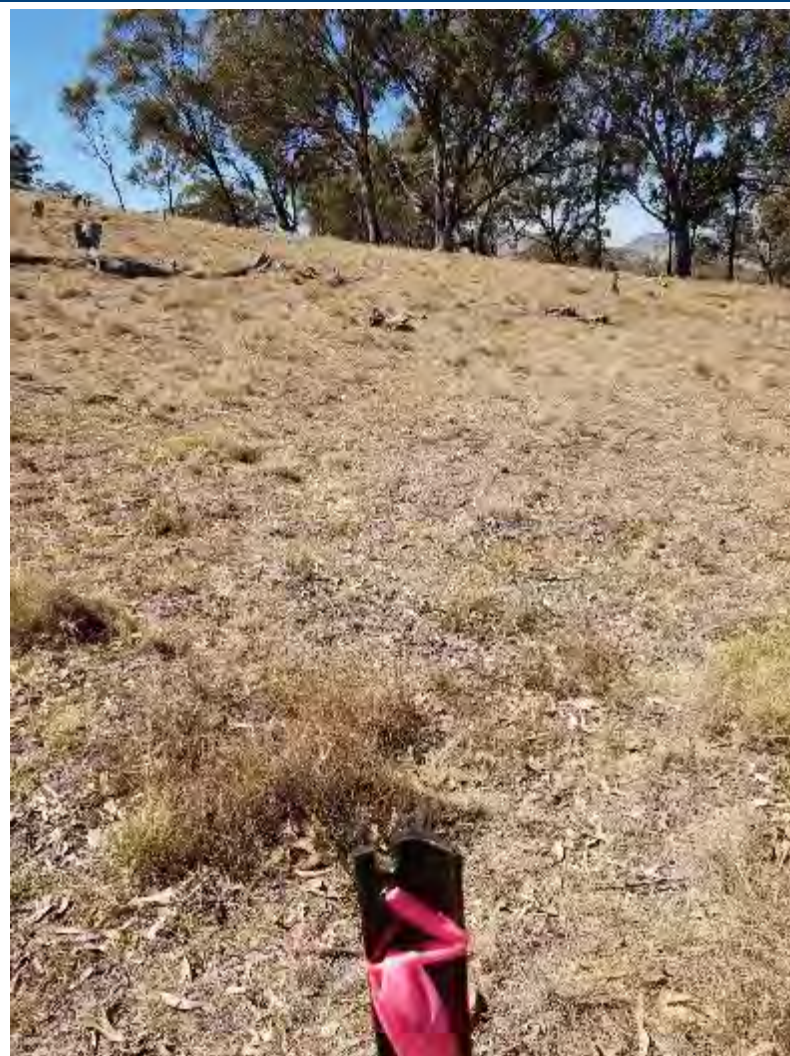
North 2019

Plot Q04: Derived Native Grassland

Weeds with high invasive potential were generally observed at low levels throughout BOAs. Weed control was previously undertaken for St John's wort (*Hypericum perforatum*) and no individuals were sighted during the walkover or when conducting floristic monitoring in 2019. However, this species has reappeared in moderate numbers across the southern portion of Offset A. Weed control across this area is recommended. The few instances of localised prickly pear (*Opuntia stricta*) and Paterson's curse (*Echium plantagineum*) infestations noted in 2019 had reduced substantially. Weed control in these areas appeared to be successful, particularly for Paterson's curse. There was also a small amount of blackberry (*Rubus fruticosus* sp. agg) present in Offset A in plot Q04, and this should be managed while it is a relatively small infestation.

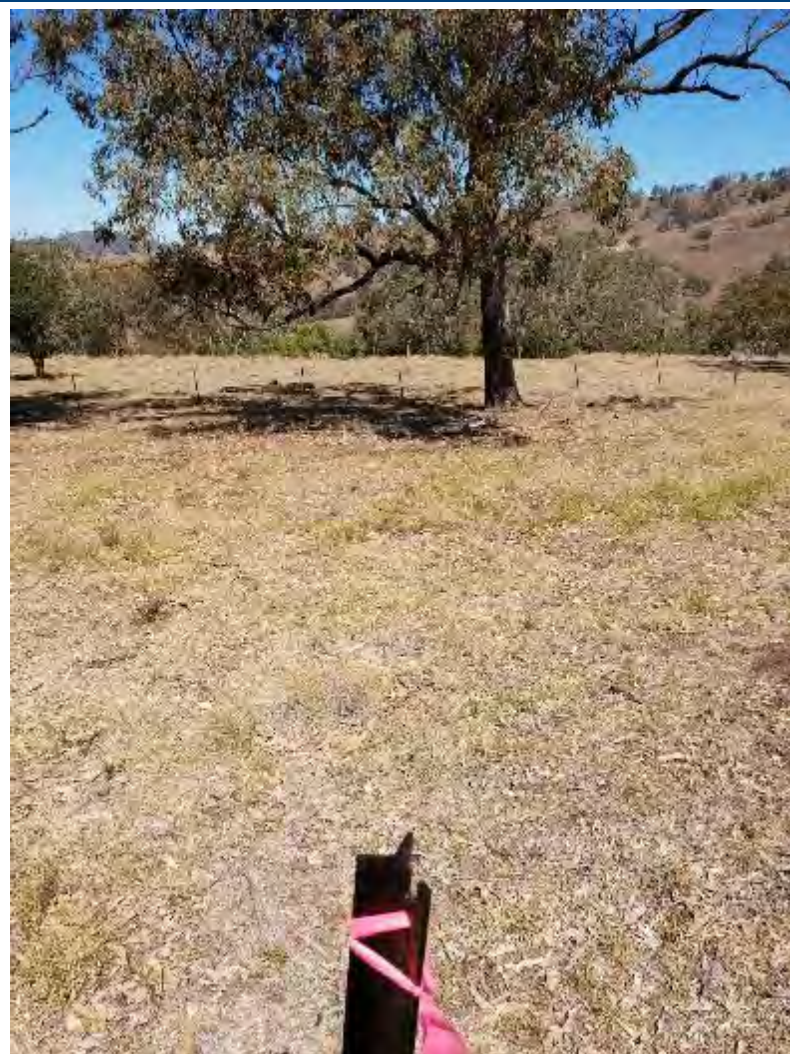
East 2019

Plot Q04: Derived Native Grassland

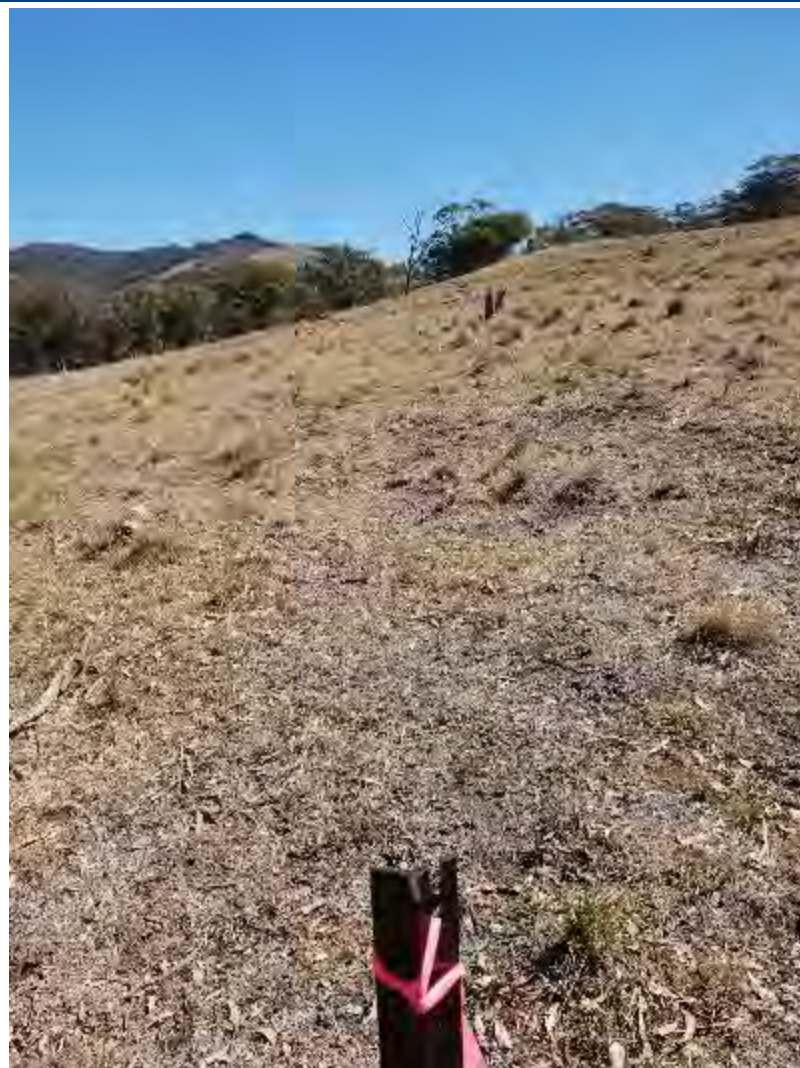
South 2019 (no picture taken 2020)

Plot Q04: Derived Native Grassland

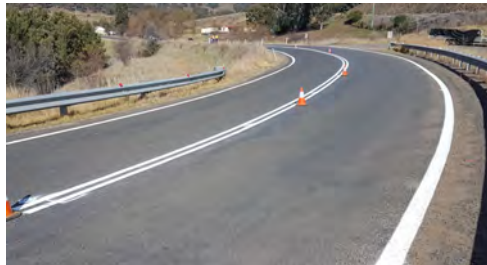
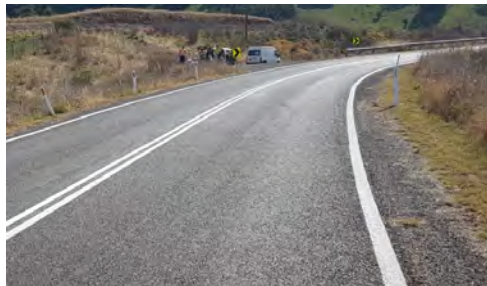
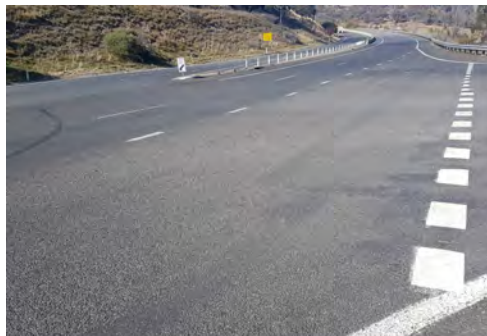
RSA report identification number	Location / category	Description of risk to road safety	Specific actions Daracon commit to undertake	Completion date (if complete) with comments	Evidence of completion	If not complete, status update as at 30 th March 2020 (provided by Daracon to DPIE)
1	Intersection of Main Street and New England Highway Northbound and Southbound Delineation	The approach to the intersection of Main Street and New England Highway is missing delineation (i.e. RRPM's) and has faded line marking. This may increase the likelihood of readability issues for a driver. The likelihood of this risk may increase at night and / or adverse weather conditions. This may result in vehicle crashes and injury to occupants of a vehicle(s).	RMS Response – New England Highway (NEH) work will be addressed by works for Daracon	Mostly complete with essential delineation re-instated along New England Highway (NEH) by RMS prior to July 2019. Main Street Ardglan delineation installed on the 11 th July 2019 by Daracon. All as shown in the images.

Longer term planning for additional NEH intersection upgrade works continues with final arrangements pending the proposed MOD #2 status.

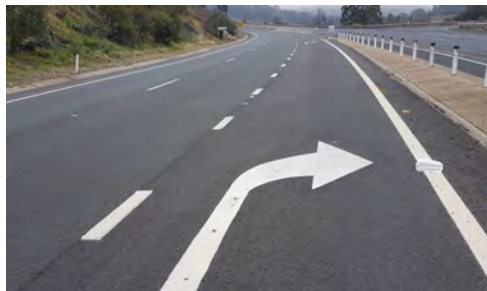
2	New England Highway Southbound Delineation	The existing right turn bay into Main Street is missing right turn pavement arrows, which may lead to readability issues for approaching vehicles. The likelihood of this risk may increase at night and / or adverse weather conditions. This may confuse oncoming drivers for the purpose of lane and cause late lane change decisions. This may result in vehicle crashes and injury to occupants of a vehicle(s).	RMS Response – RMS to install missing Right Turn Arrows. RMS to arrange to be included in this year's AC linemarking program.	Completed by RMS prior to July 2019.

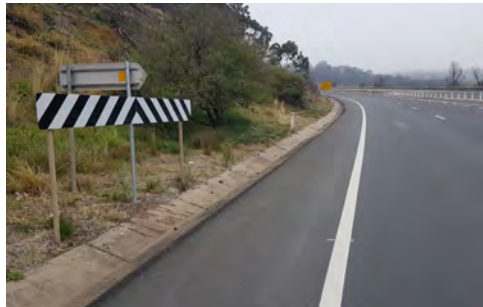
RSA report identification number	Location / category	Description of risk to road safety	Specific actions Daracon commit to undertake	Completion date (if complete) with comments	Evidence of completion	If not complete, status update as at 30 th March 2020 (provided by Daracon to DPIE)
3	New England Highway Southbound Traffic signs	The advanced warning signage on approach to Main Street appears damaged, does not provide advanced warning to approaching vehicles, and has a reduced readability due to sightlines being obscured on the horizontal curve approach. This may lead to driver confusion and increase the likelihood of drivers slowing too early prior to the intersection and may result in vehicle crashes and serious injury to occupants of a vehicle(s).	RMS Response – RMS to repair signs from Routine Maintenance	Completed by RMS prior to July 2019.

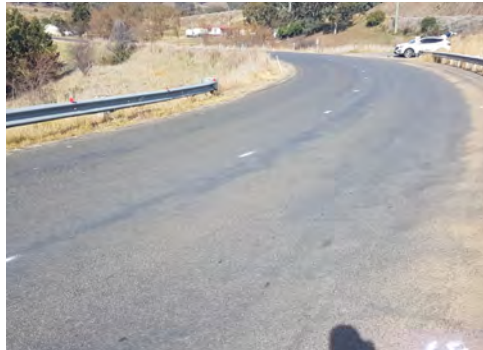
5	Main Street South of the Intersection on the outside of the curve Northbound Road pavement	At the Main Street / rail site compound access and in front of the existing w-beam safety barrier there is loose gravel on the outside of the horizontal curve. This may lead to reduced skid resistance for an errant vehicle. The likelihood of this risk may increase at night and / or adverse weather conditions. This may result in vehicle crashes and serious injury to occupants of a vehicle(s).	As agreed with LPSC representative, the loose gravel on the outside of the curve will be removed by appropriate means by Daracon.	Daracon completed this on the 3 rd April 2019 with street sweeper on site. Additional gravel removal on the 11 th July 2019 before the line marking was installed

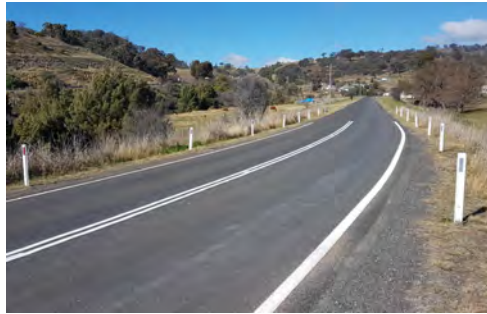
RSA report identification number	Location / category	Description of risk to road safety	Specific actions Daracon commit to undertake	Completion date (if complete) with comments	Evidence of completion	If not complete, status update as at 30 th March 2020 (provided by Daracon to DPIE)
6	Main Street – South of the intersection of New England Highway Northbound and Southbound Roadside hazards	200m along Main Street from the intersection of New England highway, there is an existing culvert with steep embankments within the clear zone. The combination of narrow shoulder widths, steep batters, culvert headwalls within the clear zone, may limit a driver's manoeuvrability to avoid striking an object or have a reduced ability to gain control of their vehicle and strike objects within the clear zone. Narrow shoulders may also limit the available road width for wide vehicle loads and restrict vehicles in the opposing direction. This may increase the likelihood of drivers encroaching into the opposing travel lane and / or vehicles driving within the road shoulder / verge area to avoid a stationary object on the road. This may result in drivers striking the object or another object within the clear zone and lead to rapid deceleration of the vehicle. This may result in serious injury (not limited to) to occupants of a vehicle(s).	As agreed with LPSC representative, Daracon proposes to install a temporary barrier (type F concrete or similar) to highlight the presence of the existing culvert and minimise the likelihood of interaction with the roadside hazard. Subject to the ongoing operation of the quarry, Daracon may choose to install a permanent barrier (guardrail or similar) at some time in the future.	Effectively complete with the self-imposed mandatory speed limit of 40kph from the New England Highway to the Quarry entrance for all trucks was imposed immediately. On the 11 th July 2019, additional controls were installed to highlight the presence of the culvert. These additional controls were the extension of the line marking and installation of extra guideposts as shown in the image.

As of the 30 th March 2020 and in consultation with LPSC, no issues or incidents have arisen at this location. This fact combined with the cessation of material export from Ardglen quarry (and the subsequent reduction in vehicular movements along Main St), combined with the fact that the additional guideposts are still present and operating effectively, means that this item remains unchanged at this time.

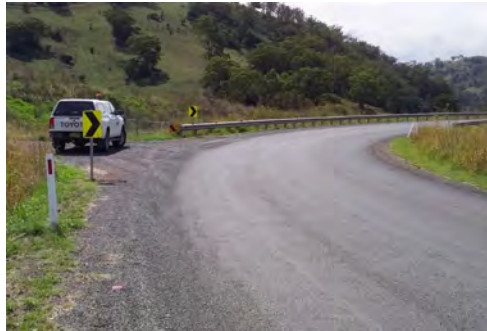
7	Main Street – Rail site compound access Northbound Road alignment and cross section and delineation	Approximately 150m from the intersection of New England Highway along Main Street there is an access track to a rail site compound. At the access there is a lack of delineation on the horizontal curve. This may give the oncoming driver the impression that the Main Street continues through rather than traveling to the right, especially at night. This may cause a driver to make a late change in direction. The combination of loose gravel on the outside of the curve and the late change in direction may result in crashes with other vehicles and result in injury to occupants of a vehicle(s).	As agreed with LPSC representative, Daracon proposes to install additional guide posts (or similar) to delineate the outside of the horizontal curve.	Completed on the 26 th March 2019.

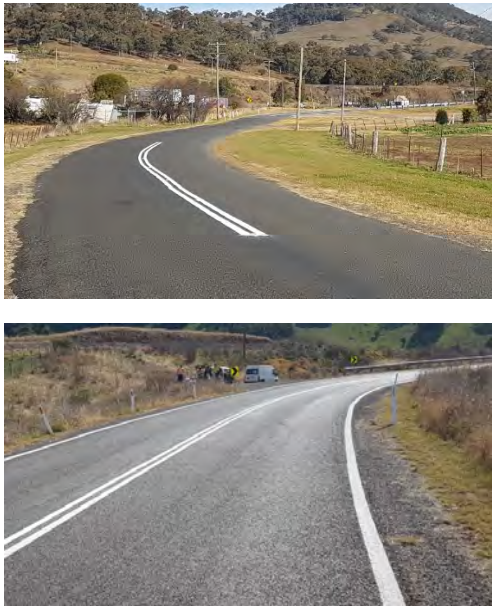
RSA report identification number	Location / category	Description of risk to road safety	Specific actions Daracon commit to undertake	Completion date (if complete) with comments	Evidence of completion	If not complete, status update as at 30 th March 2020 (provided by Daracon to DPIE)
8	Main Street Northbound and Southbound Road pavement And Road alignment and cross section	The road carriageway width does not appear suitable for vehicles to pass (i.e. trucks passing other trucks and / or cars). The travel lane widths may limit a driver's manoeuvrability and increase the likelihood of readability issues to oncoming vehicles. Narrow travel lane may also limit the available road width for wide vehicle loads and restrict vehicles in the opposing direction. This may result in drivers striking oncoming objects or another object within the clear zone and lead to rapid deceleration of the vehicle. This may result in injury to occupants of a vehicle(s).	Please also refer to LPSC point #2 below. Although the AADT would be less than 300 vehicles per day including the quarry operating at 500,000T by road per year as proposed (approximately 60 outbound and 60 inbound truck movements), it was agreed with LPSC to install additional line marking only at the curves either end of Main St. The straight section of Main St will remain with no line marking. All existing line marking will also be renewed if not completed recently by LPSC. An additional control that has been implemented is the self-imposed mandatory speed limit of 40kph from the New England Highway to the Quarry entrance for all trucks.	Completed on the 11 th July 2019.

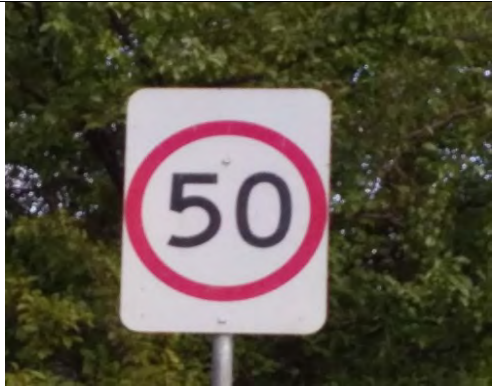
9	Main Street Intersection with Ardglen Road Northbound and Southbound Traffic signs	On Main Street approach to Ardglen Road, the existing speed zone repeater signage appears faded. This may increase the likelihood of readability issues for drivers, and increase the likelihood of a driver failing to travel to the sign posted speed limit. The likelihood of this risk may increase at night and / or adverse weather conditions. This may lead to vehicle crashes and injury to occupants of a vehicle(s).	As agreed with LPSC representative, Daracon proposes to install new speed limit signage as the existing sign is faded.	Completed on the 20 th March 2019.

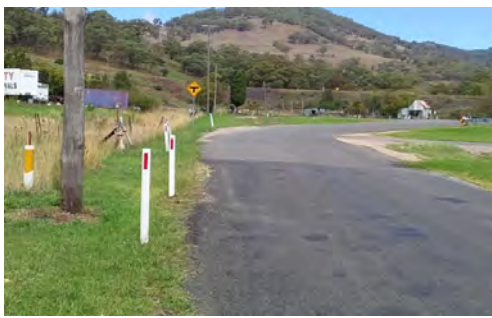
N/A
10	Main Street Approaching the Intersection with Ardglen Road Northbound and Southbound Roadside hazards	On Main Road approach to Ardglen Road, there is an existing power pole and fence posts within the clear zone. Errant vehicles at these locations may have a reduced ability to gain control of their vehicle and strike the power pole or fence post within the clear zone which may lead to rapid deceleration of the vehicle. This may be due to the combination of horizontal and / or vertical alignment of the road and / or drivers swerving to avoid striking an animal (i.e. animal carcass). The likelihood of this risk may increase at night and / or adverse weather conditions. This may result in vehicle crashes and injury to occupants of a vehicle(s), not limited to.	As agreed with LPSC representative, Daracon proposes to install delineation in the form of additional guideposts adjacent to the roadway to highlight the presence of the existing power pole.	Completed on the 26 th March 2019.

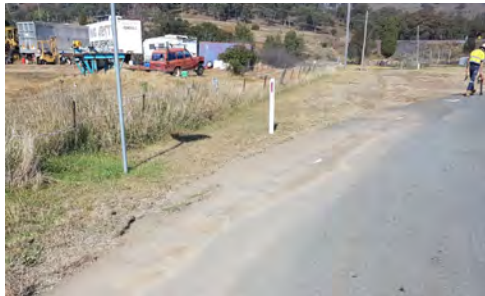
RSA report identification number	Location / category	Description of risk to road safety	Specific actions Daracon commit to undertake	Completion date (if complete) with comments	Evidence of completion	If not complete, status update as at 30 th March 2020 (provided by Daracon to DPIE)
11	Main Street Approaching the Intersection with Ardglen Road Northbound and Southbound Pavement	Approximately 65m along Main Road from the intersection of Main Road and High Road, there is loose gravel on the outside of the horizontal curve. This may lead to reduced skid resistance for an errant vehicle. The likelihood of this risk may increase at night and / or adverse weather conditions. This may result in vehicle crashes and serious injury to occupants of a vehicle(s).	As agreed with LPSC representative, the loose gravel on the outside of the curve will be removed by appropriate means by Daracon.	Completed on the 3 rd April 2019 with street sweeper on site. Additional gravel removal occurred on the 11 th July 2019 before the line marking was installed.

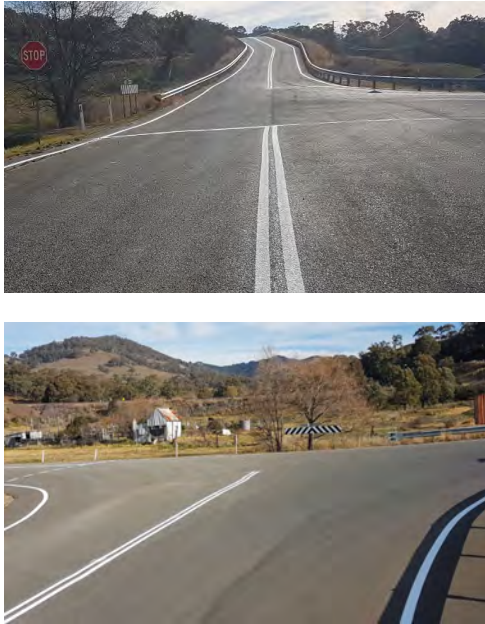
12	Main Street Intersection with High Street Delineation	At the intersection of Main Street and High Street, the existing delineation is faded. This may lead to readability issues for a driver and increase the likelihood of a vehicle failing to give way at the intersection. The likelihood of this risk may increase at night and / or adverse weather conditions. This may lead to vehicle crashes and injury to occupants of a vehicle(s).	As agreed with LPSC representative, Daracon proposes to refresh the existing line marking.	Completed on the 11 th July 2019.

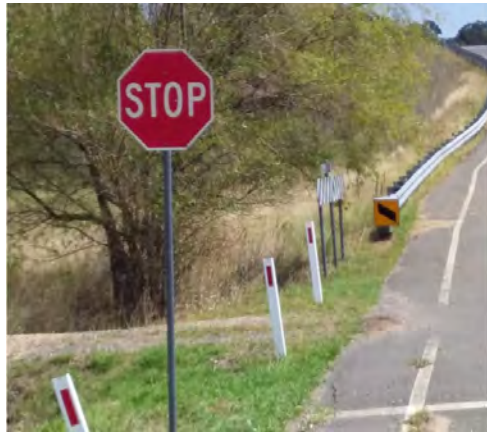
RSA report identification number	Location / category	Description of risk to road safety	Specific actions Daracon commit to undertake	Completion date (if complete) with comments	Evidence of completion	If not complete, status update as at 30 th March 2020 (provided by Daracon to DPIE)
13	Main Street Intersection with High Street Westbound Traffic signs	Approaching the intersection of Main Street and High Street from the south eastern side traveling west there is a missing Stop sign. This may increase the likelihood of readability issues for drivers and lead to drivers failing to stop to oncoming vehicles. This may increase the likelihood of vehicle crashes, especially during adverse weather conditions. This could lead to crashes with other vehicles, thus may result in serious injury to occupants of a vehicle(s).	As agreed with LPSC representative, Daracon proposes to reinstate the existing stop sign.	Completed on the 20 th March 2019.

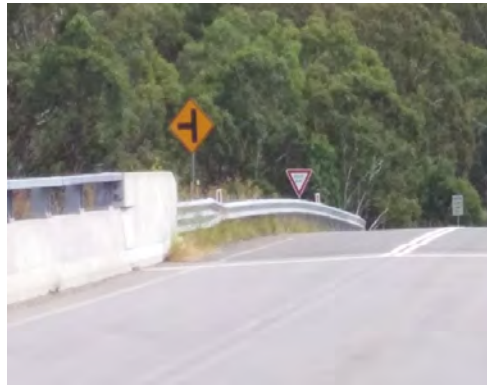
14	High Street Approach to St Stephen Street intersection Westbound Traffic signs	On the south eastern side of the intersection of High Street and St Stephen Street, the advanced warning of T-intersection signage is loose, which has caused the sign to point in the wrong direction. This may increase the likelihood of readability issues for drivers and lead to drivers failing to negotiate the intersection. This may increase the likelihood of vehicle crashes, especially during adverse weather conditions. This could lead to crashes with other vehicles, thus may result in serious injury to occupants of a vehicle(s).	As agreed with LPSC representative, Daracon proposes to reinstate the existing T intersection sign.	Completed on the 26 th March 2019.

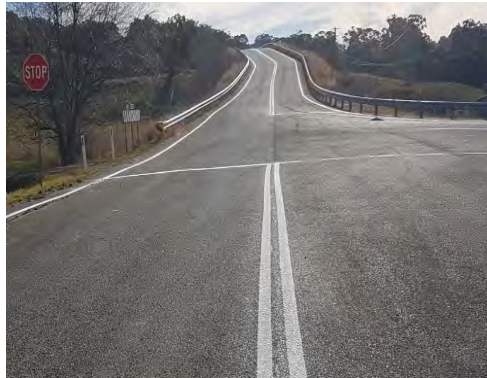
N/A
15	High street Rail overpass bridge Eastbound and Westbound Road alignment and cross section	Traveling west along High Street towards the rail overpass bridge, the travel lanes appear to narrow and there is a kink in the alignment of the road. The narrow travel lane widths may limit a driver's manoeuvrability and increase the likelihood of readability issues to oncoming vehicles. Narrow travel lane may also limit the available road width for wide vehicle loads and restrict vehicles in the opposing direction. This may result in drivers striking oncoming vehicles or safety barriers and lead to rapid deceleration of the vehicle. This may result in serious injury (not limited to) to occupants of a vehicle(s).	As agreed with LPSC representative, all existing line marking will be renewed if not completed recently by LPSC. An additional control that has been implemented is the self-imposed mandatory speed limit of 40kph from the New England Highway to the Quarry entrance for all trucks. Appropriate delineation already exists along the guardrail.	Self-imposed 40 kph speed limit imposed immediately. The line marking was completed on the 11 th July 2019.

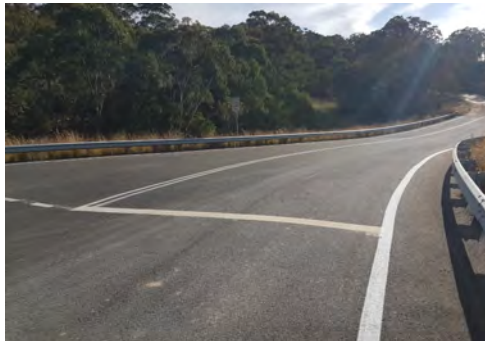
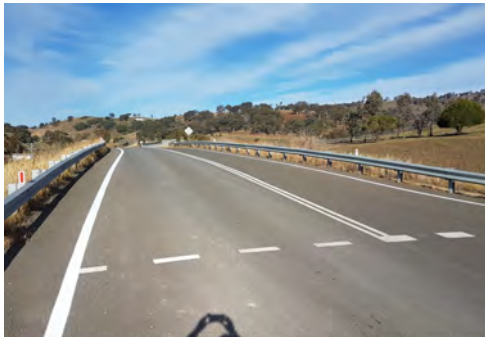
RSA report identification number	Location / category	Description of risk to road safety	Specific actions Daracon commit to undertake	Completion date (if complete) with comments	Evidence of completion	If not complete, status update as at 30 th March 2020 (provided by Daracon to DPIE)
16	High Street Approach to St Stephen Street Intersection Eastbound and Westbound Delineation	At the intersection of High Street and St Stephen Street, the existing delineated is faded. This may lead to readability issues for a driver and increase the likelihood of a vehicle failing to give way / stop at the intersection. The likelihood of this risk may increase at night and / or adverse weather conditions. This may lead to vehicle crashes and injury to occupants of a vehicle(s).	As agreed with LPSC representative, all existing line marking will be renewed by Daracon if not completed recently by LPSC.	Completed on the 11 th July 2019.

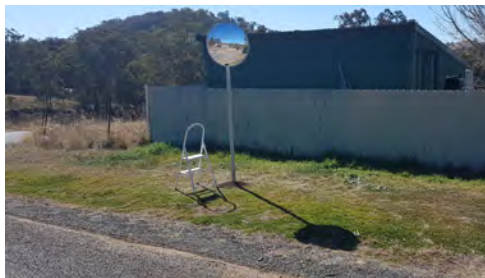
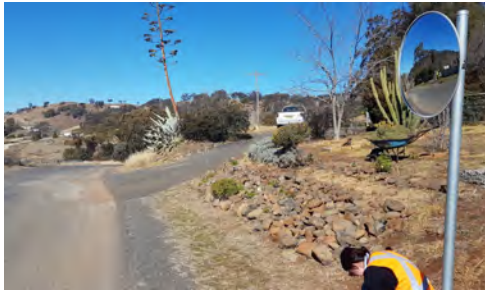
17	St Stephen Street Northbound and Southbound Road alignment and cross section	The road carriageway width along St Stephens Street does not appear suitable for vehicles to pass (i.e. trucks passing other trucks and / or cars). The travel lane widths may limit a driver's manoeuvrability and increase the likelihood of readability issues to oncoming vehicles. Narrow travel lane may also limit the available road width for wide vehicle loads and restrict vehicles in the opposing direction. This may result in drivers striking oncoming vehicles or objects within the clear zone and lead to rapid deceleration of the vehicle. This may result in serious injury (not limited to) to occupants of a vehicle(s).	As agreed with LPSC representative, Daracon will consult with the three residents along Warra and St Stephen Streets to discuss the potential installation of convex mirrors at strategic locations and will install as agreed. Daracon has also implemented a self-imposed mandatory speed limit of 40kph from the New England Highway to the Quarry entrance as well as a mandatory "call up" protocol for St Stephens and Warra St's as detailed in the TTMP.	Complete with the self-imposed mandatory speed limit of 40kph from the New England Highway to the Quarry entrance for all trucks was imposed immediately. The call up protocol for St Stephens and Warra St's was also implemented immediately as detailed in the TTMP. The residents along Warra and St Stephens St were also consulted with and agreed that the installation of "convex mirrors" located in strategic locations would assist to mitigate the issues identified. The "convex mirrors" were installed on the 15 th August 2019 as shown in the images.

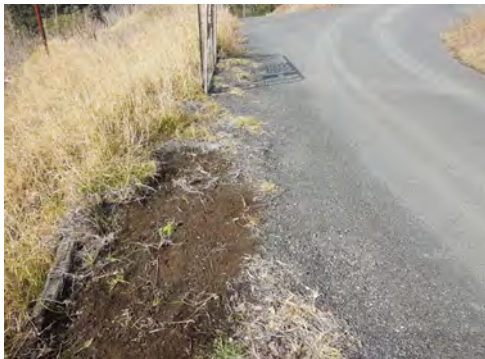
19	Warra Street Northbound and Southbound Road alignment and cross section	The road carriageway width along Warra Street does not appear suitable for vehicles to pass (i.e. trucks passing other trucks and / or cars). The travel lane widths may limit a driver's manoeuvrability and increase the likelihood of readability issues to oncoming vehicles. Narrow travel lane may also limit the available road width for wide vehicle loads and restrict vehicles in the opposing direction. This may result in drivers striking oncoming vehicles or objects within the clear zone and lead to rapid deceleration of the vehicle. This may result in serious injury (not limited to) to occupants of a vehicle(s).	Refer to RSA CAR #17.	Refer to RSA CAR #17.		N/A
20	Warra Street Near the quarry entrance Southbound Pavement And Road alignment And cross section	Near the entrance to the quarry and part of Warra Road the existing pavement is deteriorated and shoulder show evidence of erosion. This may lead to soft shoulders and may be unstable for heavy vehicle to use if divers need to move their vehicle to avoid oncoming traffic. This may result in injury to occupants of a vehicle(s), not limited to.	As agreed with LPSC representative, Daracon proposes to investigate and repair the shoulder as described in the RSA.	Completed 20 th March 2019.

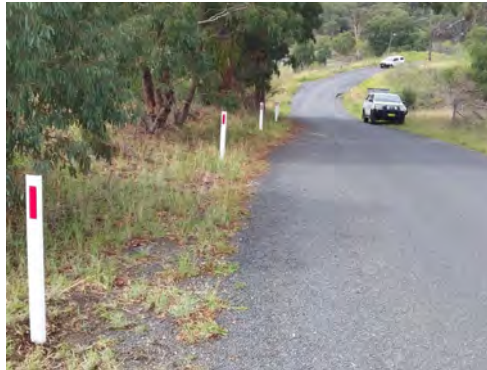
RSA report identification number	Location / category	Description of risk to road safety	Specific actions Daracon commit to undertake	Completion date (if complete) with comments	Evidence of completion	If not complete, status update as at 30 th March 2020 (provided by Daracon to DPIE)
21	Warra Street Northbound and Southbound Roadside hazards	Along Warra Street the auditors observed trees within clear zone as well as narrow carriageway. Errant vehicles at these locations may have a reduced ability to gain control of their vehicle and strike the trees within the clear zone which may lead to rapid deceleration of the vehicle. This may be due to the narrow carriageway width of the road and / or drivers swerving to avoid striking oncoming vehicles. The likelihood of this risk may increase at night and / or adverse weather conditions. This may result in vehicle crashes and injury to occupants of a vehicle(s), not limited to.	As agreed with LPSC representative, Daracon proposes to install delineation in the form of additional guideposts adjacent to the roadway to highlight the presence of the trees. Daracon has implemented a self-imposed mandatory speed limit of 40kph from the New England Highway to the Quarry entrance as well as a mandatory "call up" protocol for St Stephens and Warra St's as detailed in the TTMP.	Completed on the 26 th March 2019.

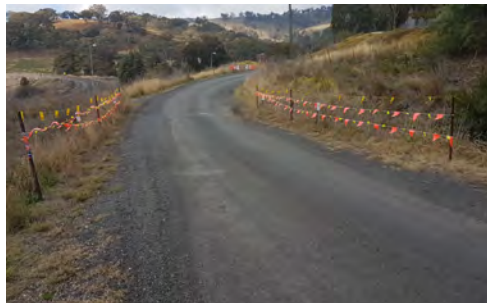
22	Warra Street Northbound and Southbound Roadside hazards	Approximately 50m from the entrance of the quarry there is an existing culvert headwall with drop-off within the clear zone. Errant vehicles at these locations may have a reduced ability to gain control of their vehicle impact with the existing headwall and / or surrounding objects within the clear zone. This may be due to the narrow carriageway width of the road and / or drivers swerving to avoid striking oncoming vehicles. The likelihood of this risk may increase at night and / or adverse weather conditions. This may result in vehicle crashes and serious injury to occupants of a vehicle(s).	As agreed with LPSC representative, Daracon proposes to install a temporary barrier (type F concrete or similar) to highlight the presence of the existing culvert and minimise the likelihood of interaction with the roadside hazard. Additionally, LPSC have committed to investigating the option of extending the existing storm water pipe to permit widening of the formation thus eliminating the roadside hazard.	The self-imposed mandatory speed limit of 40kph from the New England Highway to the Quarry entrance for all trucks was imposed immediately. The call up protocol for St Stephens and Warra St's was also implemented immediately as detailed in the TTMP. Temporary delineation was installed on the 1 st April 2019 as shown in the image. These are considered appropriate short term rectification measures due to the fact that this location exists beyond the section of Warra St that requires private vehicular access and only quarry traffic utilises this section of road.

Longer term planning for additional works along Warra St are continuing in consultation with LPSC with final arrangements pending the proposed MOD #2 status. This matter was discussed and agreed with Warren Faulkner from LPSC on the 26 th February 2020.

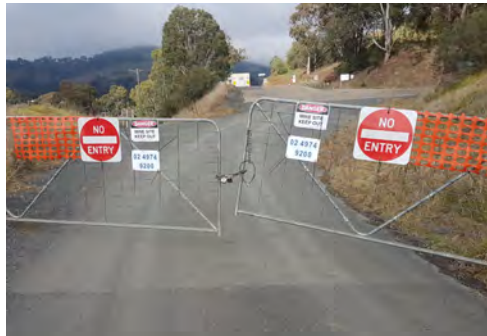
RSA report identification number	Location / category	Description of risk to road safety	Specific actions Daracon commit to undertake	Completion date (if complete) with comments	Evidence of completion	If not complete, status update as at 30 th March 2020 (provided by Daracon to DPIE)
23	Warra Street Quarry entrance Northbound and Southbound Road alignment and cross section	At the site entry of the quarry, the entry appears narrow, lack of carriageway width for drivers to turn around as well as lack of restriction signage / no through road. This may lead to driver frustration and confusion which may contribute to driver error. The likelihood of this risk may increase at night and / or adverse weather conditions. This may result in vehicle crashes and serious injury to occupants of a vehicle(s).	As agreed with LPSC representative, Daracon has implemented a self-imposed mandatory speed limit of 40kph from the New England Highway to the Quarry entrance as well as a mandatory “call up” protocol for St Stephens and Warra St’s as detailed in the TTMP.	The self-imposed mandatory speed limit of 40kph from the New England Highway to the Quarry entrance for all trucks was imposed immediately. The call up protocol for St Stephens and Warra St’s was also implemented immediately as detailed in the TTMP. Additional “no entry” and “no through road” signage was installed on the 11 th July 2019.

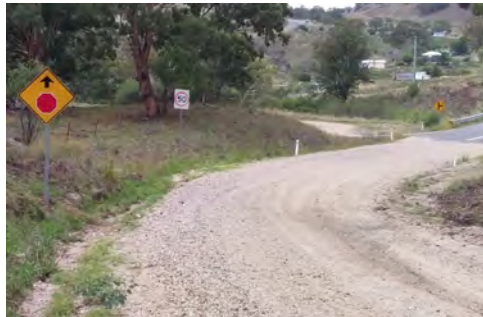
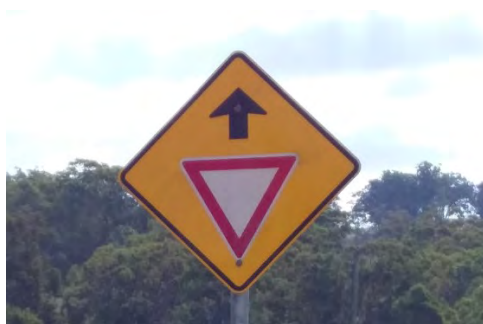
RSA report identification number	Location / category	Description of risk to road safety	Specific actions Daracon commit to undertake	Completion date (if complete) with comments	Evidence of completion	If not complete, status update as at 30 th March 2020 (provided by Daracon to DPIE)
LPSC #1	Either side of the rail overpass bridge	<p>The two 'T' intersections either side of the rail overpass bridge are not your normal 'T' intersections in that the approach roads to the top of the 'T' have right away, whereas the thru road normally has right of way. Whilst 'Give Way' and 'Stop Signs' along with line marking (that needs maintaining) exists, I think advance warning 'Give Way Sign Ahead' and 'Stop Sign Ahead' signs (W3-1B and W3-2B) should be considered to forewarn road users along High Street and Swinging Ridges Road as the thru road(s).</p>	<p>Daracon agree to install additional advance warning 'Give Way Sign Ahead' and 'Stop Sign Ahead' signs (W3-1B and W3-2B) to forewarn road users along High Street and Swinging Ridges Road as the thru road(s)</p>	<p>Completed on the 20th March 2019.</p>

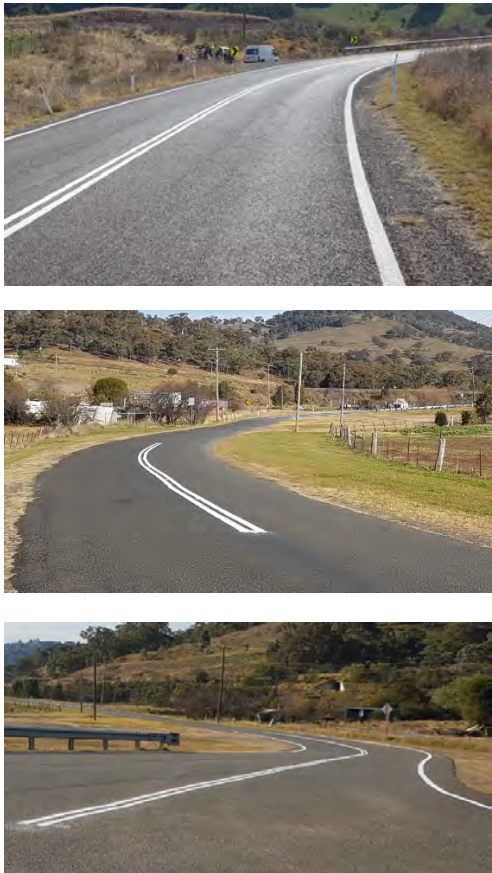
RSA report identification number	Location / category	Description of risk to road safety	Specific actions Daracon commit to undertake	Completion date (if complete) with comments	Evidence of completion	If not complete, status update as at 30 th March 2020 (provided by Daracon to DPIE)
LPSC #2	Main Street	There is no centreline delineation along the Ardglan Road (it is being called Main Street in the RSA). High Street has centreline marking (albeit it is very faded and needs redoing). Given there are 2 curves along the Ardglan Road, the RSA should identify the lack of centreline marking along this road in greater detail.	Although the AADT would be less than 300 vehicles per day including the quarry operating at 500,000T by road per year as proposed (approximately 60 outbound and 60 inbound truck movements), it was agreed with LPSC to install additional line marking only at the curves either end of Main St. The straight section of Main St will remain with no line marking. All existing line marking will also be renewed if not completed recently by LPSC. An additional control that has been implemented is the self-imposed mandatory speed limit of 40kph from the New England Highway to the Quarry entrance for all trucks.	Completed on the 11 th July 2019.

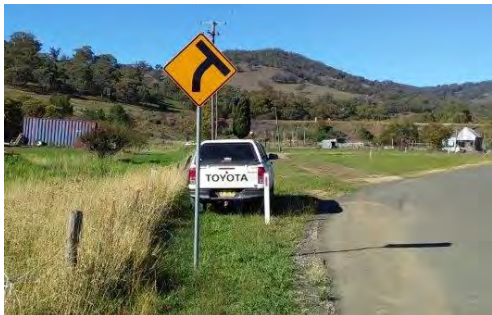
LPSC #3	Main Street	The advance 'T' junction warning sign on Ardglan Road on approach to High Street does not depict the road alignment on approach to the intersection. The approach to the intersection has a horizontal curve between the Advanced intersection Warning Sign and the intersection. The sign should be changed to a Curved Intersection (W2-14B) sign.	Daracon agrees to change the advance 'T' junction warning sign on Ardglan Road on approach to High Street to a Curved Intersection (W2-14B) sign.	Completed on the 3 rd April 2019.

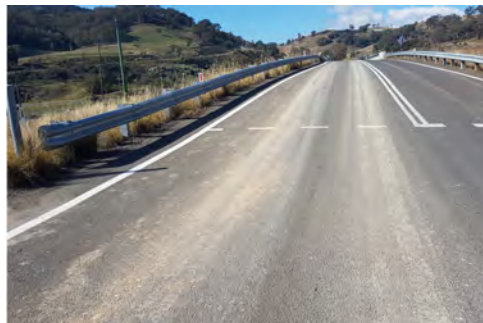
<p>Note – The dirt present on the road surface (as shown in the above image) was the result of LPSC unsealed road maintenance occurring along Swinging Ridges Rd and was in no way associated with truck movements to or from Ardglen Quarry.</p>	N/A
