ARDGLEN QUARRY

2021 Annual Environmental Management Report (AEMR)

PROJECT APPROVAL MP 06_0264

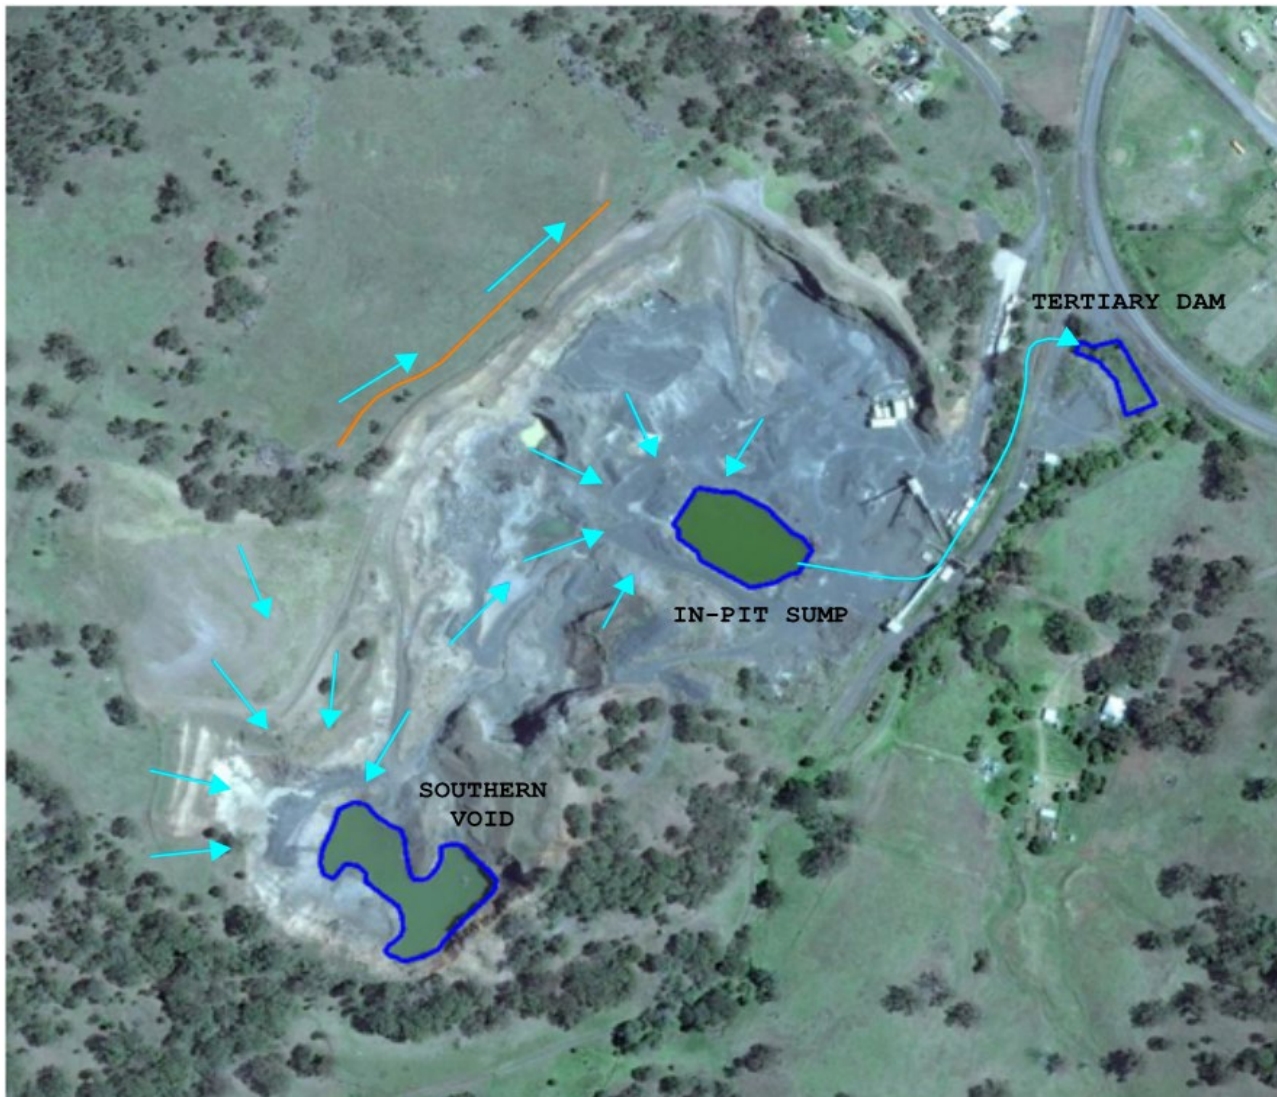
Figure 3: Surface Water Management

The Site Water Management Plan (SWMP), including the following, has recently been reviewed and uploaded to the DPIE Major Projects Portal. Subject to approval of DPIE, this will be enacted prior to commencing work in the Extension Area. The SWMP includes:

- An assessment of basin volumes is included as part of the revised SWMP;
- An assessment of the reliability of the water supply to the operation is included as part of the SWMP;
- Operational and maintenance activities that could cause soil erosion and sediment generation are identified and described in the SWMP;
- Procedures to manage unforeseen water quality impacts;
- Water treatment processes to enable discharge as required (subject to the approval of a variation to the site EPL);
- The proposed strategy to monitor and subsequently manage any groundwater interactions on site;
- A variation to the EPL has been submitted and, at the time of this report, the EPA and Daracon are currently reviewing this application;

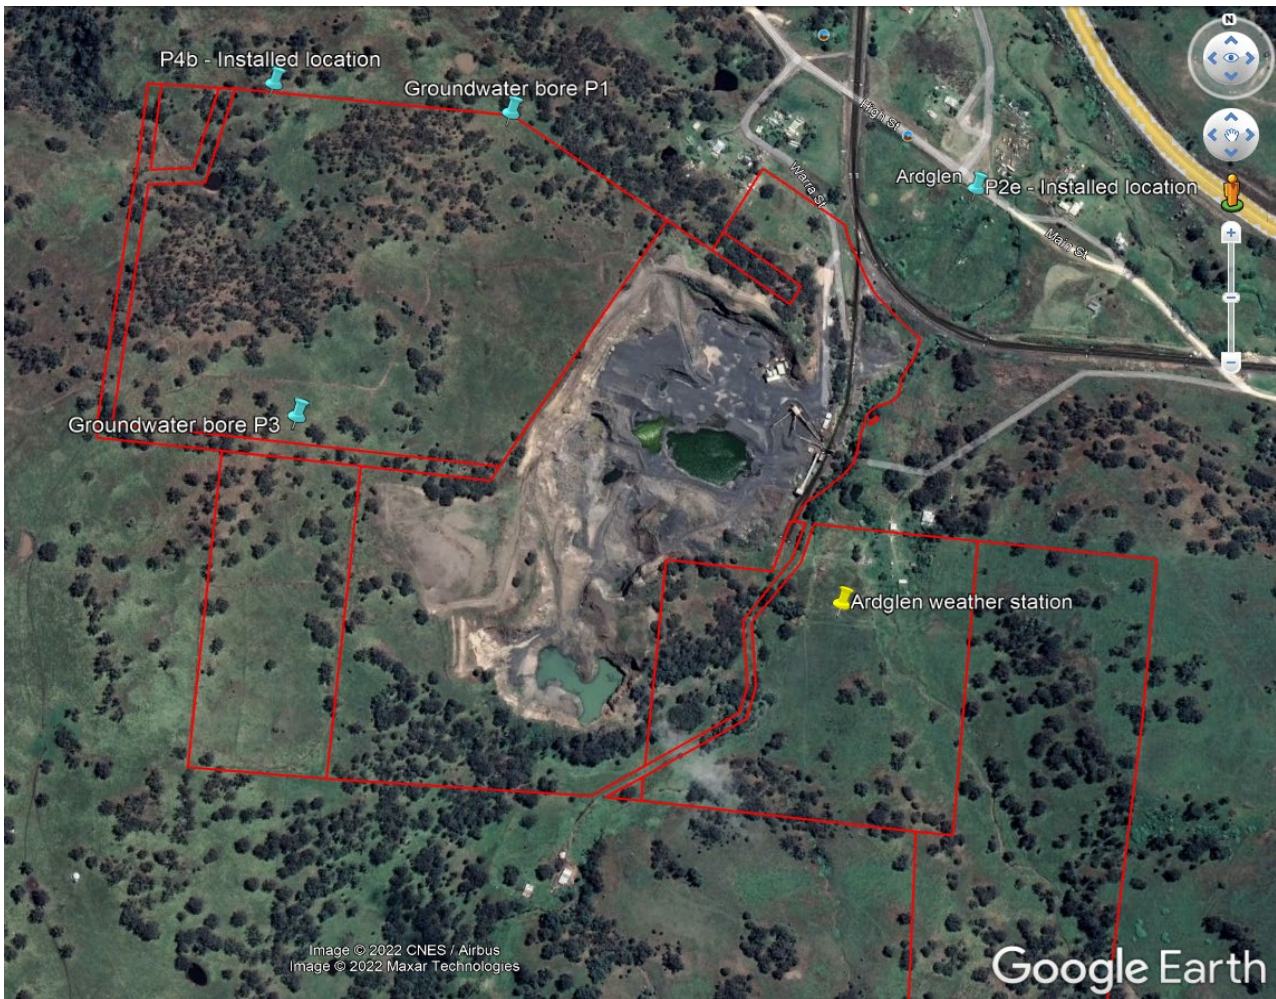
Figure 4: Ground Water Monitoring Network

Figure 4 below shows the indicative locations of the groundwater monitoring wells installed during the reporting period. Ongoing monitoring of the various groundwater parameters has commenced and will be ongoing for the foreseeable future.

In accordance with Mod 2, once we've obtained sufficient data relating to the various groundwater parameters, we will analyse the data collected and further develop the Groundwater study. This may require us to update the SWMP to include any subsequent management actions required to adequately address the findings of the groundwater study.

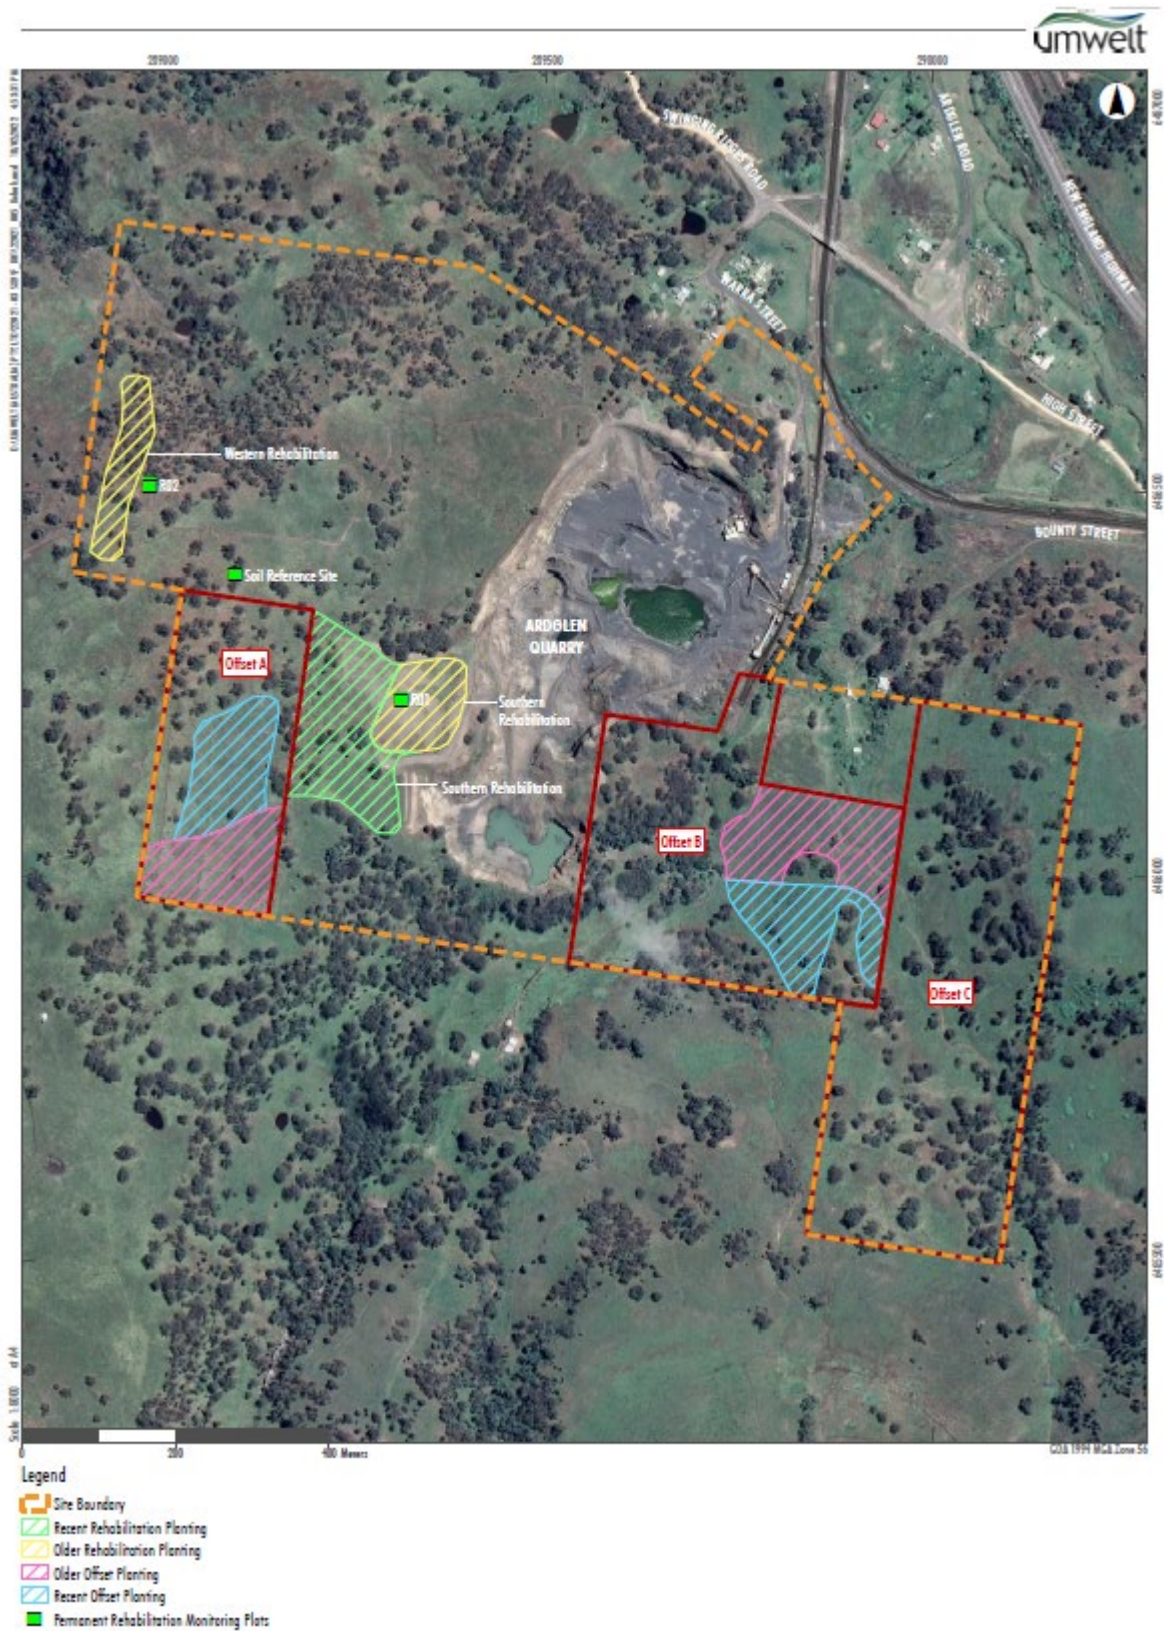
Figure 5: Rehabilitation planting areas

- Offset A – Two planting events occurred during the reporting period with the first occurring during April/May 2021 (shown as pink hatched area in Figure 5) and the second occurring during October 2021 (shown as blue hatched area in Figure 5);
- Offset B - Two planting events occurred during the reporting period with the first occurring during April/May 2021 (shown as pink hatched area in Figure 5) and the second occurring during October 2021 (shown as blue hatched area in Figure 5). Also see Photo 1 for an example of such;

Approximately 447 tubestock were planted within Offset A and Offset B in 2021 in the indicative planting areas shown in Figure 5. Older offset supplementary plantings were made in Autumn 2021, with recent plantings made in Spring 2021. Though most species could not be identified due to their young age, the species mix appeared to be a satisfactory mix of representative canopy and mid-storey species for the area. Heights ranged from approximately 0.2 – 1.1m. Condition and survivorship of these plantings was good, with approximately 75% of older plantings and approximately 90% of recent plantings surviving. Most of the losses encountered appeared to have been contributed to by destructive behaviour by feral pigs and deer, which has also resulted in damage to tree guards.

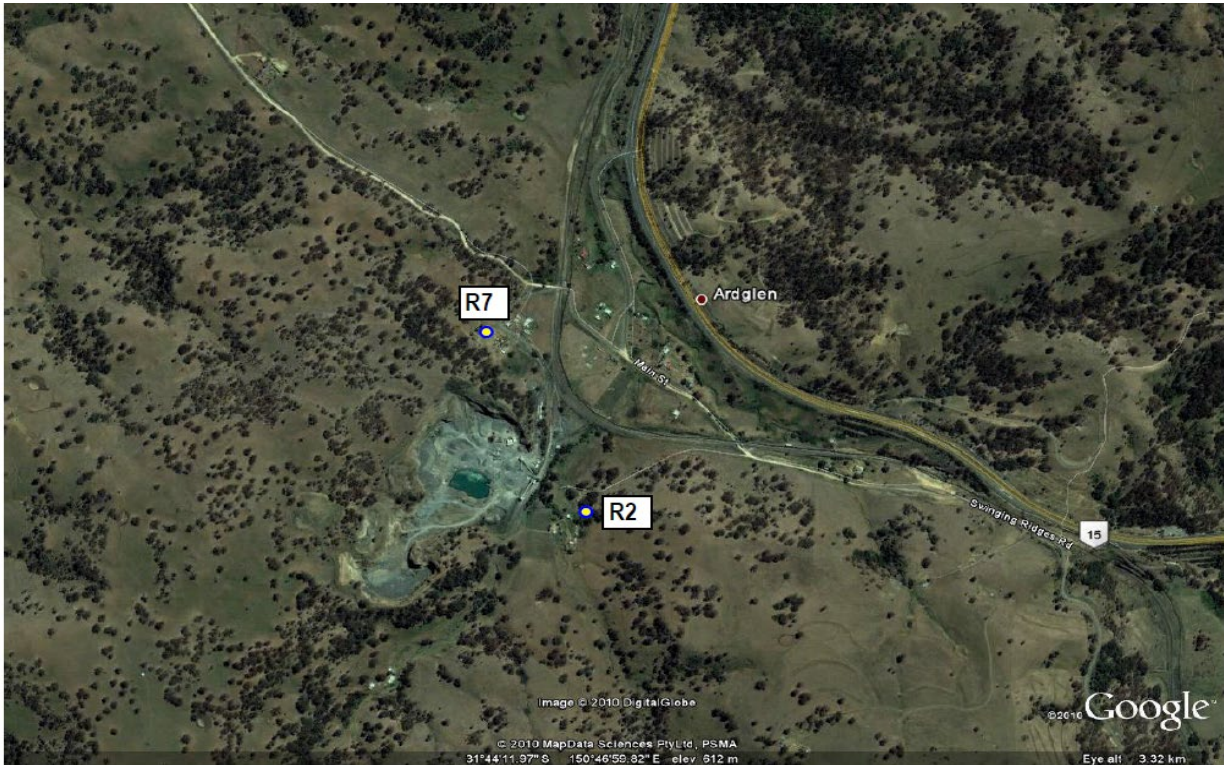
Figure 7: Blast Monitoring Locations

The Blast Monitoring program requires monitoring to take place at specified locations as shown in **Figure 7**. The Noise Monitoring Plan calls for quarterly attended noise monitoring to be completed and take place at specified noise monitoring locations as shown in **Figure 8**.

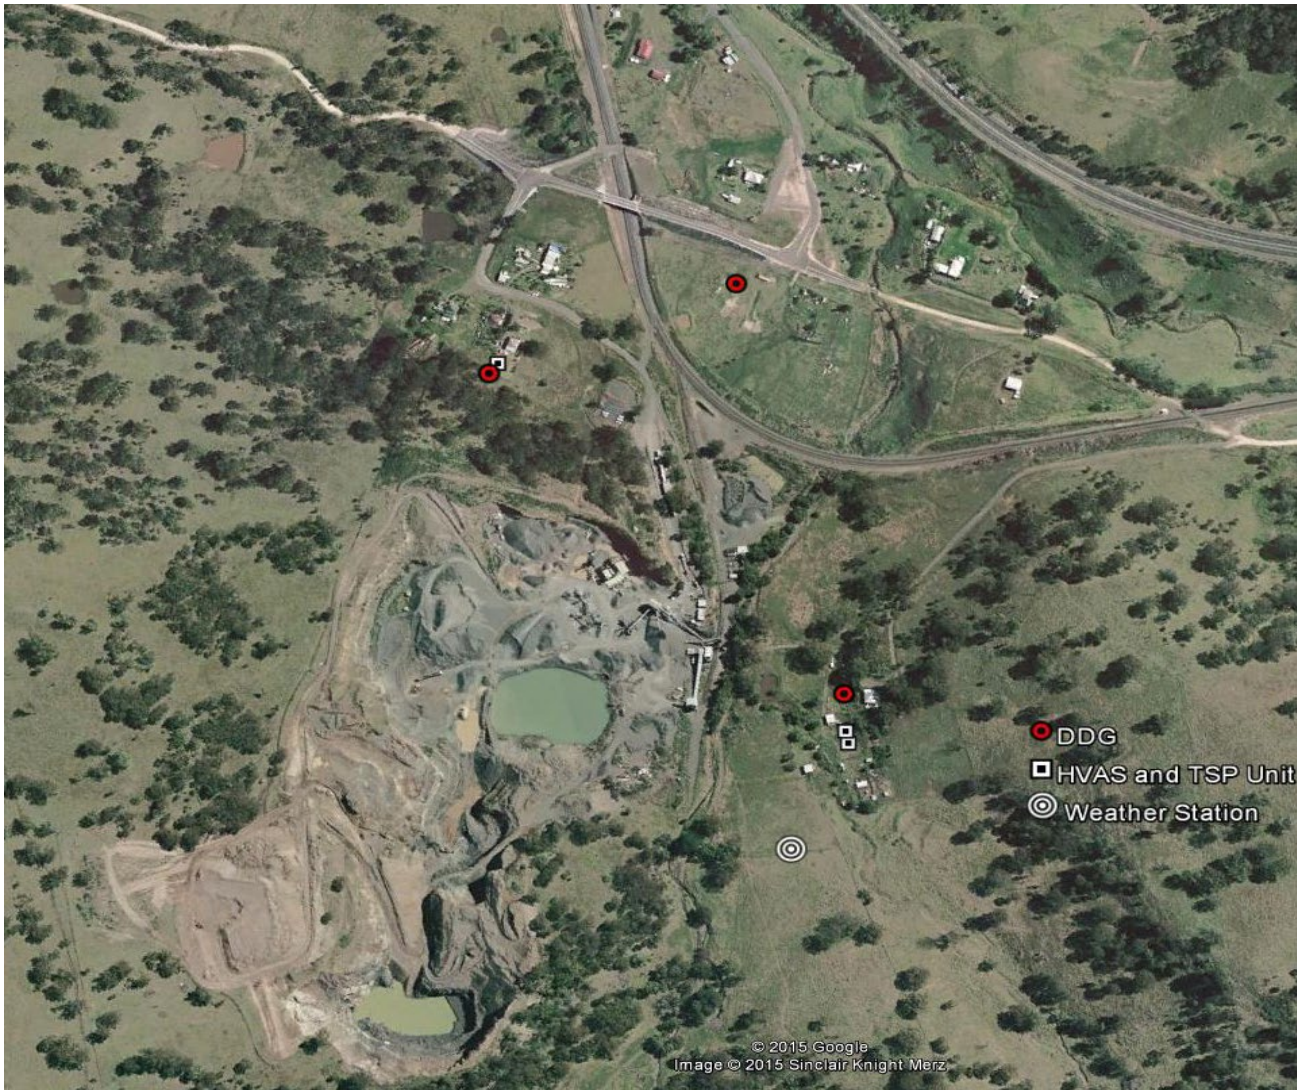
Figure 9: Air Quality Monitoring and Weather Station Locations

The current air quality monitoring network consists of three deposited dust gauges (DDG), two HVAS units and one TSP unit (see **Figure 9**). A PM2.5 unit will also be installed as detailed in the revised AQMP approved by DPIE in December 2021.

The location of the air quality monitoring equipment (primarily to the North-East and East of the Quarry) was deduced from the location of the surrounding residences.

Condition 18 of the Approval requires that a meteorological station to operate in the vicinity of the project site for the life of the project. Daracon has installed a meteorological station (Figure 9), ensuring that the meteorological station complies with the requirements in the “Approved Methods for Sampling of Air Pollutants in New South Wales Guideline”.

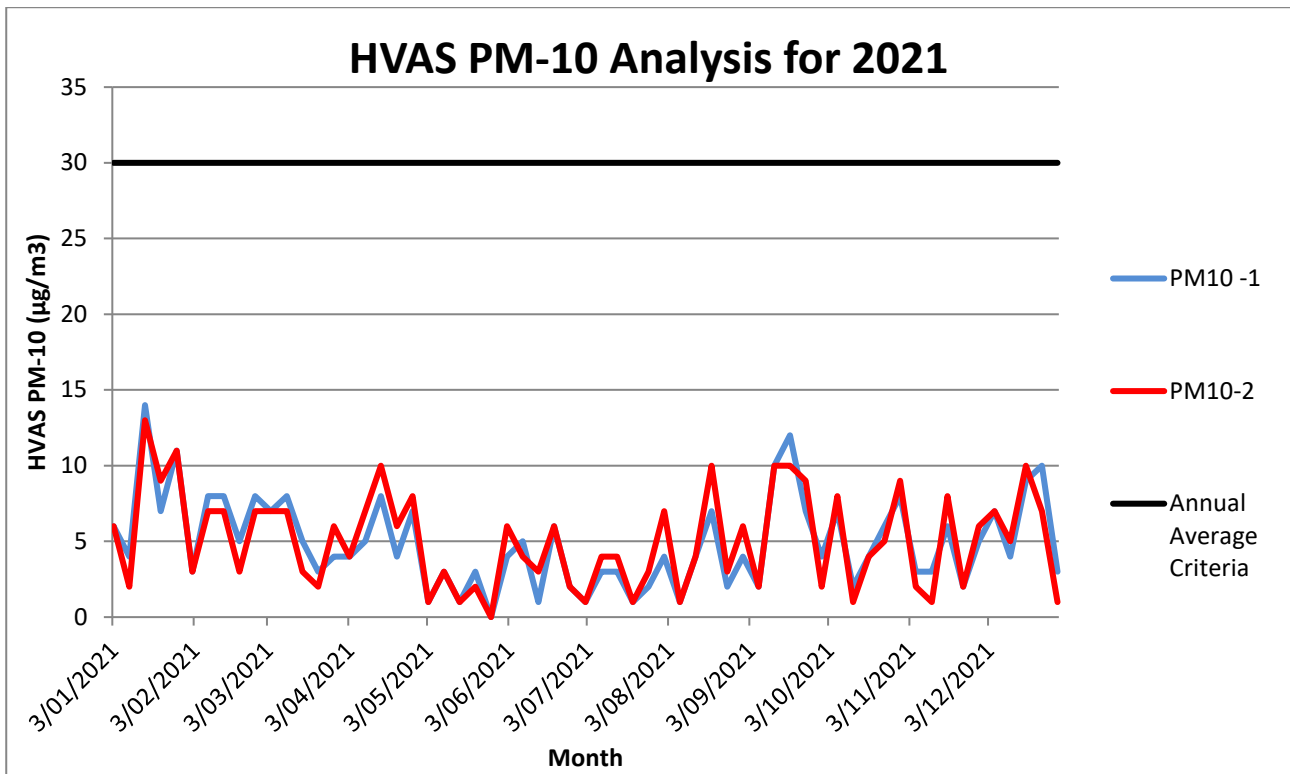
Figure 11: HVAS (PM-10) results for the reporting period

*The HVAS PM10 24-hour criterion of 25µg/m3 is based on the short term impact assessment criterion for particulate matter. The annual average is the long term impact assessment criteria for deposited dust as shown in Condition 15 of the Approval.

Unit	Ardglen HVAS Annual Average	24 hour Criterion (Short Term)	Annual Average Criterion (Long Term)
PM10-1	4.9	50	25
PM10-2	5.1	50	25
TSP	10.5	N/A	90
PM2.5	N/A	25	8

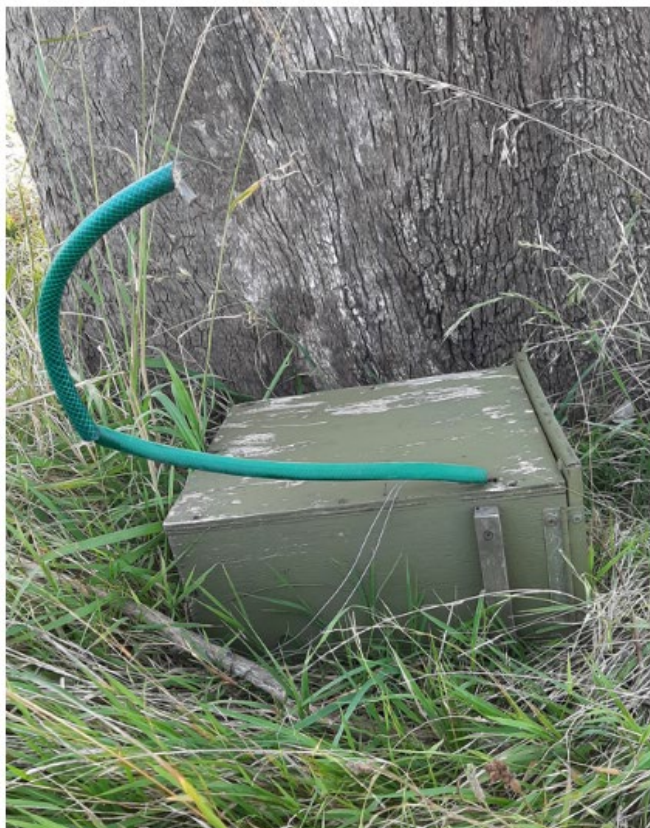
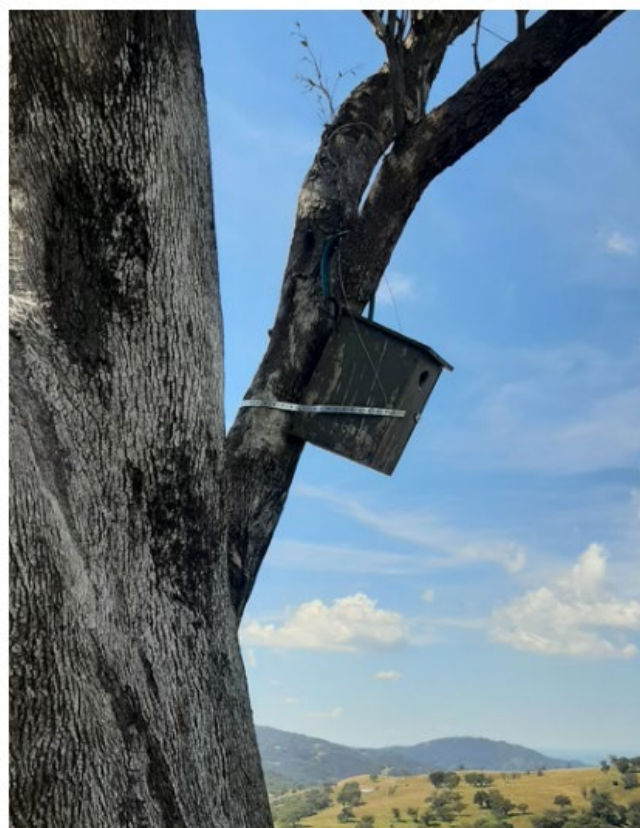
Photo 2: Nest box 12 re-installed early 2022

NB12 fallen off tree

NB 12 re-installed onto tree

- Next year's natural regeneration monitoring should incorporate monitoring of both natural and assisted regeneration outcomes for better comparison and overall picture of regeneration – **Noted;**
- Nest Box 12 should be fixed and reattached to its host tree with a sturdier attachment style as a priority – **Nest box 12 was re-attached soon after the Umwelt inspection occurred as shown in Photo 2 below;**

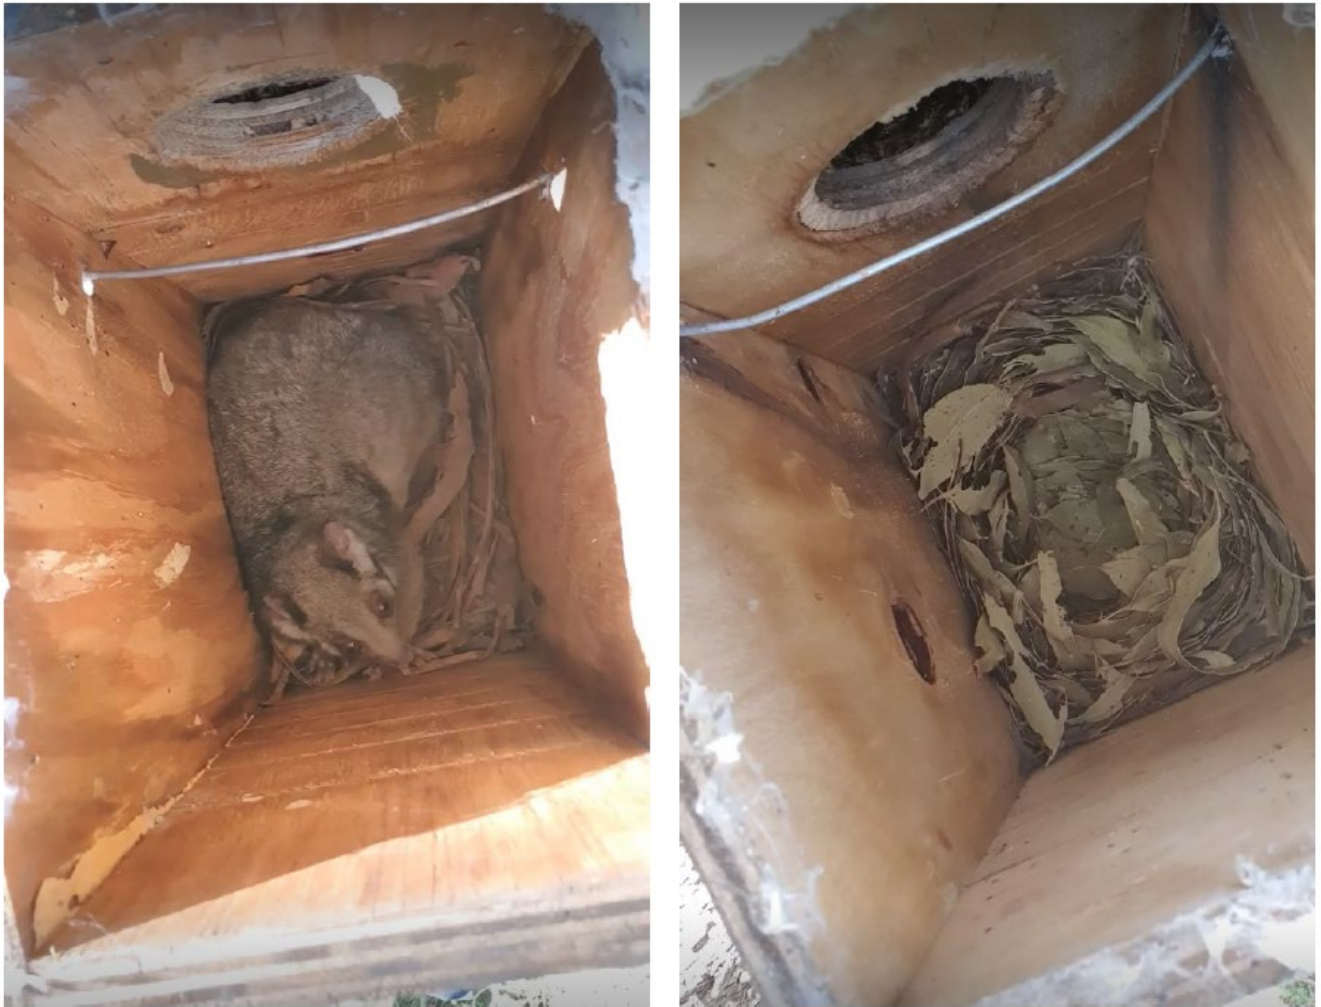
Photo 3: Nest box usage

The report associated with the annual inspections of the nesting boxes is attached in **Appendix 6**. Photo 3 below also demonstrates nest box usage as detailed within the 2021 Rehabilitation and nesting inspection report.

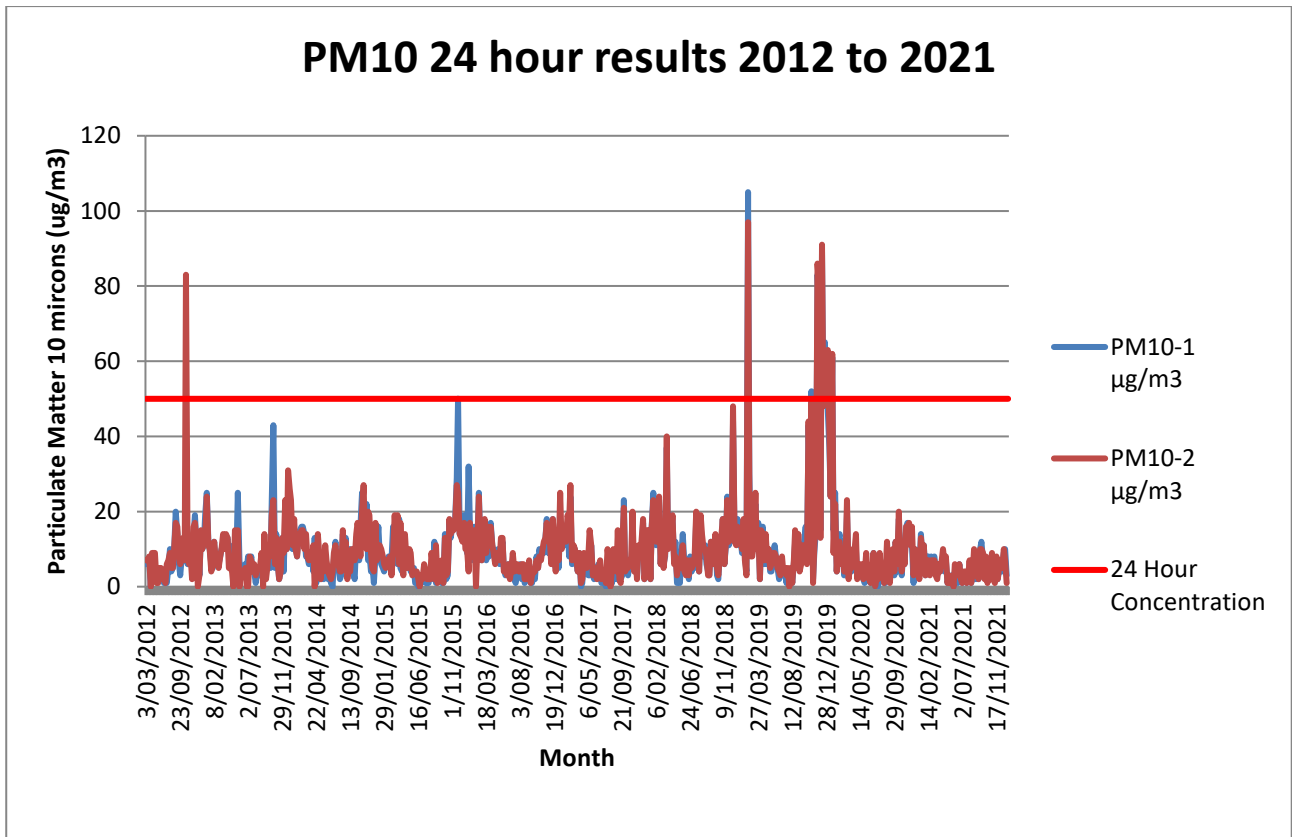
Figure 15: Twenty-four-hour concentration PM-10 results from 2012 to 2021

- Figure 15 – This shows the HVAS PM-10 “24 hour” monitoring results from 2012 to 2021. As seen in this figure, the annual average results are all below the criterion apart from the results obtained in 2012 and more recently during late 2018, late 2019 and into early 2020. For clarification regarding the prevailing weather conditions during this reporting period, please see also see below Figure 17 (taken from the biodiversity monitoring report) which demonstrates that the region surrounding Ardglan quarry was experiencing ‘non drought’ conditions for the first time since 2017;

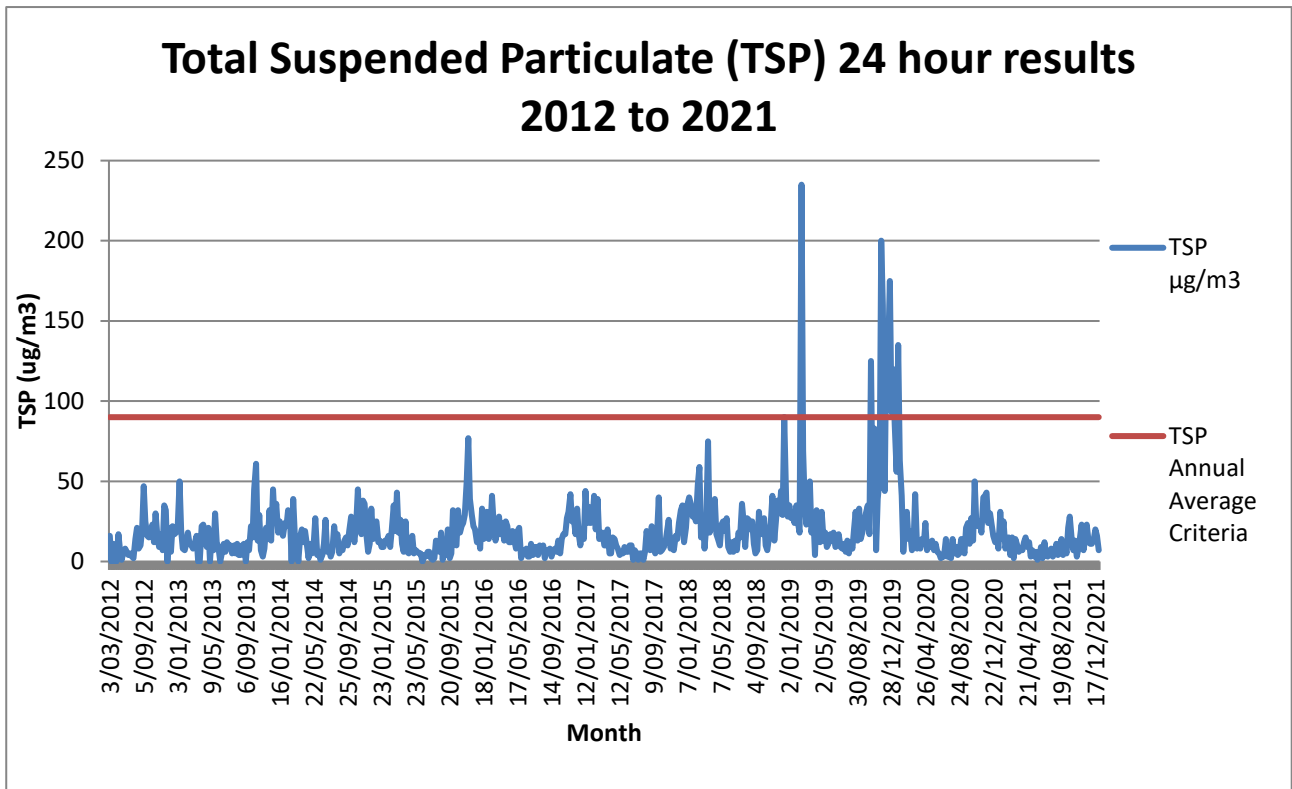
Figure 16: Annual average TSP results from 2012 to 2021

- Figure 16 – This shows the HVAS TSP monitoring results from 2012 to 2021. As seen in this figure, the TSP results are all below the criterion apart from the results obtained during late 2018, late 2019 and into early 2020. For clarification regarding the prevailing weather conditions during this reporting period, please see also see below Figure 17 (taken from the biodiversity monitoring report) which demonstrates that the region surrounding Ardglan quarry was experiencing ‘non drought’ conditions for the first time since 2017;
