# ARDGLEN QUARRY

## 2022 Annual Environmental Management Report (AEMR)

PROJECT APPROVAL MP 06\_0264 - MOD 2

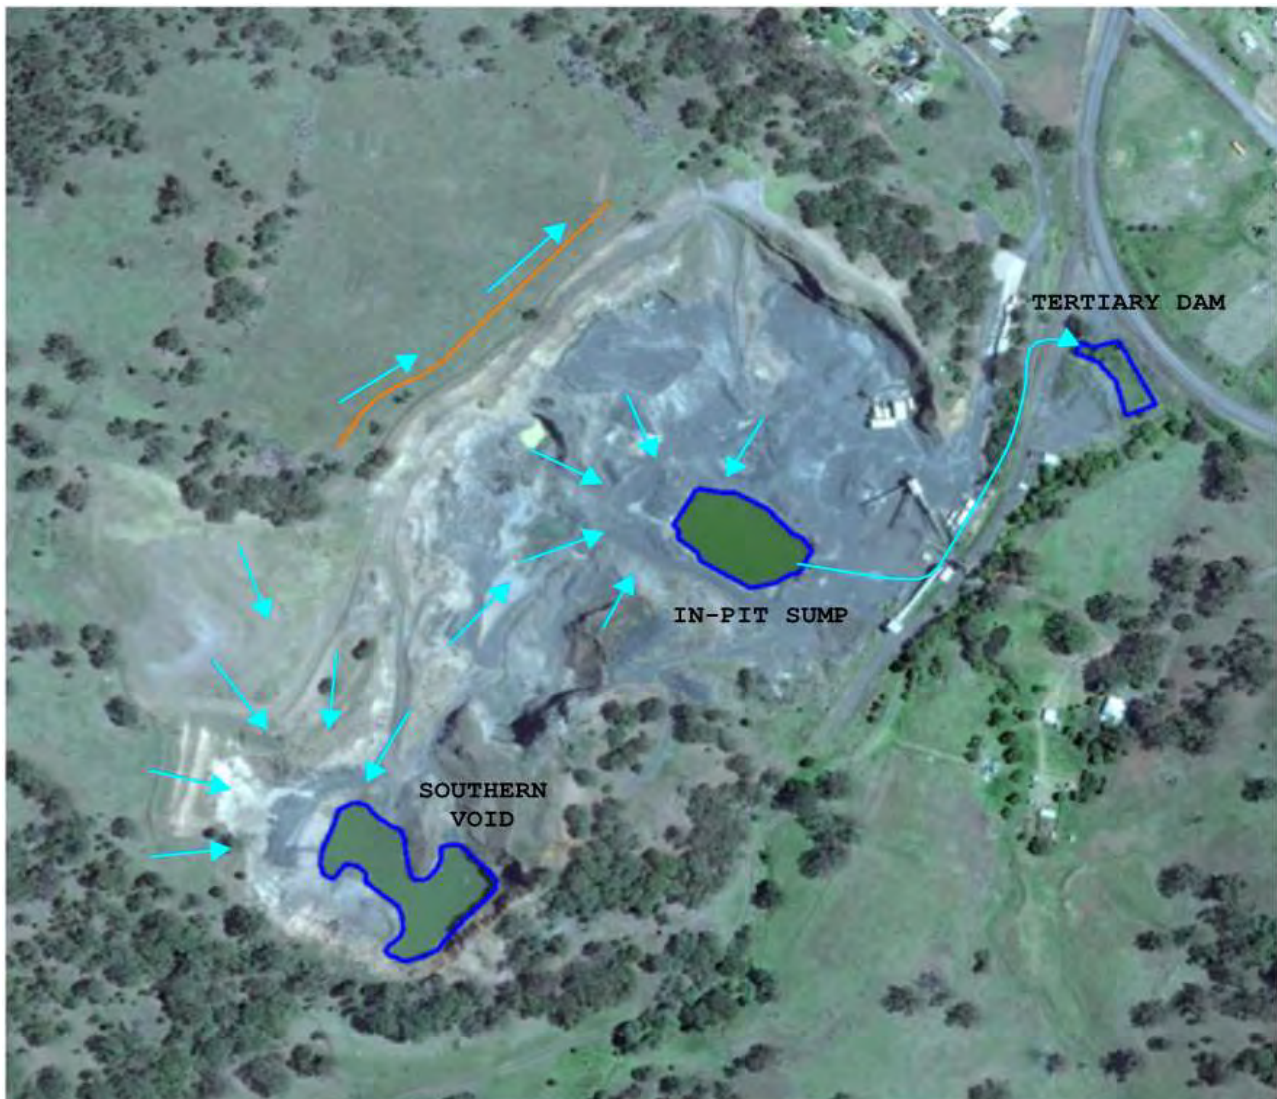
**Figure 3: Surface Water Management**

- An assessment of basin volumes is included as part of the revised SWMP;
- An assessment of the reliability of the water supply to the operation is included as part of the SWMP;
- Operational and maintenance activities that could cause soil erosion and sediment generation are identified and described in the SWMP;
- Procedures to manage unforeseen water quality impacts;
- Water treatment processes to enable discharge as required (in accordance with the revised EPL);
- The proposed strategy to monitor and subsequently manage any groundwater interactions on site;

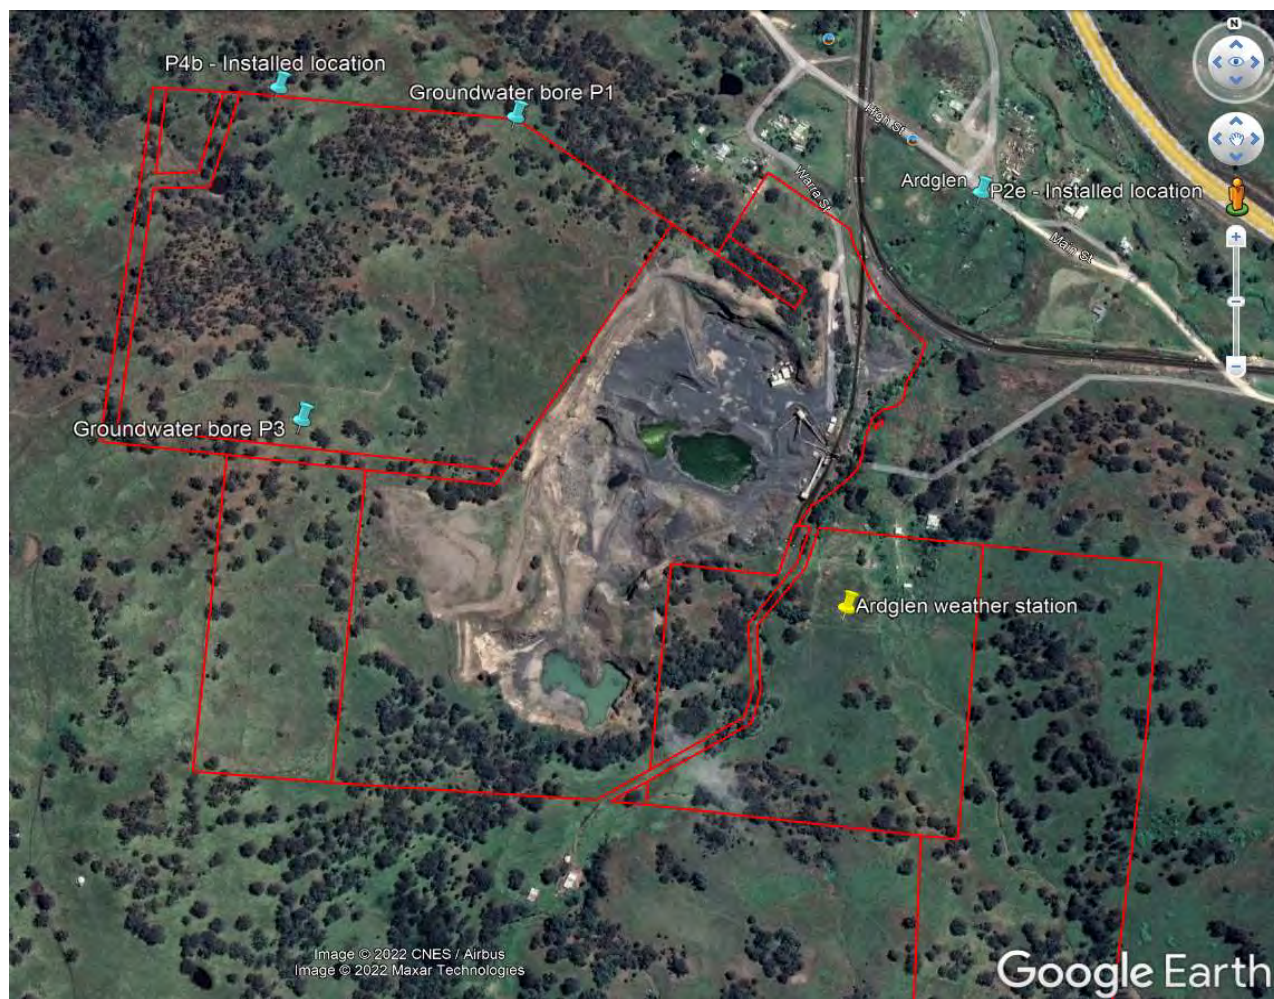
**Figure 4: Ground Water Monitoring Network**

In accordance with Mod 2, once we've obtained sufficient data relating to the various groundwater parameters, we will analyse the data collected and further develop the Groundwater study. This may require us to update the SWMP to include any subsequent management actions required to adequately address the findings of the groundwater study.

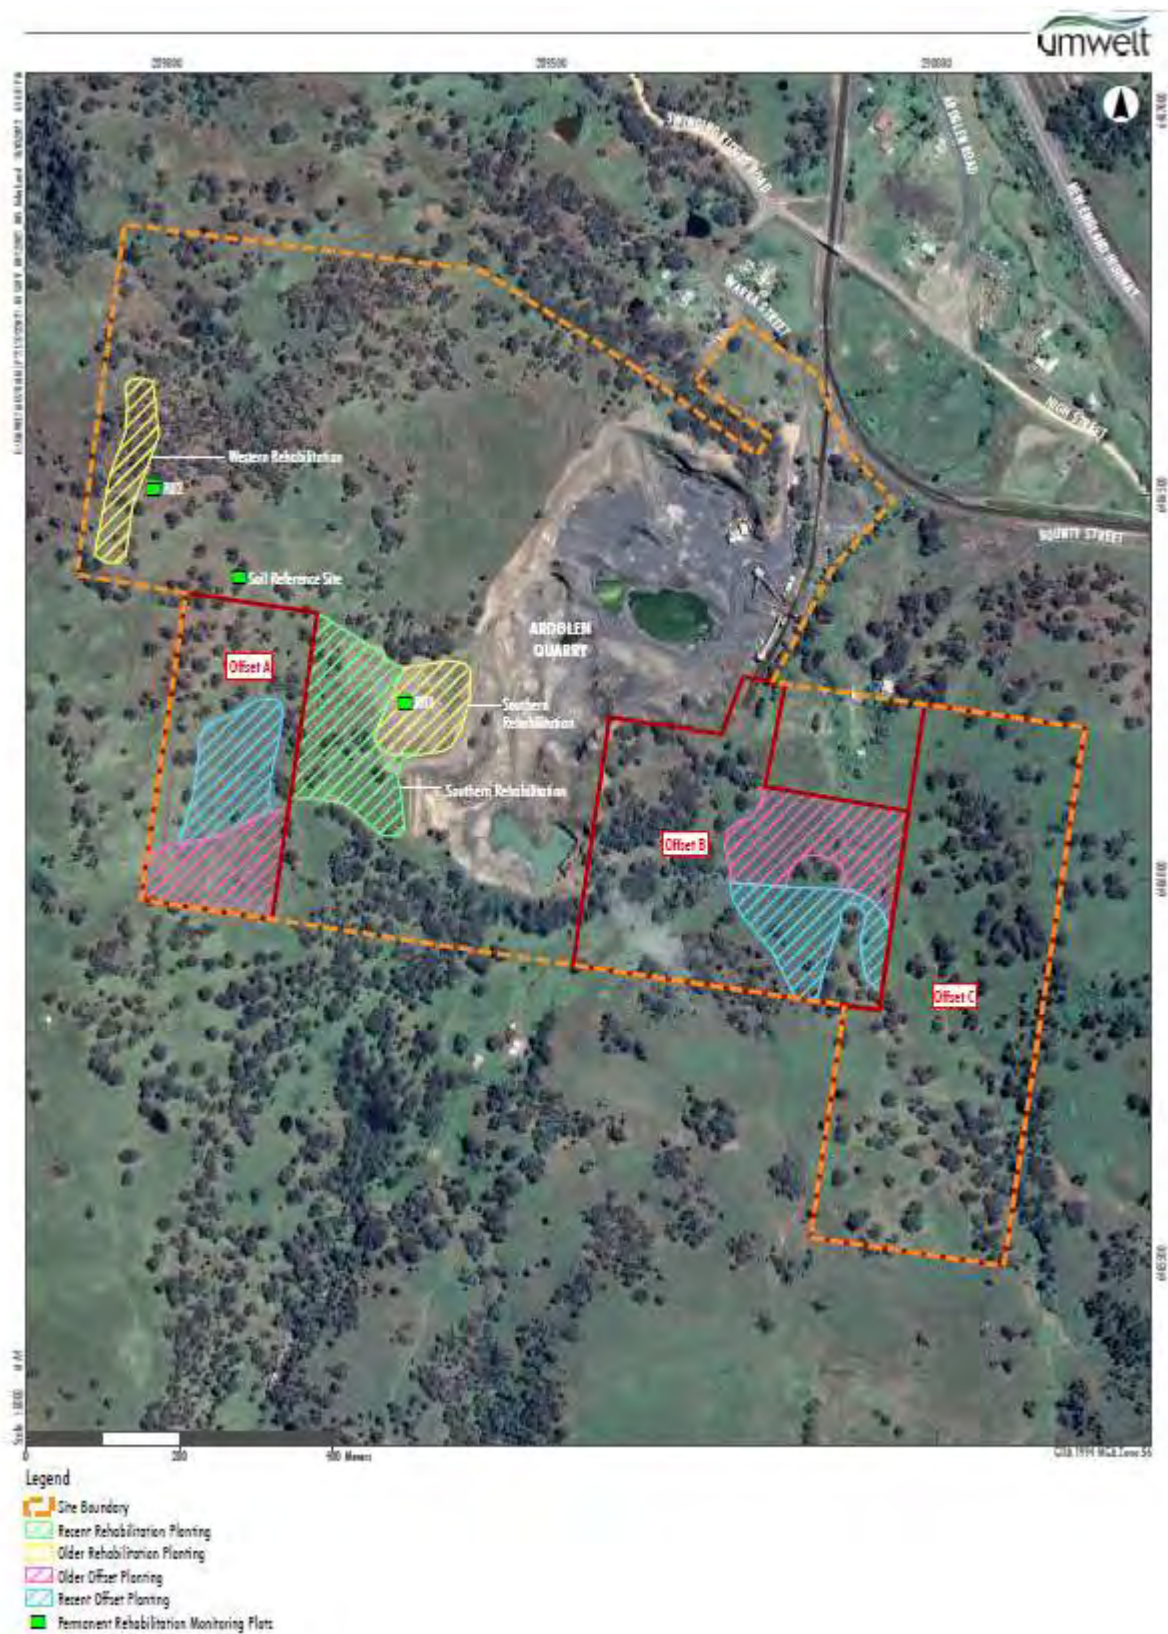
Figure 5: Rehabilitation planting areas

Please also refer to Figure 5 and Section 4.4.4 for further details regarding the rehabilitation progress and suggested actions.

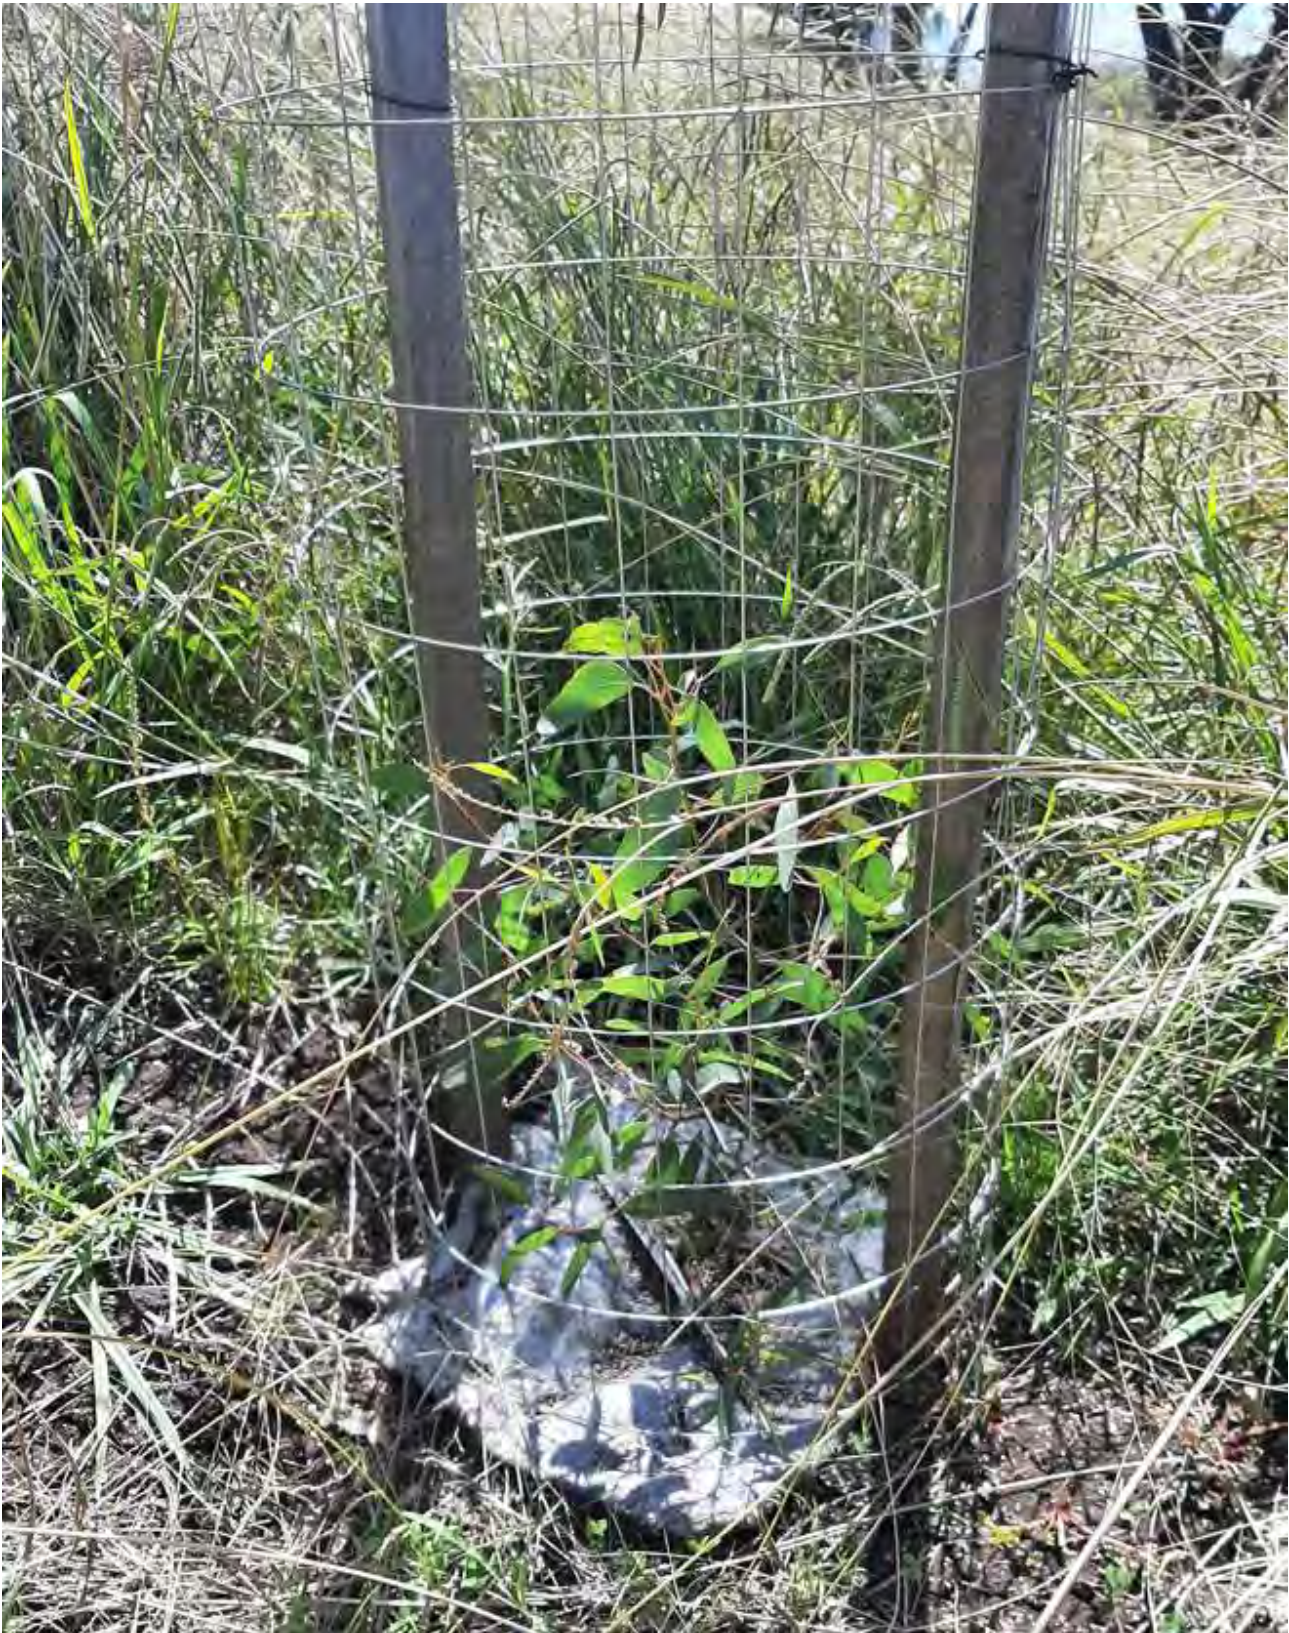
Photo 1: Rehabilitation planting in Offset A

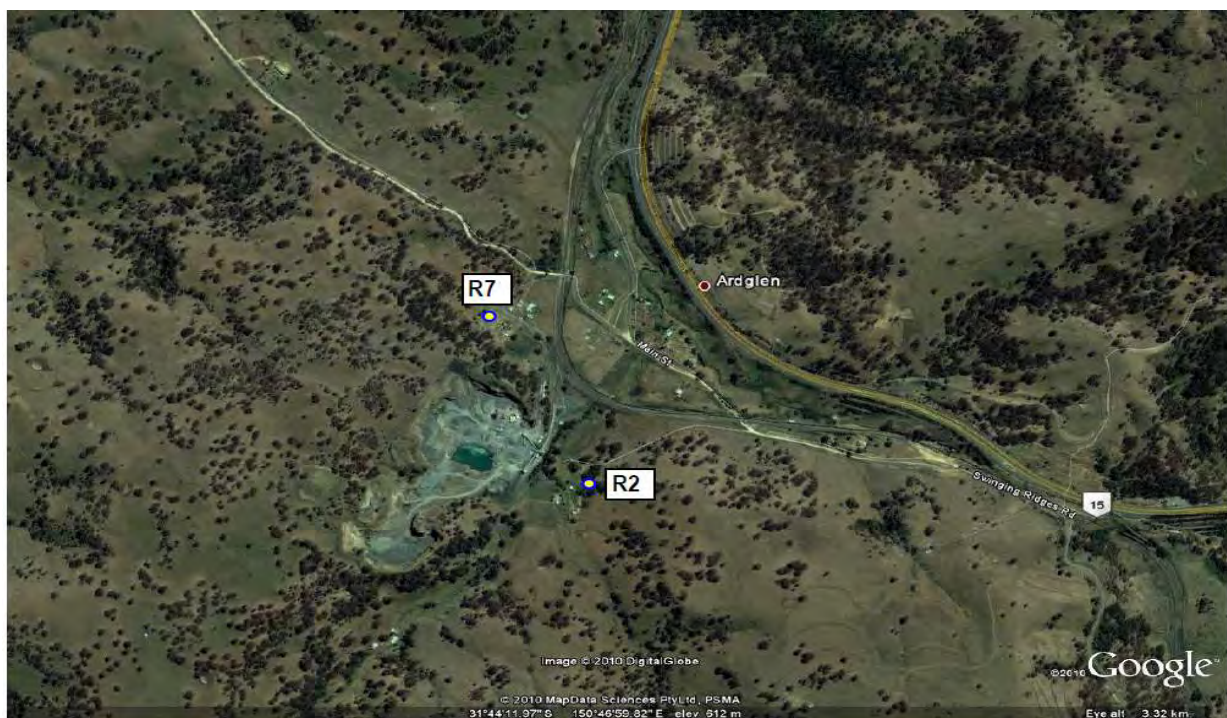
**Figure 7: Blast Monitoring Locations**

The Blast Monitoring Plan requires monitoring to take place at specified locations as shown in **Figure 7**. Daracon have also recently approached all local landholders regarding their interest in receiving blast notifications. Once the relevant landholders that wish to receive a blast notification is known, they'll receive the relevant notifications prior to blasting as required by the Approval.

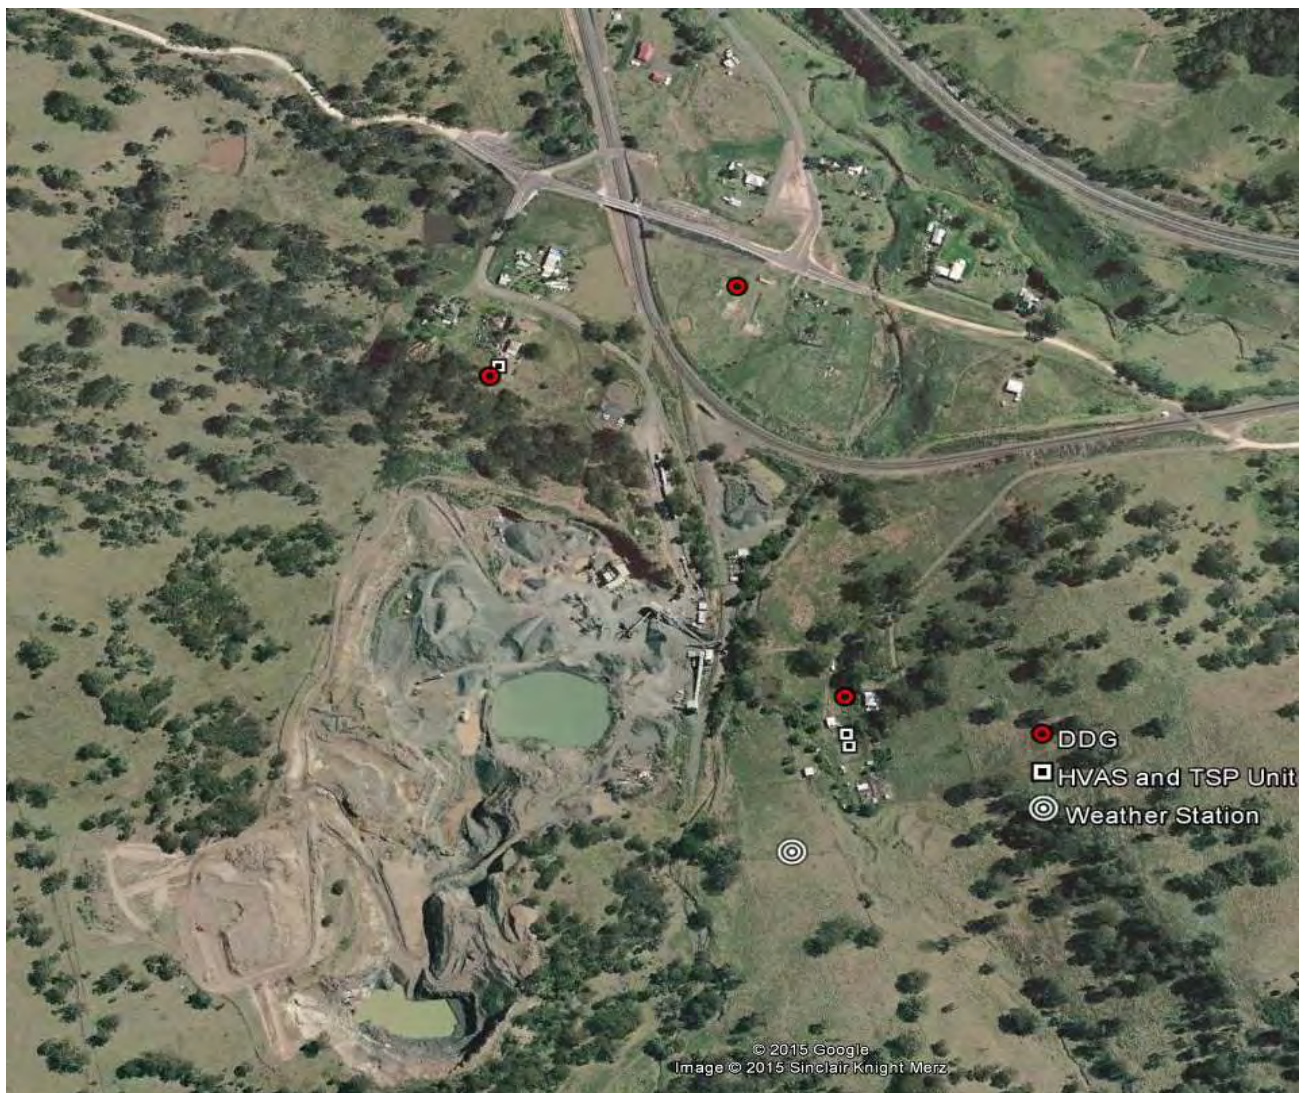
**Figure 9: Air Quality Monitoring and Weather Station Locations**

Condition 18 of the Approval requires that a meteorological station to operate in the vicinity of the project site for the life of the project. Daracon has installed a meteorological station (Figure 9), ensuring that the meteorological station complies with the requirements in the "Approved Methods for Sampling of Air Pollutants in New South Wales Guideline".

The location of the air quality monitoring equipment (primarily to the North-East and East of the Quarry) was deduced from the location of the surrounding residences.

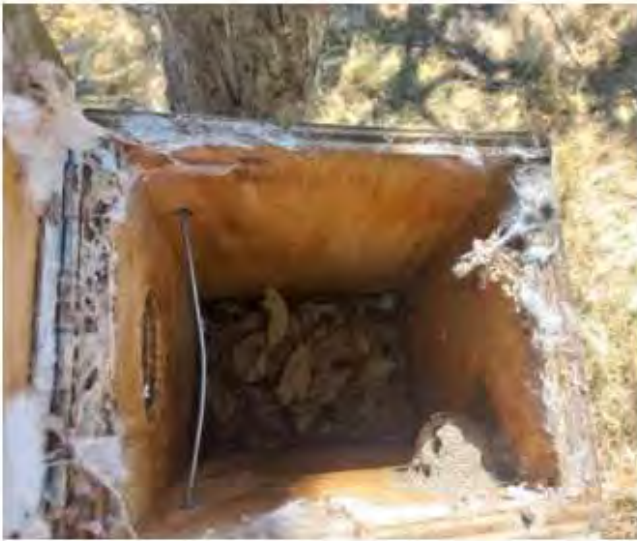
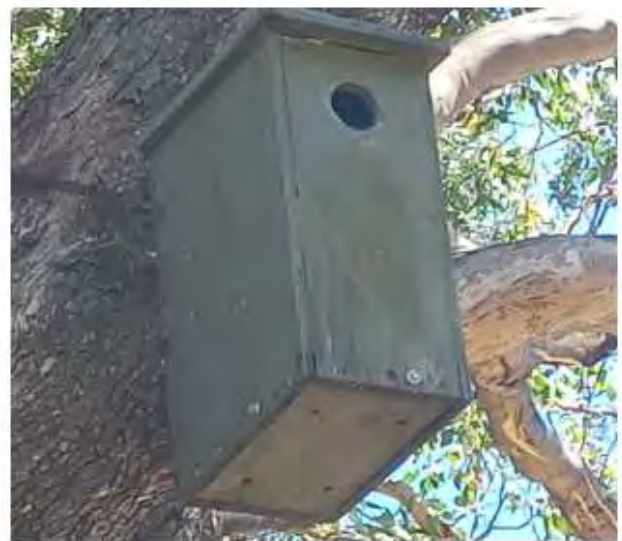
Photo 2: Nest box repairs completed

**NB 17 REPAIRED**

**NB 20 REPAIRED**

- It is recommended that Nest Box 20 should be fixed to have the base reattached to the main structure as the nest box will not remain functional for much longer. It is also recommended that the ply stuck to the upper part of Nest Box 17 (TT158) is removed to better facilitate monitoring of the box, however this is a low priority as access to the box by animals is not impeded – **Following the Umwelt inspection in early 2023, the base of nest box 20 was promptly repaired and the ply stuck to the upper part of nest box 17 was removed as shown in Photo 2;**

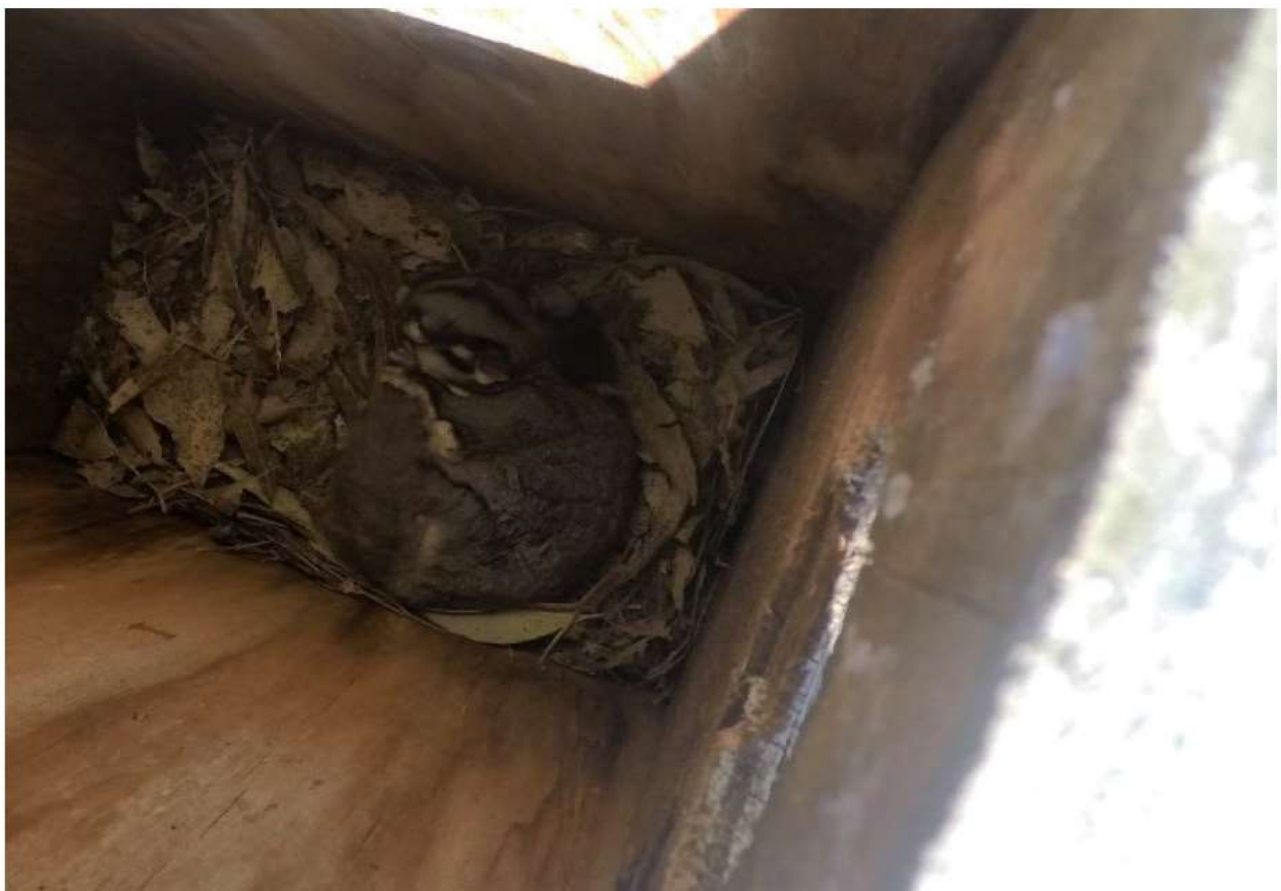
Photo 3: Nest box usage

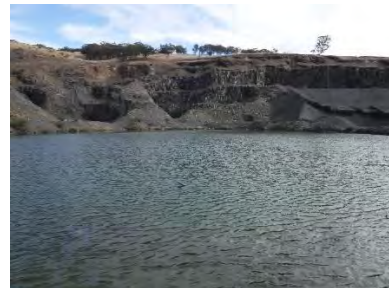
ISSUE NO.	LOCATION	ISSUE/MATTER		RECOMMENDATION/COMMENT		PHOTOGRAPH	
1.	Main central dam.	The inspection occurred following an extended period of ongoing rainfall totalling approximately 60mm in the preceding week. Runoff from the quarry slopes and floor is directed to the main central dam, which was spilling via overland drainage line at the time of the inspection. The visual water quality of the central dam was very good with very low turbidity levels.		Continue to monitor the dam, adjacent drainage lines and the contributing catchment.

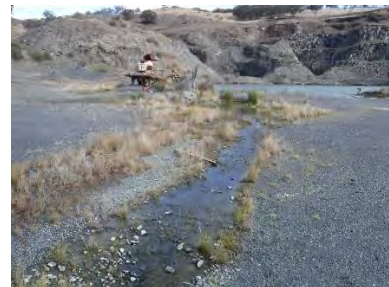
2.	Main central dam.	As above.		As above.

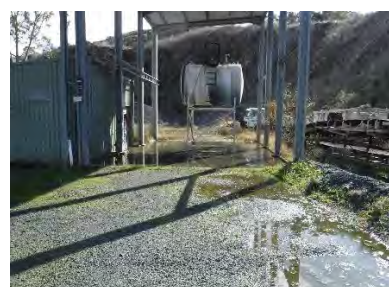
3.	Lube shed and fuel storage area.	As noted on previous inspections, the lube shed area remains secure and dormant with adequate bund storage and controls. Ponded water in the surrounding areas was clear and no oil sheens were present.		Continue maintain the area and visually monitor water quality in the surrounding areas.

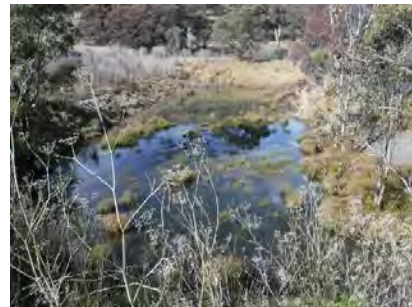
ISSUE NO.	LOCATION	ISSUE/MATTER	RECOMMENDATION/COMMENT	PHOTOGRAPH
4.	Sediment basin adjacent rail corridor.	The sediment basin adjacent to the rail corridor was inspected. As noted, recent ongoing rainfall has been experienced in the catchment. The water quality in the dam was visibly good indicating low turbidity levels.	Continue to monitor and maintain the drainage lines and the contributing catchment of the basin.

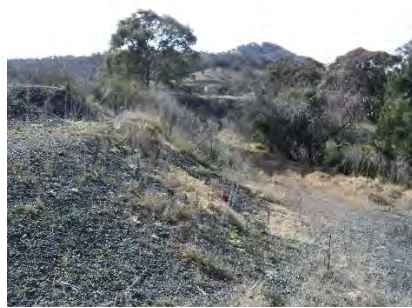
5.	Warra Street rail siding area.	The area around the former stockpile area near the Warra Street rail siding was inspected. In the time since the previous inspection, the area has been fully recolonised by emergent vegetation. It was noted that weed outbreaks in the area had been treated in the time since the previous inspection.	As discussed, the area is now vegetated and stable. Continue to monitor the area and ensure the area continues to be included in the periodic weed treatment program.

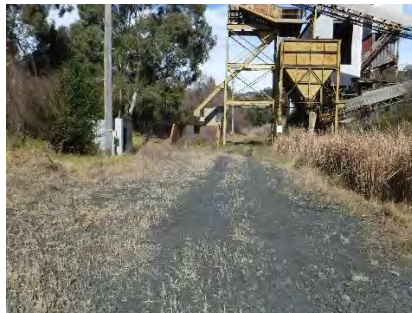
6.	Rail loading area.	The rail loading area is largely colonised by ground cover vegetation and pasture grasses. Run-off from the upper quarry areas is filtered by vegetation along the length of the drainage line.	Continue to monitor the drainage lines and undertake periodic weed suppression in the area as required.

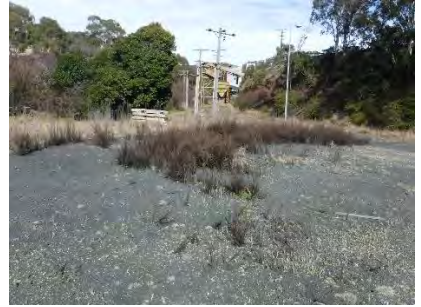
ISSUE NO.	LOCATION	ISSUE/MATTER	RECOMMENDATION/COMMENT	PHOTOGRAPH
7.	Weed control – main quarry.	As noted on previous inspections, the weed suppression program has been implemented regularly within the quarry surrounds. Evidence of die back of previously treated areas was noted in several areas. In general, outbreaks of weeds are being regularly suppressed and no significant weed outbreaks were noted in the main quarry floor and surrounds.	Continue to monitor the quarry working area and perimeter areas and implement periodic weed control as required.

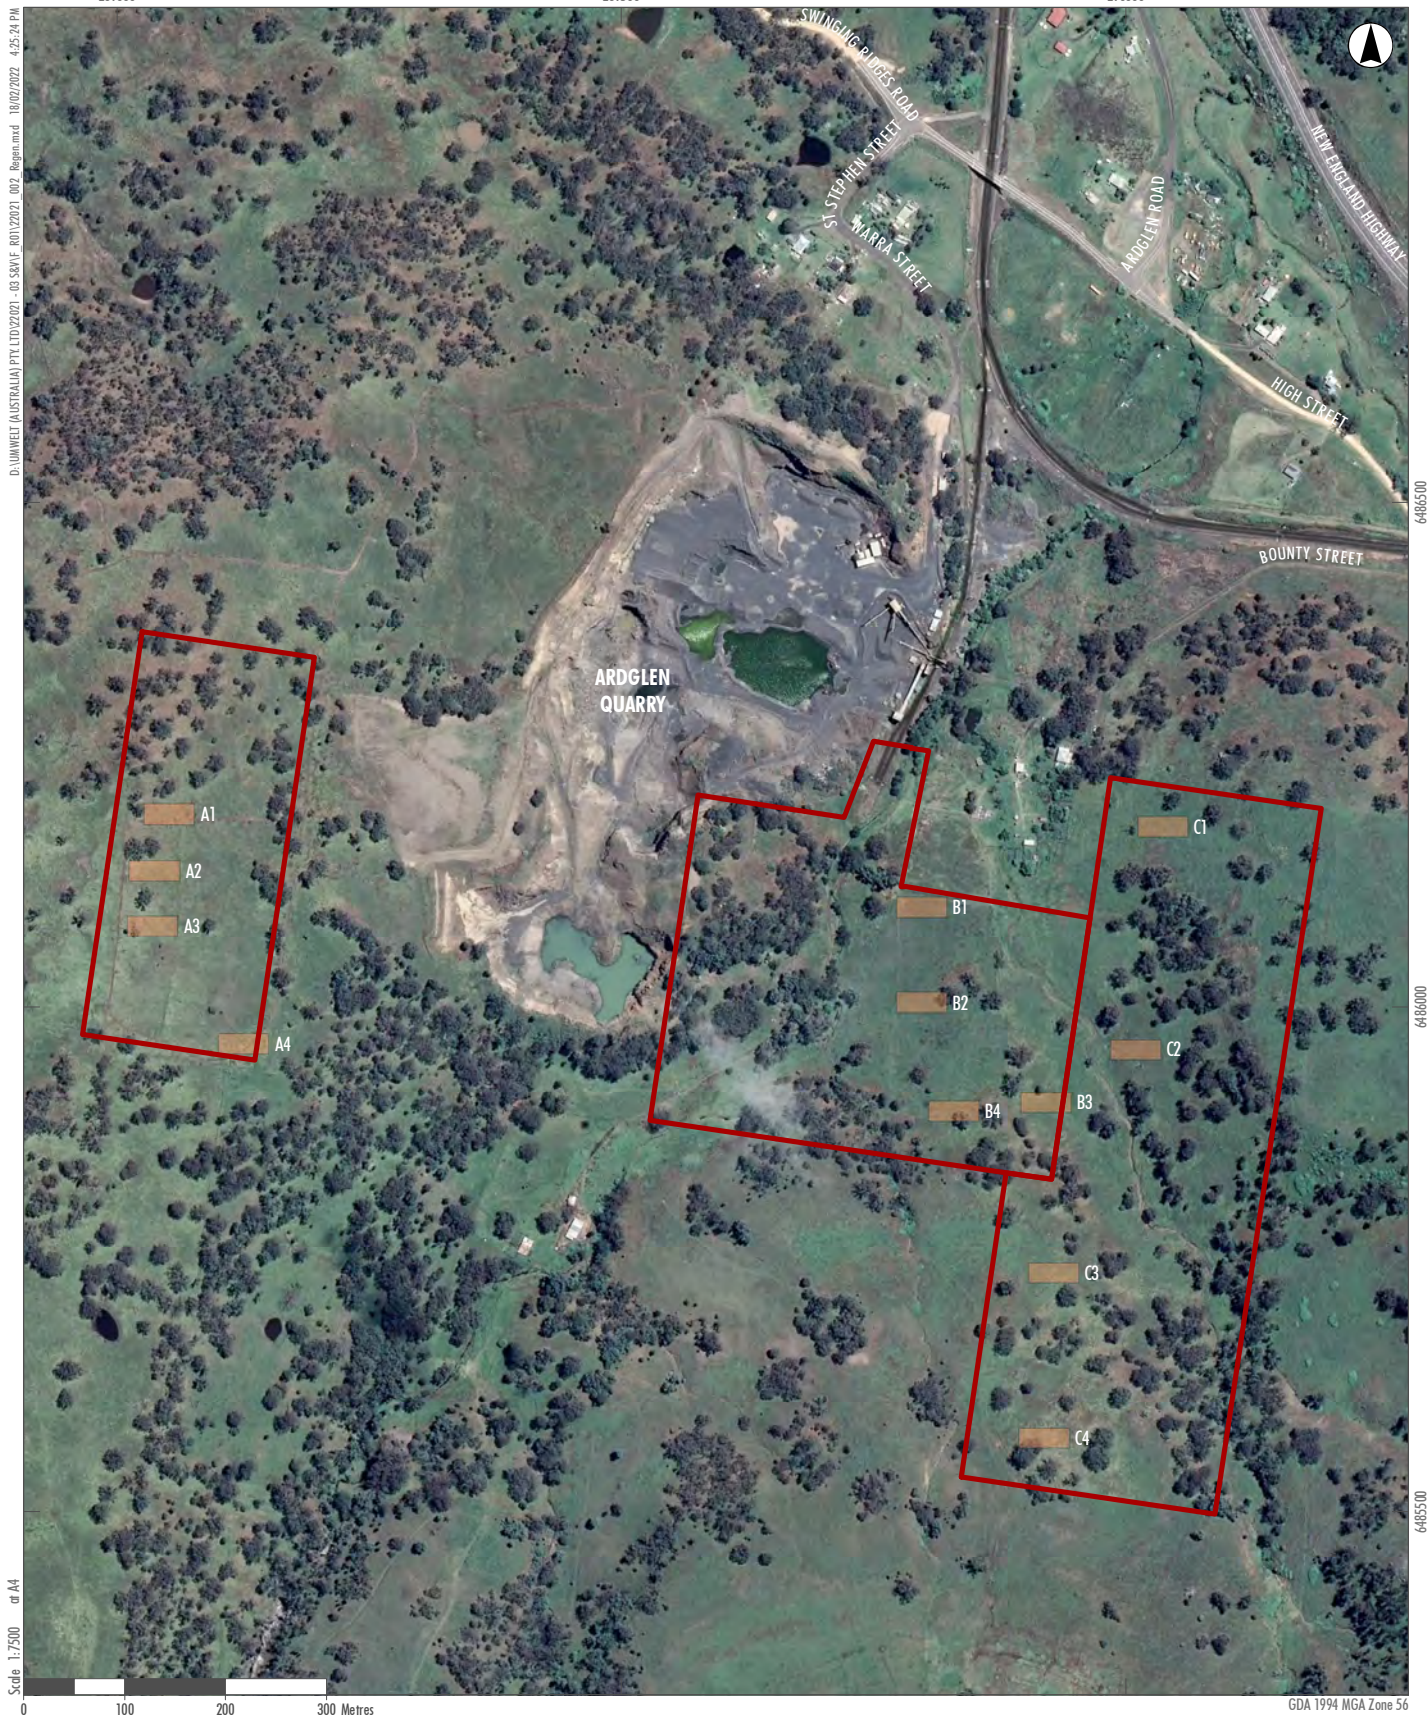
FIGURE 2.1

Natural regeneration was assessed within Derived Native Grassland communities at each of the BOAs. Four 50 m x 20 m plots were established in 2019 in the grassland area within each BOA (12 plots in total), with a small wooden picket marking the northeast corner of each permanent plot. The canopy cover (projective foliage cover %) was assessed within each plot. The location of the natural regeneration monitoring plots is shown on **Figure 2.1**.

Natural Regeneration Monitoring Plots

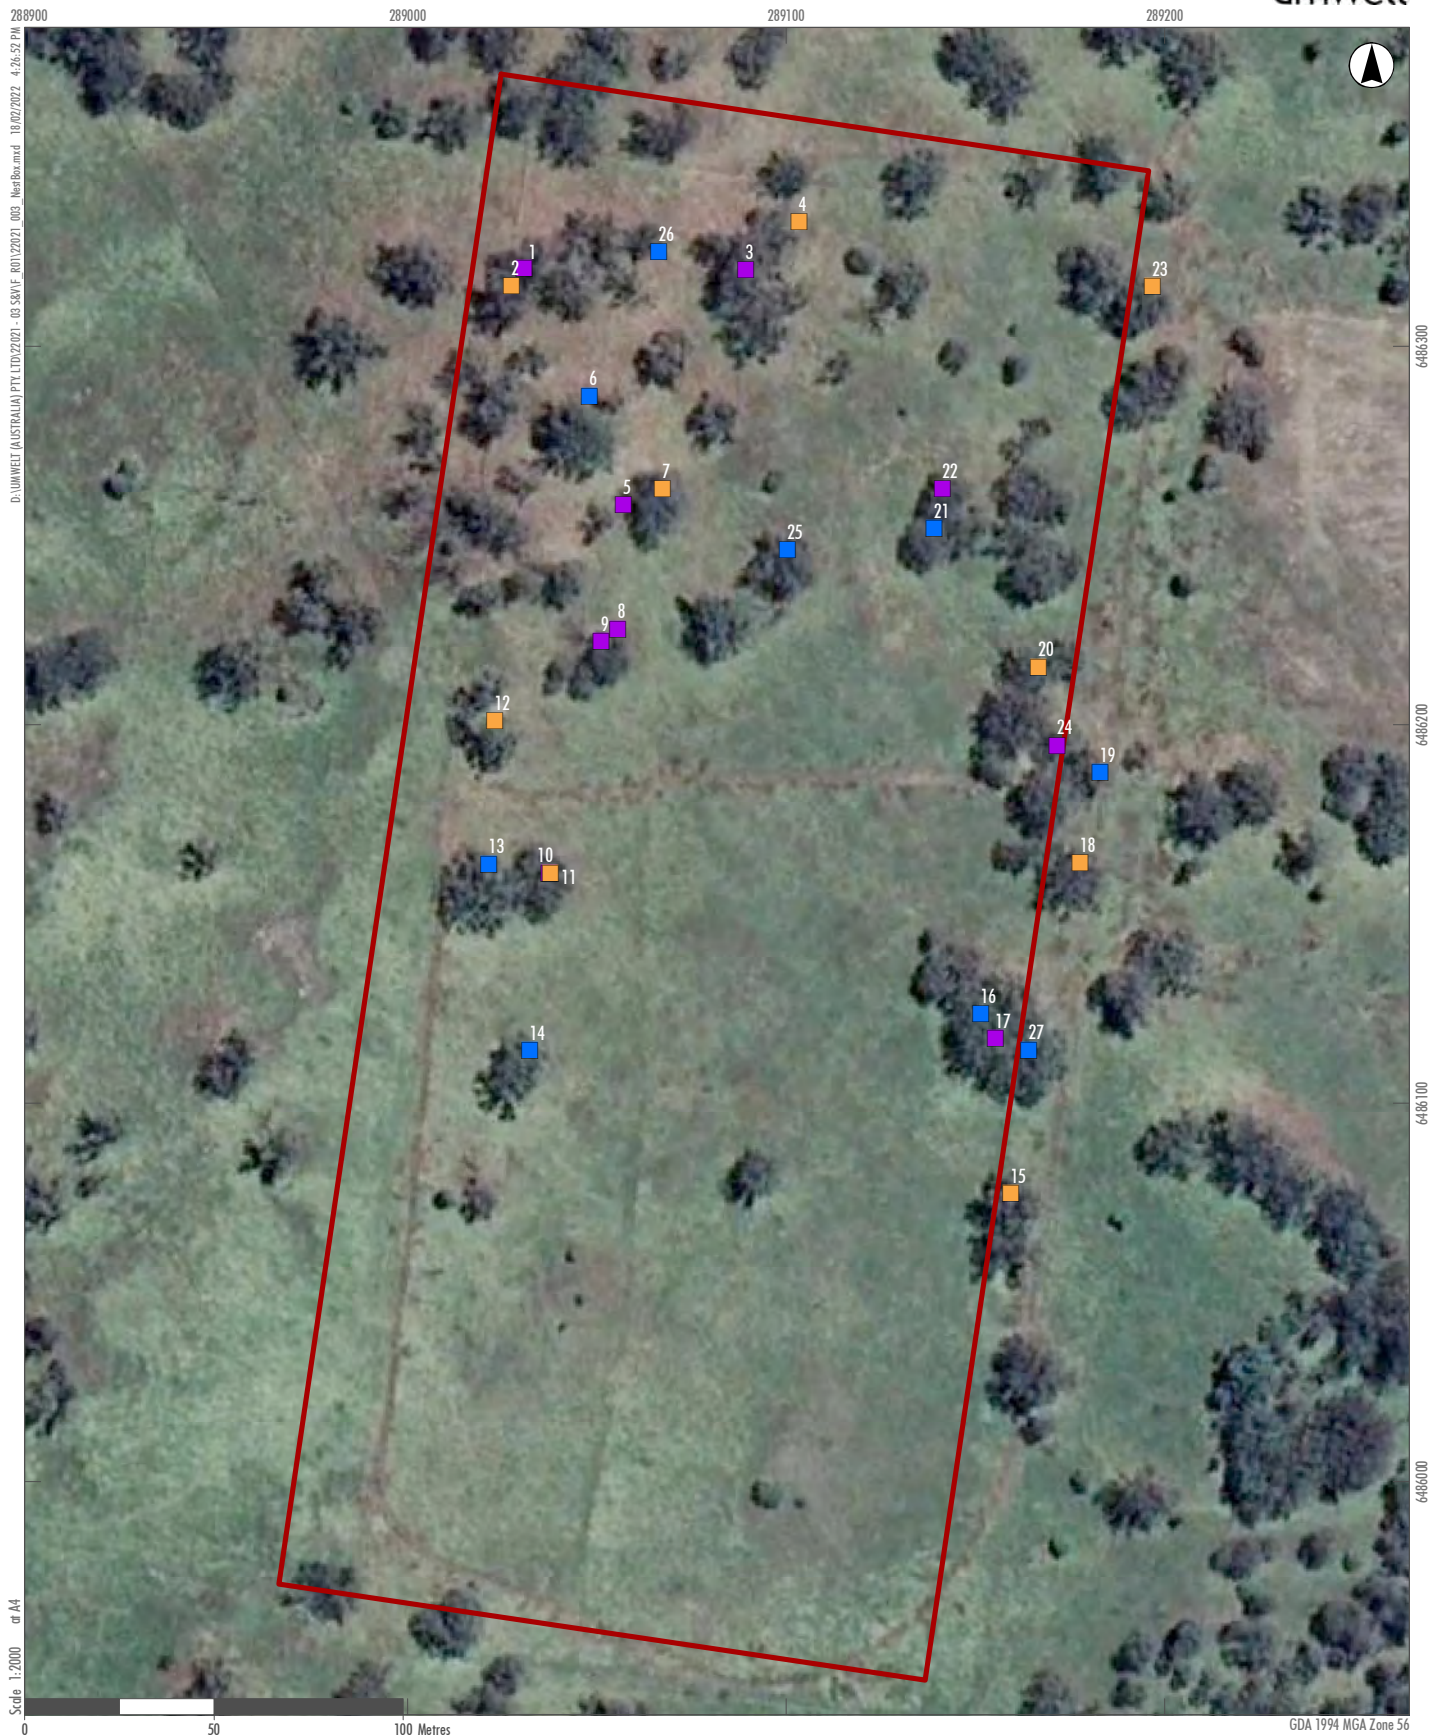
**FIGURE 2.2**  
**Nest Box Locations**

Nest box monitoring was undertaken for 27 nest boxes installed in Offset A (Lot 187 DP 751028) which are shown in **Figure 2.2**. These boxes were comprised of:

Boxes were inspected using a pole-mounted camera. Monitoring comprised content and condition assessment and included the following:

- content monitoring
- target species use
- signs of presence such as nesting material or feathers
- predator use
- presence of native fauna
- presence of non-target species such as bees, wasps and introduced birds.
- condition monitoring:
  - collapsing joints
  - missing lids
  - bowing timber
  - perishing timber
  - tree attachment.

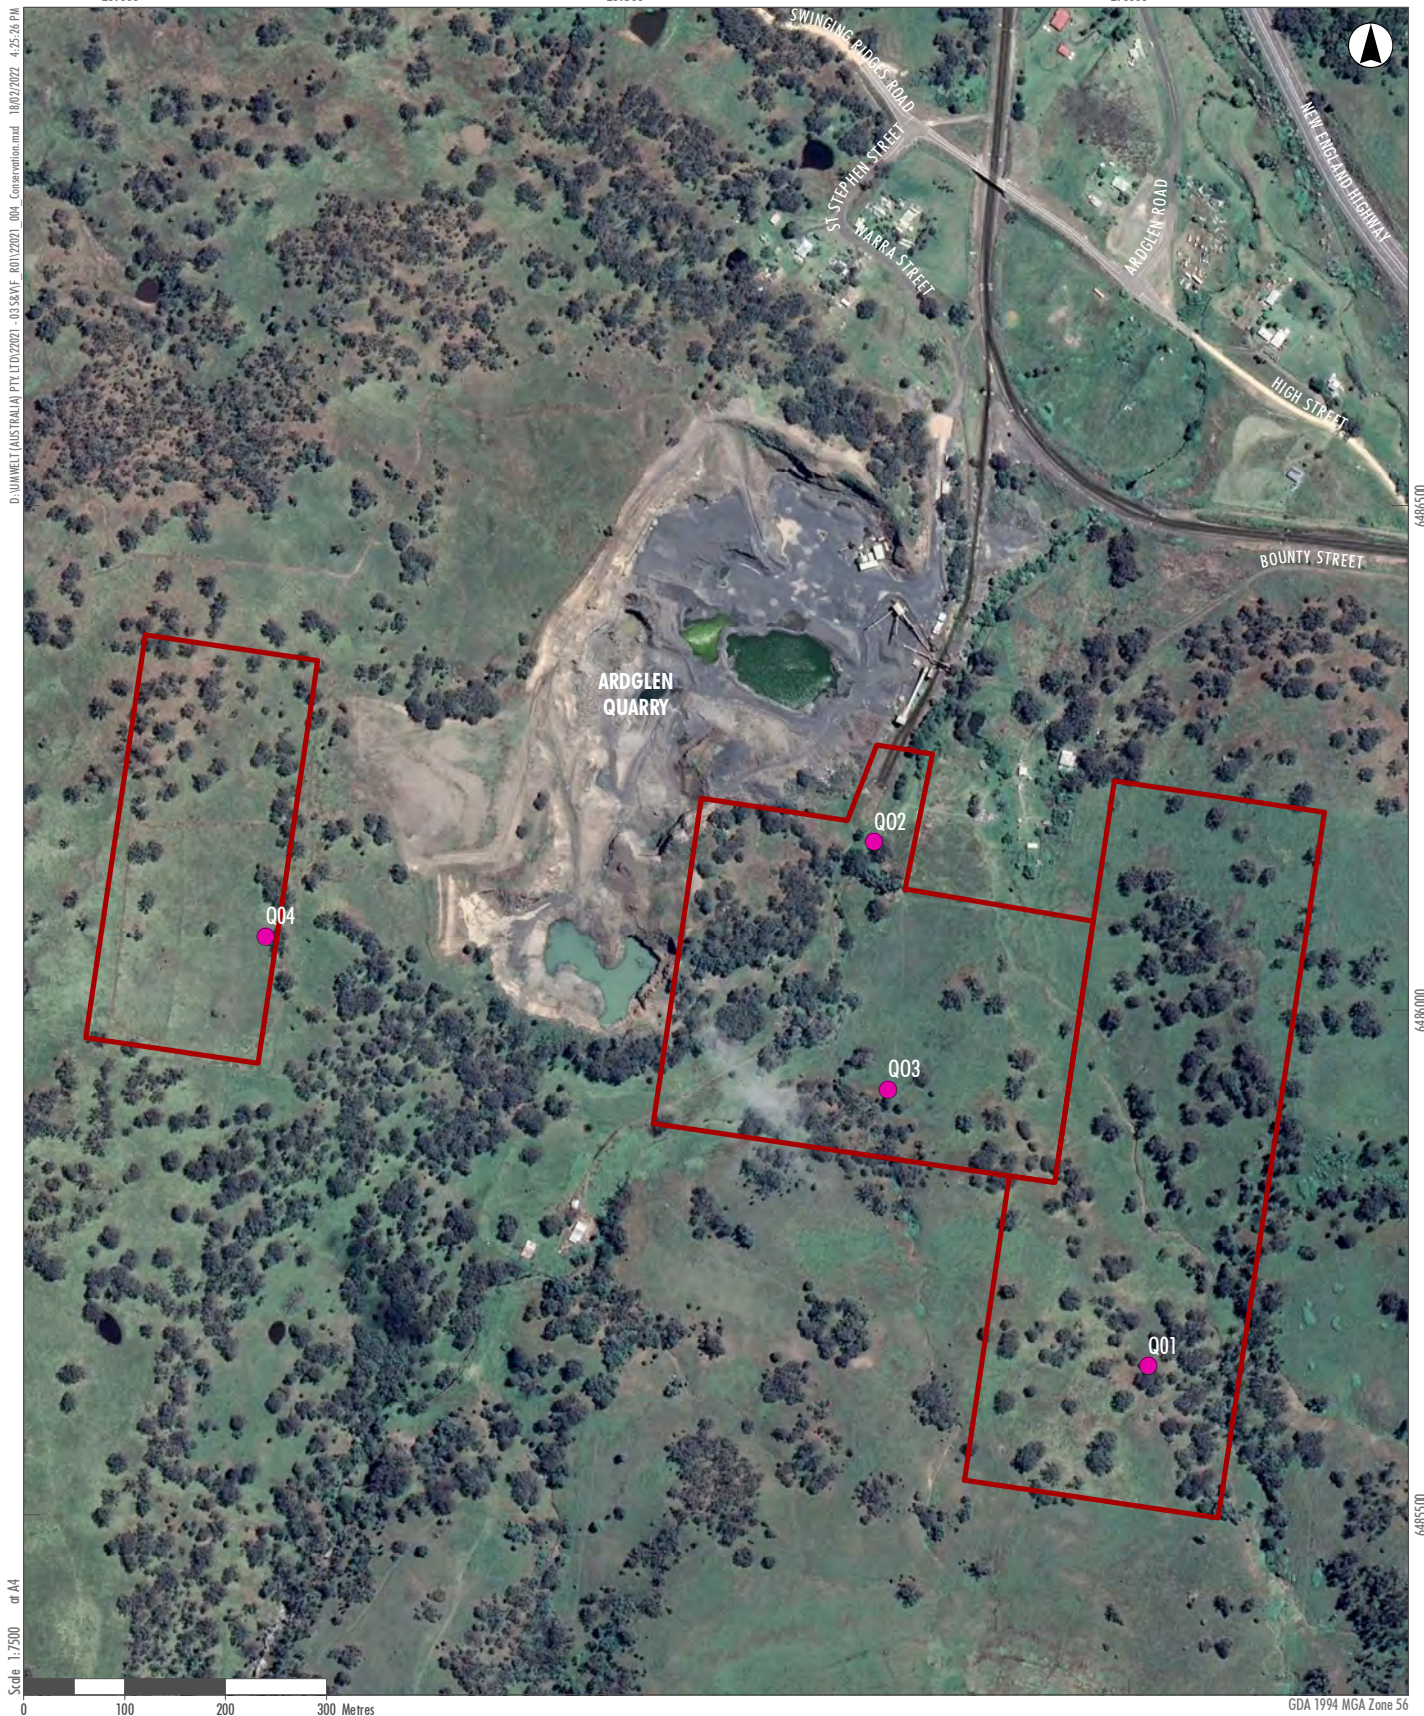
FIGURE 2.3

Four permanent monitoring plots have been established within each of the four vegetation zones in the BOAs identified by Orogen (2010). Each plot was marked in the northeast corner (of the 20 m x 20 m subplot) with a steel picket and high visibility flagging tape. Plot locations are shown in **Figure 2.3**. Photo monitoring, floristic and biometric data collection and a walkover assessment were completed according to the BioBanking Assessment Method (BBAM) methodology (OEH 2014) and are further described in the following sections.

Conservation Agreement Plot Locations
