# ARDGLEN QUARRY

## 2022 Annual Environmental Management Report (AEMR)

PROJECT APPROVAL MP 06\_0264 - MOD 2

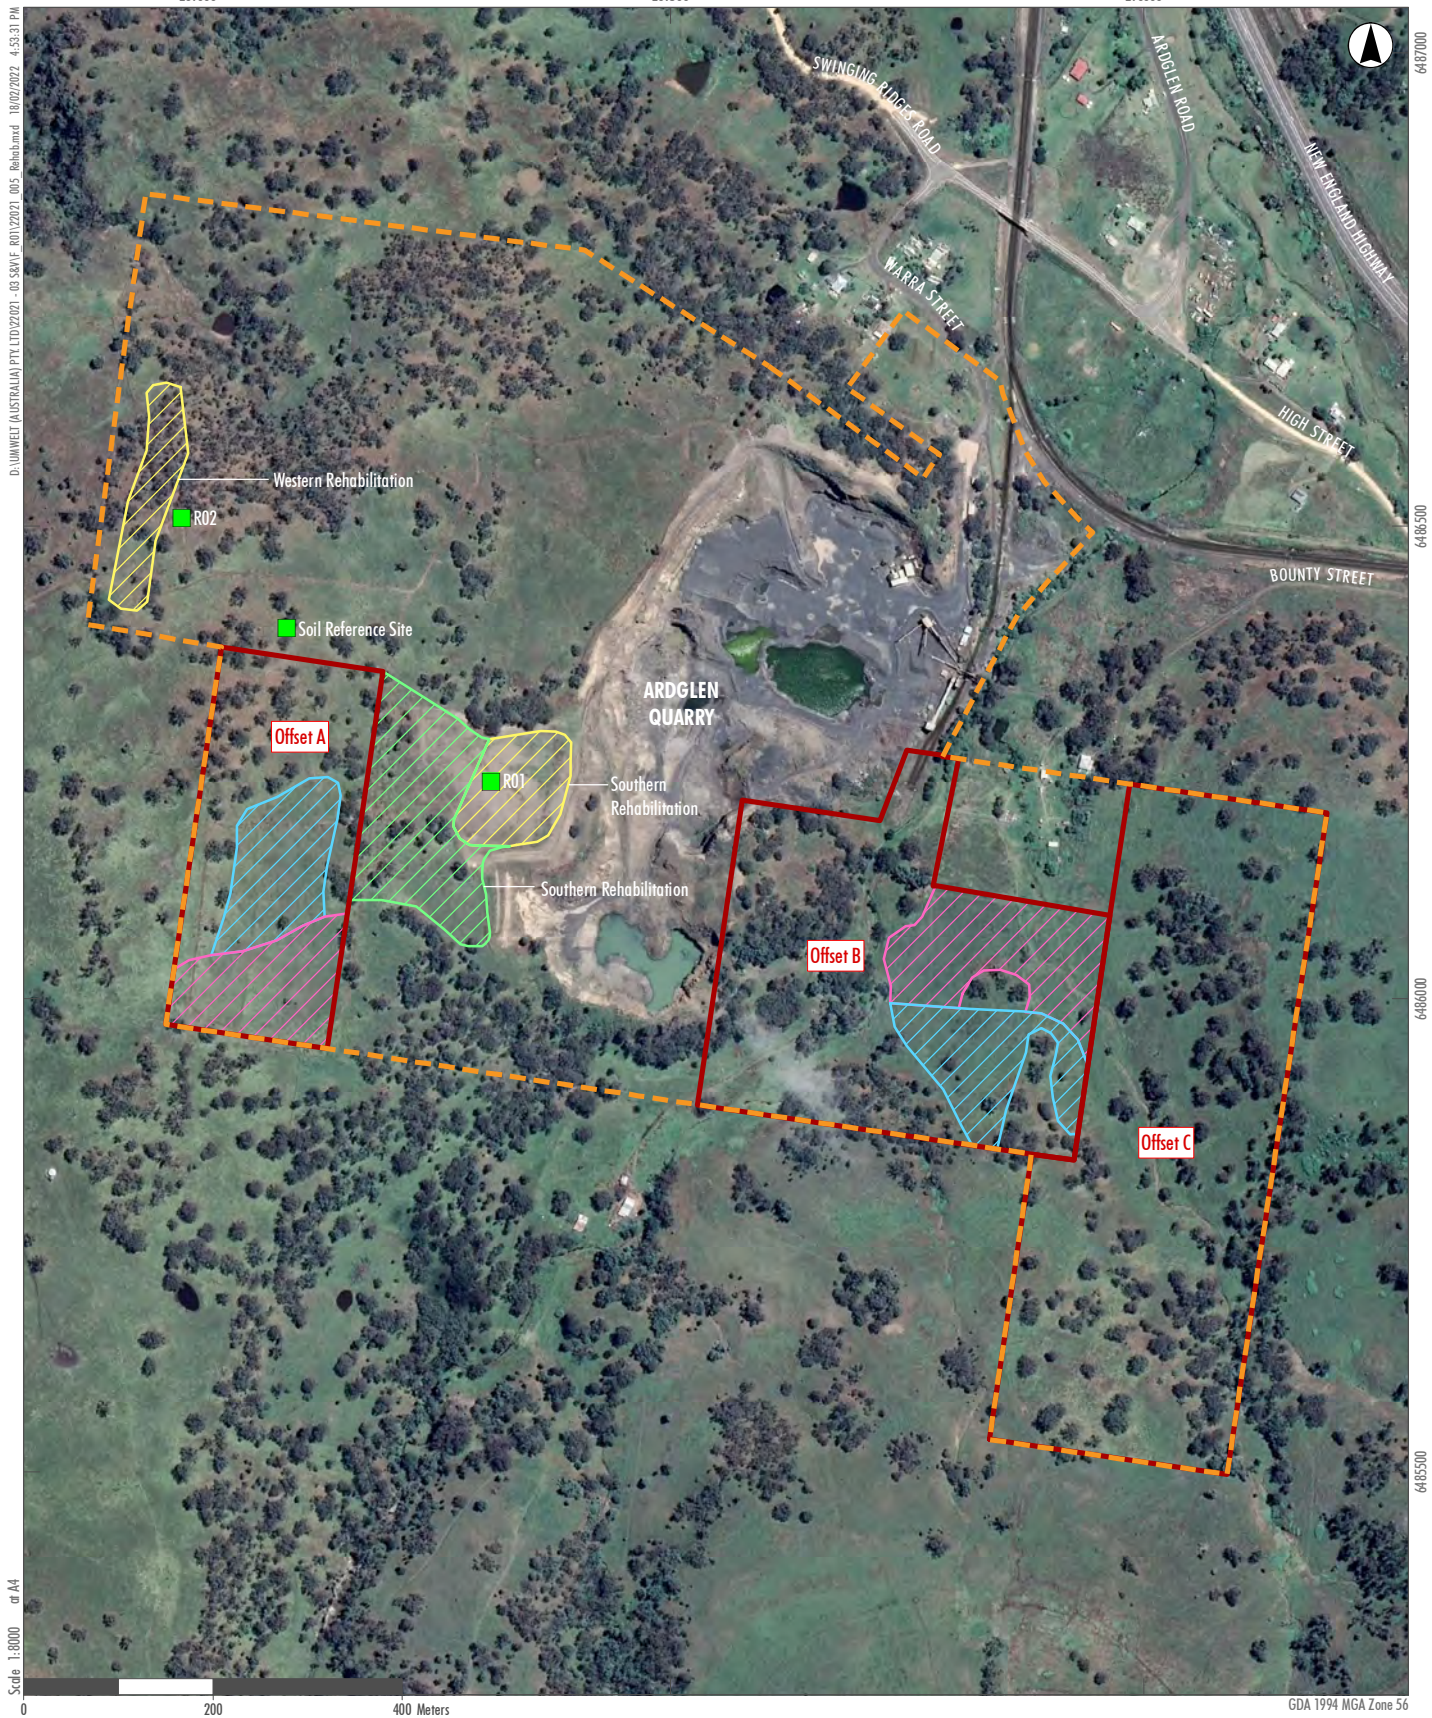
**FIGURE 2.4**

Approximately 500 saplings have been planted in areas adjacent the existing quarry in September 2019 and March/April 2020, with some replanting in 2021 as shown in **Figure 2.4**. Please note that the rehabilitation planting areas on this figure represent the intended planting areas in the LMP and are indicative of the planting areas. The following was undertaken in these areas:

- Two rehabilitation monitoring plots (20 m x 50 m) were monitored using floristic and biometric data collection methods in accordance with the BioBanking Assessment Methodology (BBAM) (OEH 2014).
- The proportion of seedling survivability was monitored in each of the rehabilitation monitoring plots. This was calculated by counting the number of stems within each rehabilitation monitoring plot and assessing their survivability status (dead, alive, senescent etc.) over time.
- No soil sample analysis was undertaken during the 2022 monitoring survey. Soil samples are undertaken on a three yearly monitoring rotation.

Approximately 500 saplings were planted in the two rehabilitation areas outside of the BOAs and identified in the indicative planting areas in Figure 2.4. Two areas were planted within the quarry boundary. The Western Rehabilitation plantings were undertaken in September 2019 along with the

Approximately 447 tubestock were planted within Offset A and Offset B in 2021 in the indicative planting areas shown in **Figure 2.4**. Older offset supplementary plantings were made in Autumn 2021, with recent plantings made in Spring 2021. Though most species could not be identified due to their young age, the species mix appeared to be a satisfactory mix of representative canopy and mid-storey species for the area. Heights ranged from approximately 0.5 – 1.7 m. Condition and survivorship of these plantings was good, with approximately 75% of plantings surviving. Most of the losses encountered appeared to have been contributed to by destructive behaviour by feral pigs and deer, which has also resulted in damage to tree guards. In some cases, weeds and high grass are competing with saplings for space (**Photo 4.3 and Photo 4.4**).

Approximately 500 saplings were planted in the two rehabilitation areas outside of the BOAs and identified in the indicative planting areas in **Figure 2.4**. Two areas were planted within the quarry boundary. The Western Rehabilitation plantings were undertaken in September 2019 along with the lower/eastern plantings in the and the Southern Rehabilitation area. The top/western portion of this area was planted in March/April 2020.

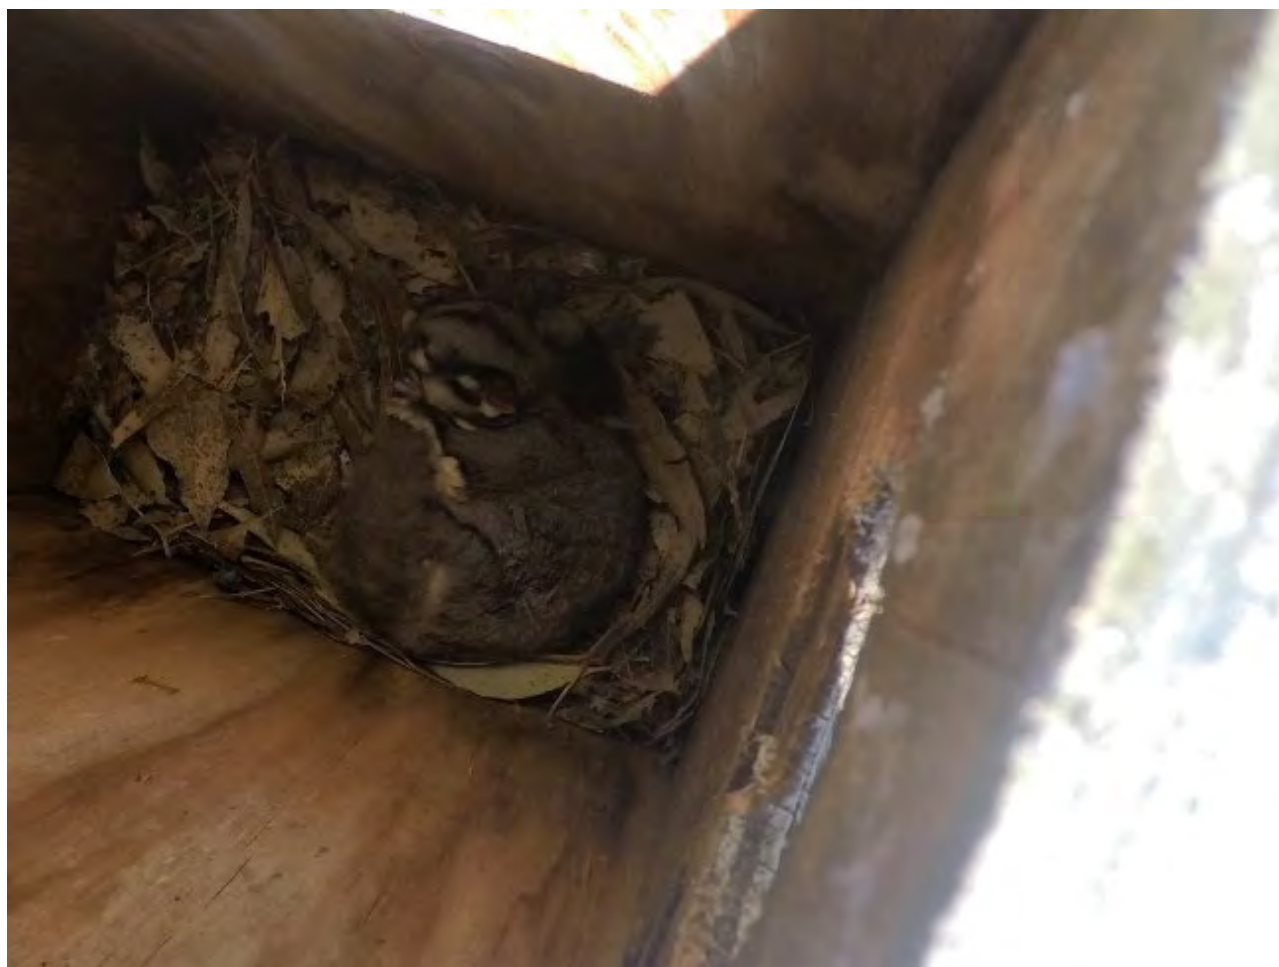
**Photo 4.1**      **Glider (sugar or squirrel, indeterminate) identified in NB23/TT111**

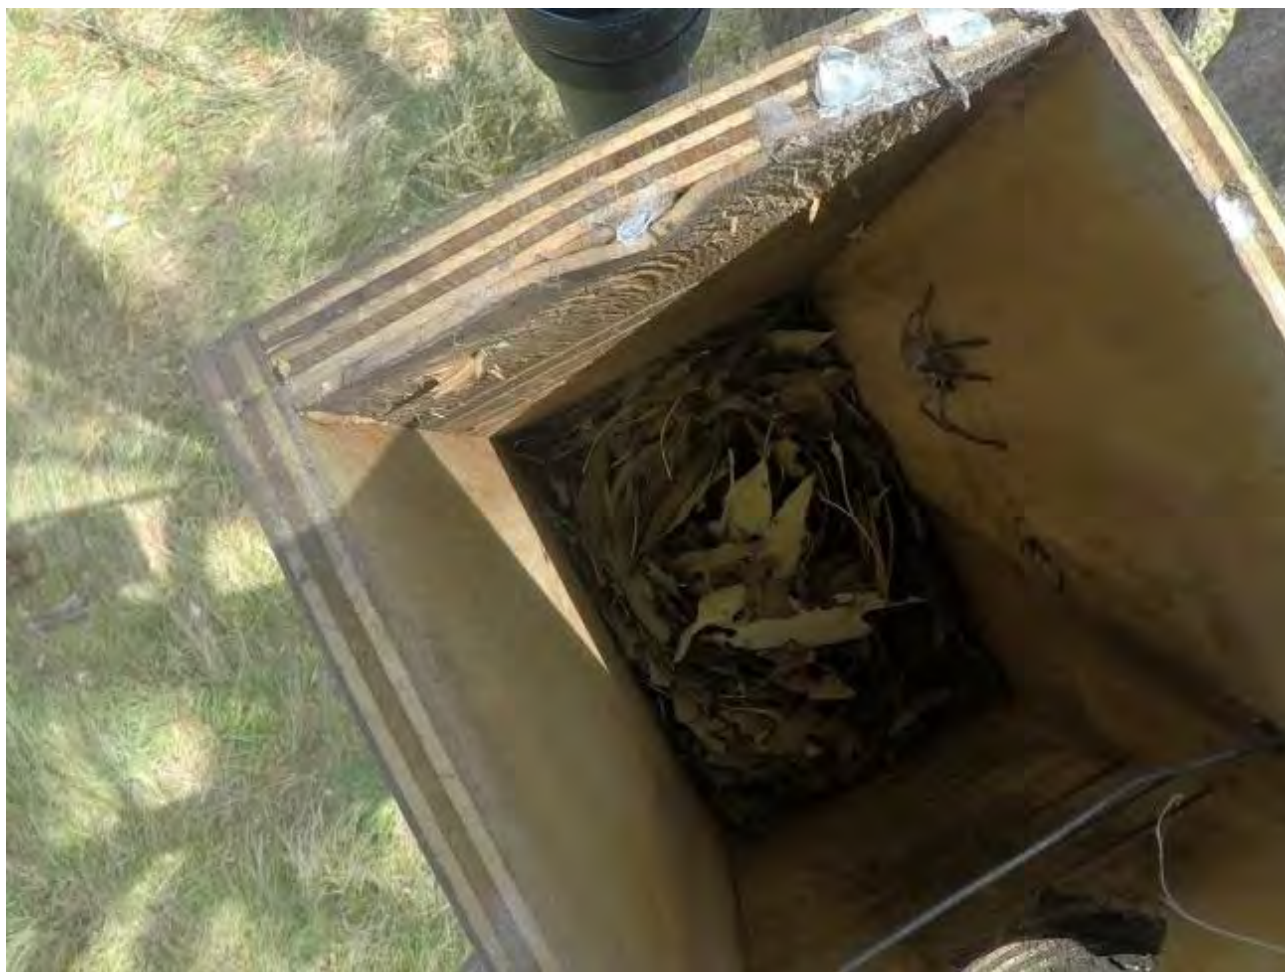
**Photo 4.2** Glider nest (sugar or squirrel, indeterminate) in NB01/TT175

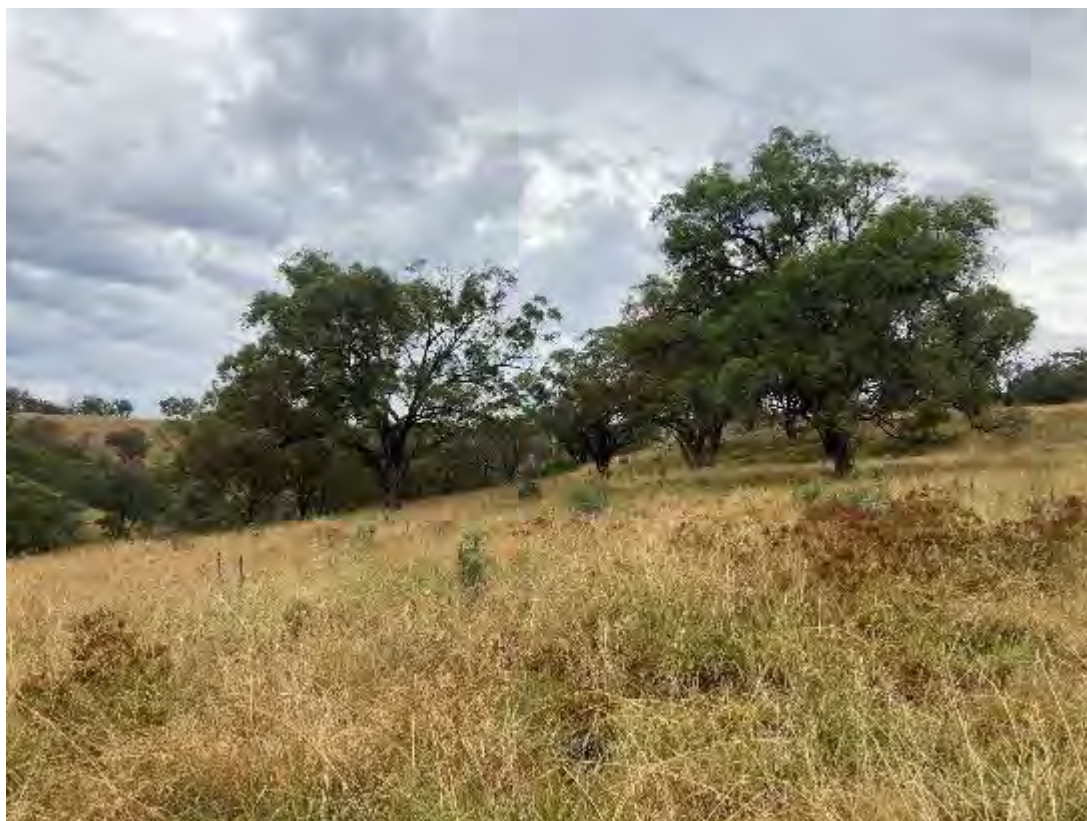
**Photo 4.3**      **Plantings in Offset B – more successful on upper slopes where there is less competition and encroachment from tall grasses and weeds**

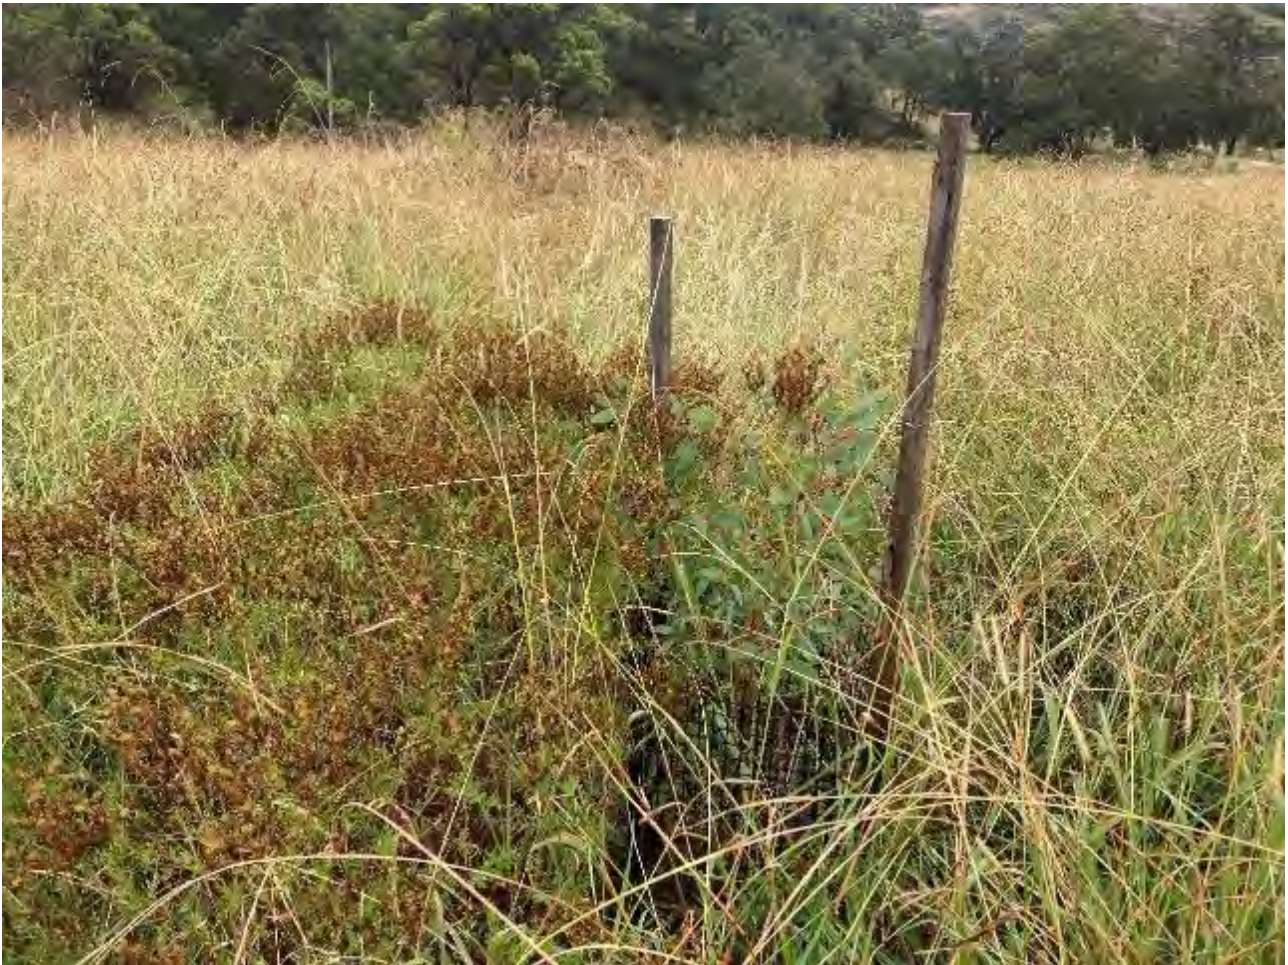
**Photo 4.4**      **Planting in Offset B – see example of weed encroachment**

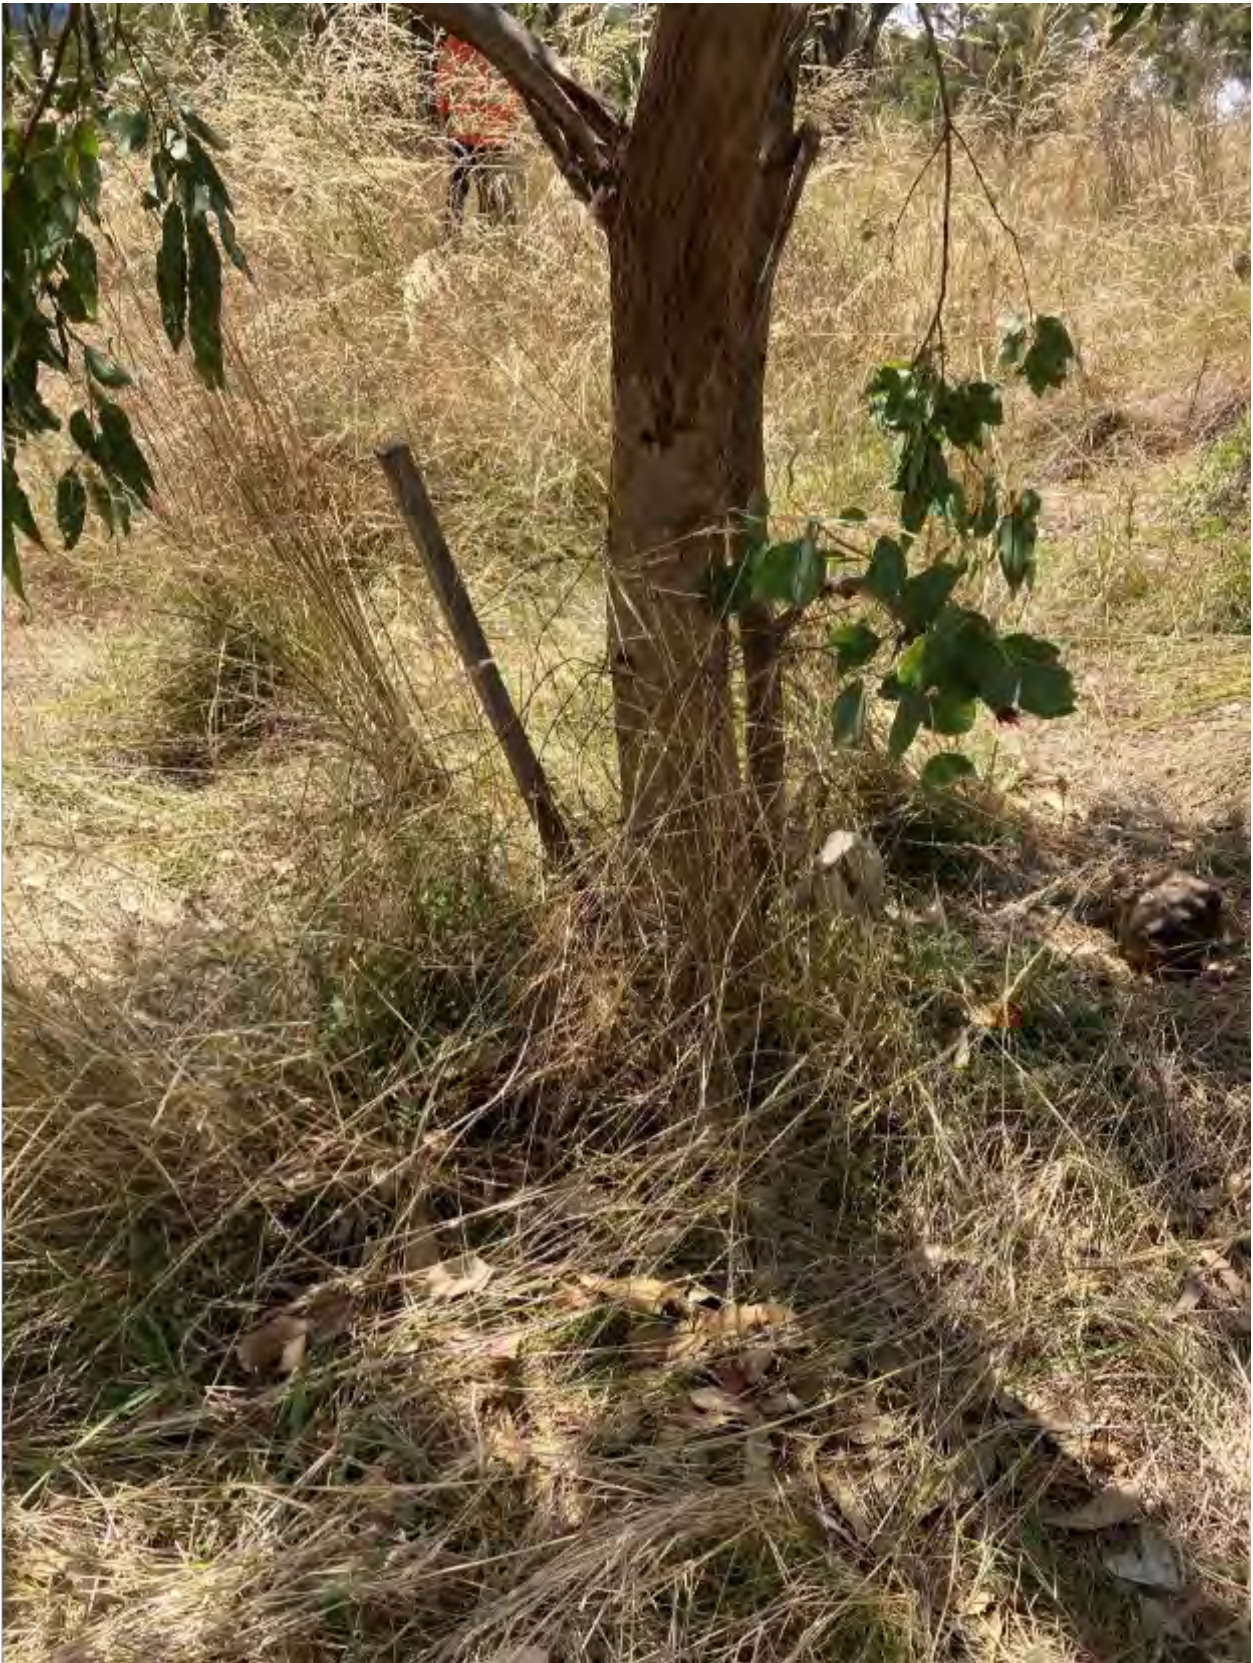
**Photo 4.5 Rehabilitation planting near R02 – the sapling is now established; fencing should be removed for tree safety**

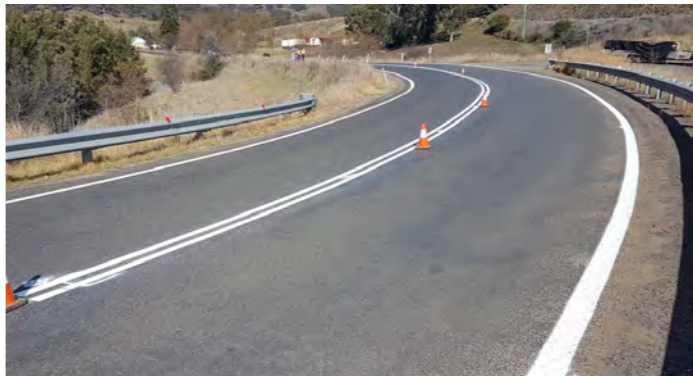
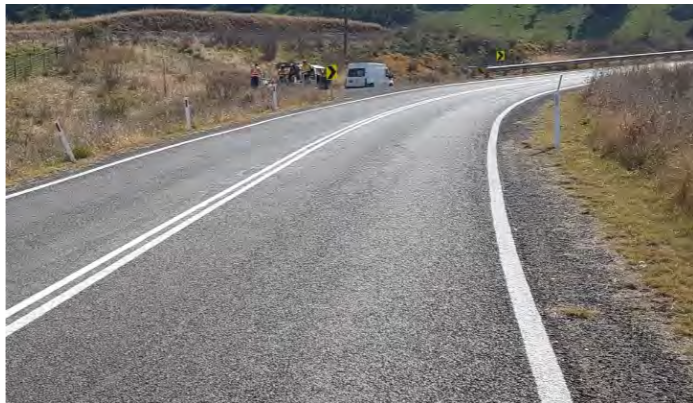
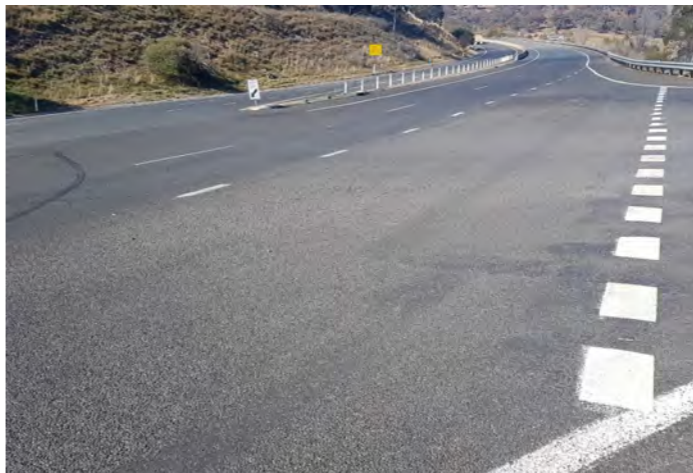
RSA report identification number	Location / category	Description of risk to road safety	Specific actions Daracon commit to undertake	Completion date (if complete) with comments	Evidence of completion	If not complete, status update as at <b>24<sup>th</sup> March 2023</b>
1	Intersection of Main Street and New England Highway Northbound and Southbound Delineation	The approach to the intersection of Main Street and New England Highway is missing delineation (i.e. RRPM's) and has faded line marking. This may increase the likelihood of readability issues for a driver. The likelihood of this risk may increase at night and / or adverse weather conditions. This may result in vehicle crashes and injury to occupants of a vehicle(s).	RMS Response – New England Highway (NEH) work will be addressed by works for Daracon	Mostly complete with essential delineation re-instated along New England Highway (NEH) by RMS prior to July 2019. Main Street Ardglen delineation installed on the 11 <sup>th</sup> July 2019 by Daracon. All as shown in the images.

As of the 24 <sup>th</sup> March 2023, we've completed the access road widening and construction work (as approved by LPSC) and plan to complete the NEH intersection scope imminently. This will be completed before we increase laden truck movements in accordance with the Approval.

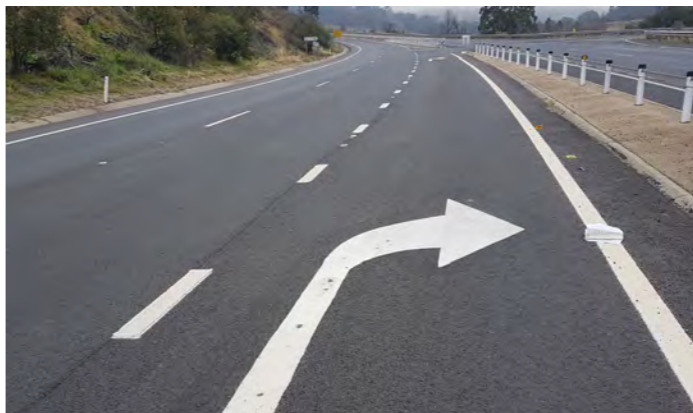
2	New England Highway Southbound Delineation	The existing right turn bay into Main Street is missing right turn pavement arrows, which may lead to readability issues for approaching vehicles. The likelihood of this risk may increase at night and / or adverse weather conditions. This may confuse oncoming drivers for the purpose of lane and cause late lane change decisions. This may result in vehicle crashes and injury to occupants of a vehicle(s).	RMS Response – <b>RMS to install missing Right Turn Arrows.</b> RMS to arrange to be included in this year's AC linemarking program.	Completed by RMS prior to July 2019.

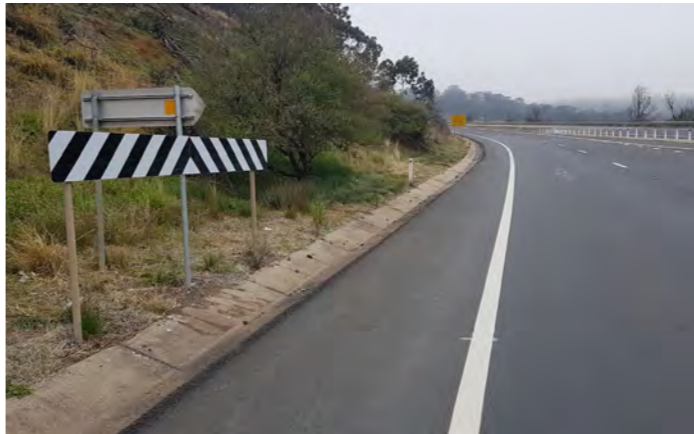
RSA report identification number	Location / category	Description of risk to road safety	Specific actions Daracon commit to undertake	Completion date (if complete) with comments	Evidence of completion	If not complete, status update as at 24 <sup>th</sup> March 2023
3	New England Highway Southbound Traffic signs	The advanced warning signage on approach to Main Street appears damaged, does not provide advanced warning to approaching vehicles, and has a reduced readability due to sightlines being obscured on the horizontal curve approach. This may lead to driver confusion and increase the likelihood of drivers slowing too early prior to the intersection and may result in vehicle crashes and serious injury to occupants of a vehicle(s).	RMS Response – <b>RMS to repair signs</b> from Routine Maintenance	Completed by RMS prior to July 2019.

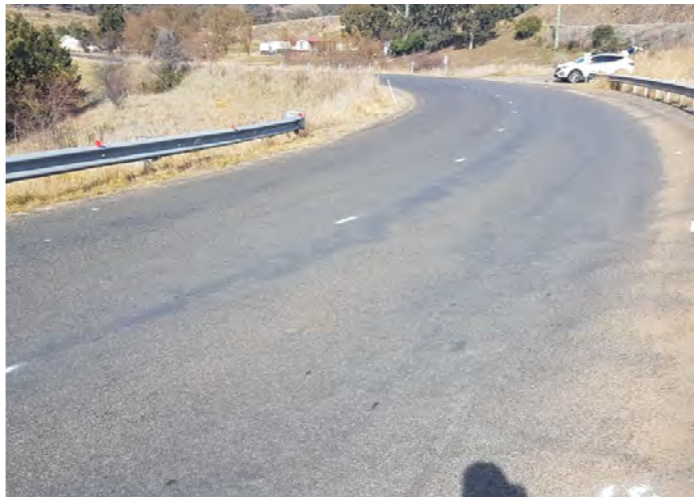
5	Main Street South of the Intersection on the outside of the curve Northbound Road pavement	At the Main Street / rail site compound access and in front of the existing w-beam safety barrier there is loose gravel on the outside of the horizontal curve. This may lead to reduced skid resistance for an errant vehicle. The likelihood of this risk may increase at night and / or adverse weather conditions. This may result in vehicle crashes and serious injury to occupants of a vehicle(s).	As agreed with LPSC representative, the loose gravel on the outside of the curve will be removed by appropriate means by Daracon.	Daracon completed this on the 3 <sup>rd</sup> April 2019 with street sweeper on site. Additional gravel removal on the 11 <sup>th</sup> July 2019 before the line marking was installed

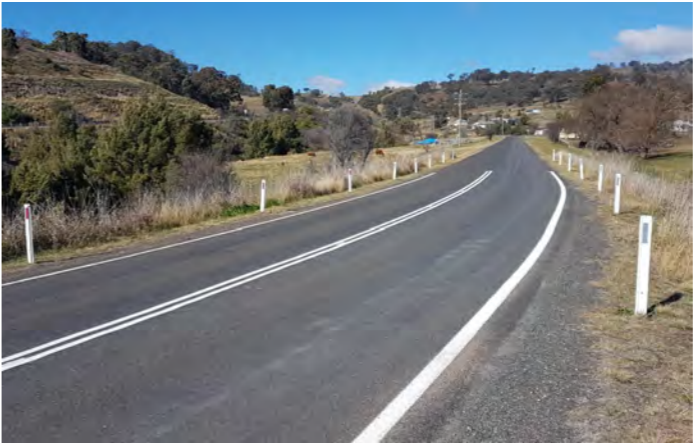
RSA report identification number	Location / category	Description of risk to road safety	Specific actions Daracon commit to undertake	Completion date (if complete) with comments	Evidence of completion	If not complete, status update as at <b>24<sup>th</sup> March 2023</b>
6	Main Street – South of the intersection of New England Highway Northbound and Southbound Roadside hazards	200m along Main Street from the intersection of New England highway, there is an existing culvert with steep embankments within the clear zone. The combination of narrow shoulder widths, steep batters, culvert headwalls within the clear zone, may limit a driver's manoeuvrability to avoid striking an object or have a reduced ability to gain control of their vehicle and strike objects within the clear zone. Narrow shoulders may also limit the available road width for wide vehicle loads and restrict vehicles in the opposing direction. This may increase the likelihood of drivers encroaching into the opposing travel lane and / or vehicles driving within the road shoulder / verge area to avoid a stationary object on the road. This may result in drivers striking the object or another object within the clear zone and lead to rapid deceleration of the vehicle. This may result in serious injury (not limited to) to occupants of a vehicle(s).	As agreed with LPSC representative, Daracon proposes to install a temporary barrier (type F concrete or similar) to highlight the presence of the existing culvert and minimise the likelihood of interaction with the roadside hazard. Subject to the ongoing operation of the quarry, Daracon may choose to install a permanent barrier (guardrail or similar) at some time in the future.	Effectively complete with the self-imposed mandatory speed limit of 40kph from the New England Highway to the Quarry entrance for all trucks was imposed immediately. On the 11 <sup>th</sup> July 2019, additional controls were installed to highlight the presence of the culvert. These additional controls were the extension of the line marking and installation of extra guideposts as shown in the image.

<p>As of the 24<sup>th</sup> March 2023 and in consultation with LPSC, guardrail has been installed at this location (as approved by LPSC), which permanently resolves this issue.</p>

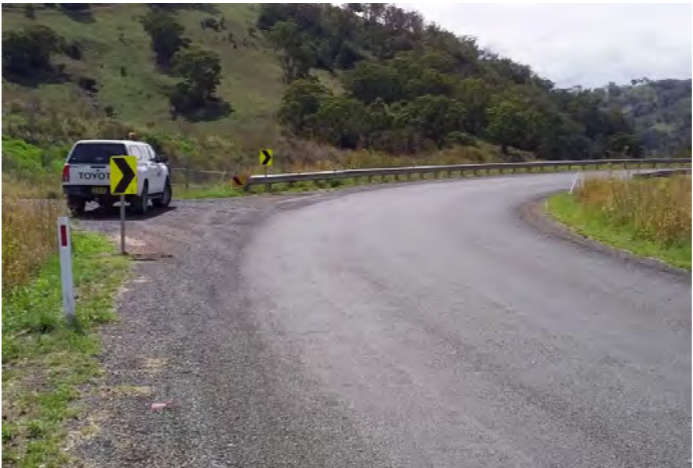
7	Main Street – Rail site compound access Northbound Road alignment and cross section and delineation	Approximately 150m from the intersection of New England Highway along Main Street there is an access track to a rail site compound. At the access there is a lack of delineation on the horizontal curve. This may give the oncoming driver the impression that the Main Street continues through rather than the traveling to the right, especially at night. This may cause a driver to make a late change in direction. The combination of loose gravel on the outside of the curve and the late change in direction may result in crashes with other vehicles and result in injury to occupants of a vehicle(s).	As agreed with LPSC representative, Daracon proposes to install additional guide posts (or similar) to delineate the outside of the horizontal curve.	Completed on the 26 <sup>th</sup> March 2019.

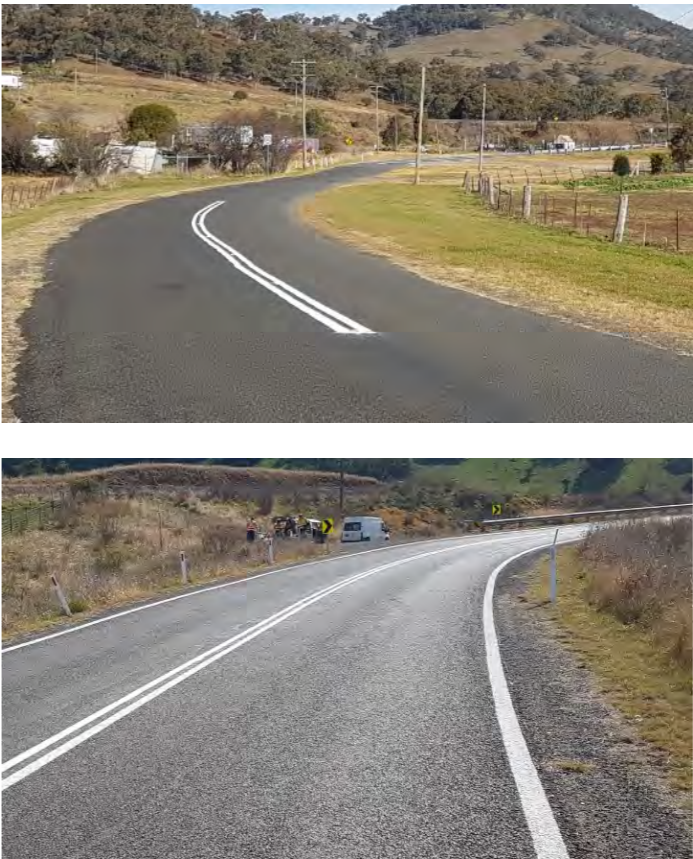
RSA report identification number	Location / category	Description of risk to road safety	Specific actions Daracon commit to undertake	Completion date (if complete) with comments	Evidence of completion	If not complete, status update as at <b>24<sup>th</sup> March 2023</b>
8	Main Street Northbound and Southbound Road pavement And Road alignment and cross section	The road carriageway width does not appear suitable for vehicles to pass (i.e. trucks passing other trucks and / or cars). The travel lane widths may limit a driver's manoeuvrability and increase the likelihood of readability issues to oncoming vehicles. Narrow travel lane may also limit the available road width for wide vehicle loads and restrict vehicles in the opposing direction. This may result in drivers striking oncoming objects or another object within the clear zone and lead to rapid deceleration of the vehicle. This may result in injury to occupants of a vehicle(s).	Please also refer to LPSC point #2 below. Although the AADT would be less than 300 vehicles per day including the quarry operating at 500,000T by road per year as proposed (approximately 60 outbound and 60 inbound truck movements), it was agreed with LPSC to install additional line marking only at the curves either end of Main St. The straight section of Main St will remain with no line marking. All existing line marking will also be renewed if not completed recently by LPSC. An additional control that has been implemented is the self-imposed mandatory speed limit of 40kph from the New England Highway to the Quarry entrance for all trucks.	Completed on the 11 <sup>th</sup> July 2019.

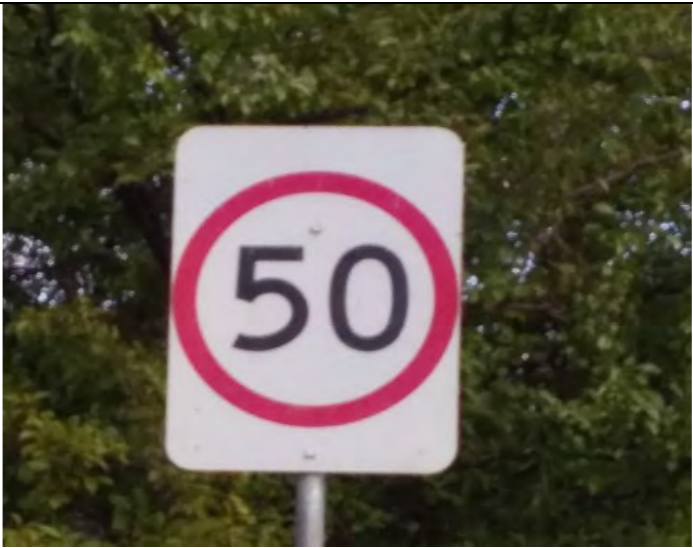
9	Main Street Intersection with Ardglen Road Northbound and Southbound Traffic signs	On Main Street approach to Ardglen Road, the existing speed zone repeater signage appears faded. This may increase the likelihood of readability issues for drivers, and increase the likelihood of a driver failing to travel to the sign posted speed limit. The likelihood of this risk may increase at night and / or adverse weather conditions. This may lead to vehicle crashes and injury to occupants of a vehicle(s).	As agreed with LPSC representative, Daracon proposes to install new speed limit signage as the existing sign is faded.	Completed on the 20 <sup>th</sup> March 2019.

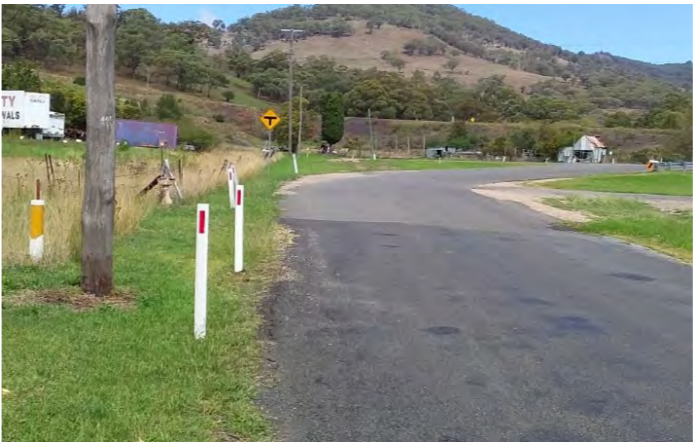
N/A
10	Main Street Approaching the Intersection with Ardglen Road Northbound and Southbound Roadside hazards	On Main Road approach to Ardglen Road, there is an existing power pole and fence posts within the clear zone. Errant vehicles at these locations may have a reduced ability to gain control of their vehicle and strike the power pole or fence post within the clear zone which may lead to rapid deceleration of the vehicle. This may be due to the combination of horizontal and / or vertical alignment of the road and / or drivers swerving to avoid striking an animal (i.e. animal carcass). The likelihood of this risk may increase at night and / or adverse weather conditions. This may result in vehicle crashes and injury to occupants of a vehicle(s), not limited to.	As agreed with LPSC representative, Daracon proposes to install delineation in the form of additional guideposts adjacent to the roadway to highlight the presence of the existing power pole.	Completed on the 26 <sup>th</sup> March 2019.

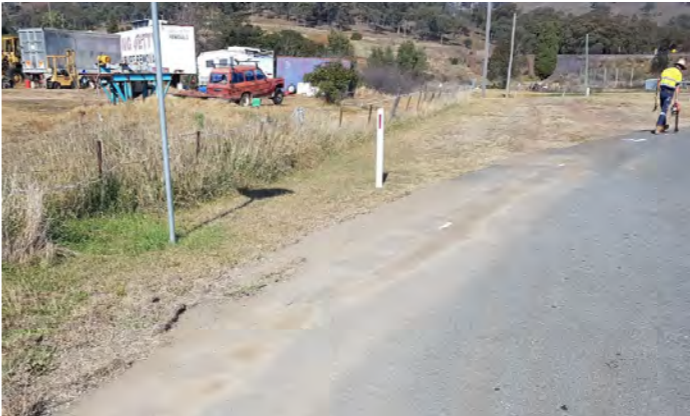
RSA report identification number	Location / category	Description of risk to road safety	Specific actions Daracon commit to undertake	Completion date (if complete) with comments	Evidence of completion	If not complete, status update as at <b>24<sup>th</sup> March 2023</b>
11	Main Street Approaching the Intersection with Ardglan Road Northbound and Southbound Pavement	Approximately 65m along Main Road from the intersection of Main Road and High Road, there is loose gravel on the outside of the horizontal curve. This may lead to reduced skid resistance for an errant vehicle. The likelihood of this risk may increase at night and / or adverse weather conditions. This may result in vehicle crashes and serious injury to occupants of a vehicle(s).	As agreed with LPSC representative, the loose gravel on the outside of the curve will be removed by appropriate means by Daracon.	Completed on the 3 <sup>rd</sup> April 2019 with street sweeper on site. Additional gravel removal occurred on the 11 <sup>th</sup> July 2019 before the line marking was installed.

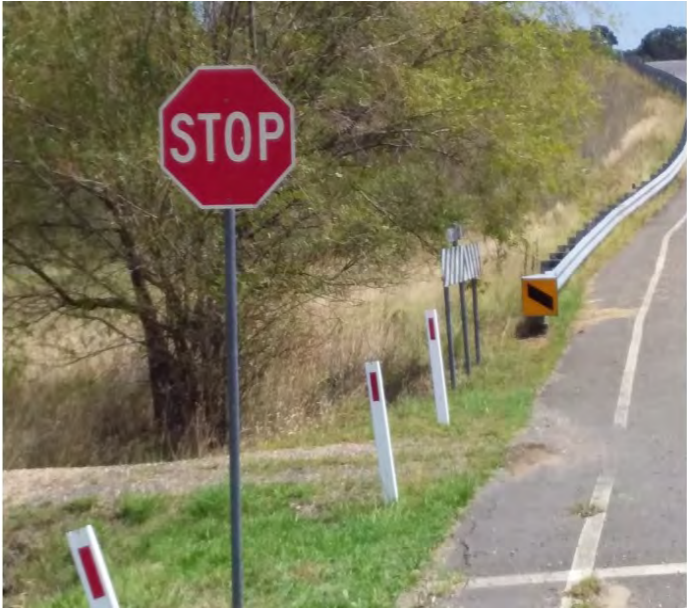
RSA report identification number	Location / category	Description of risk to road safety	Specific actions Daracon commit to undertake	Completion date (if complete) with comments	Evidence of completion	If not complete, status update as at <b>24<sup>th</sup> March 2023</b>
13	Main Street Intersection with High Street Westbound Traffic signs	Approaching the intersection of Main Street and High Street from the south eastern side traveling west there is a missing Stop sign. This may increase the likelihood of readability issues for drivers and lead to drivers failing to stop to oncoming vehicles. This may increase the likelihood of vehicle crashes, especially during adverse weather conditions. This could lead to crashes with other vehicles, thus may result in serious injury to occupants of a vehicle(s).	As agreed with LPSC representative, Daracon proposes to reinstate the existing stop sign.	Completed on the 20 <sup>th</sup> March 2019.

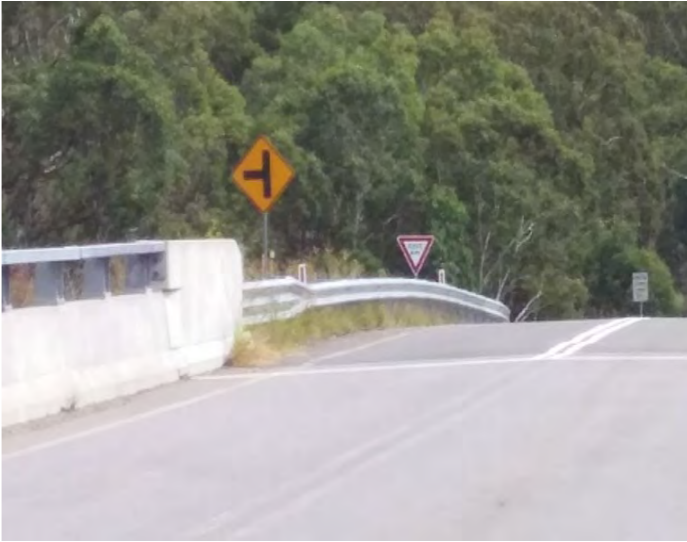
14	High Street Approach to St Stephen Street intersection Westbound Traffic signs	On the south eastern side of the intersection of High Street and St Stephen Street, the advanced warning of T-intersection signage is loose, which has caused the sign to point in the wrong direction. This may increase the likelihood of readability issues for drivers and lead to drivers failing to negotiate the intersection. This may increase the likelihood of vehicle crashes, especially during adverse weather conditions. This could lead to crashes with other vehicles, thus may result in serious injury to occupants of a vehicle(s).	As agreed with LPSC representative, Daracon proposes to reinstate the existing T intersection sign.	Completed on the 26 <sup>th</sup> March 2019.

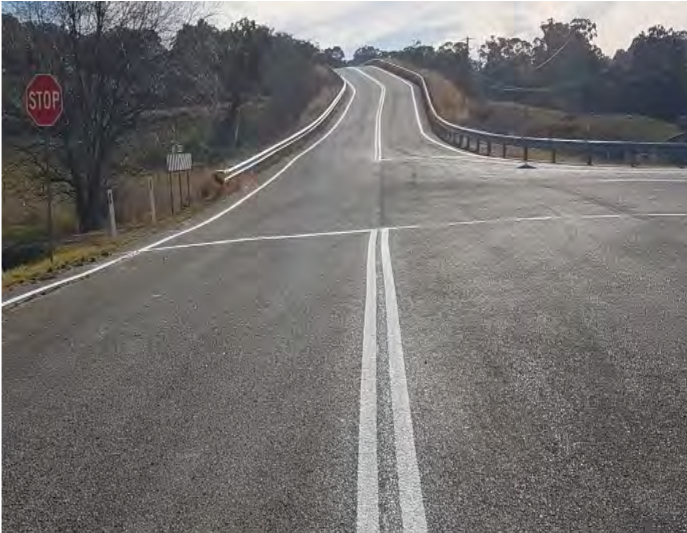
N/A
15	High street Rail overpass bridge Eastbound and Westbound Road alignment and cross section	Traveling west along High Street towards the rail overpass bridge, the travel lanes appear to narrow and there is a kink in the alignment of the road. The narrow travel lane widths may limit a driver's manoeuvrability and increase the likelihood of readability issues to oncoming vehicles. Narrow travel lane may also limit the available road width for wide vehicle loads and restrict vehicles in the opposing direction. This may result in drivers striking oncoming vehicles or safety barriers and lead to rapid deceleration of the vehicle. This may result in serious injury (not limited to) to occupants of a vehicle(s).	As agreed with LPSC representative, all existing line marking will be renewed if not completed recently by LPSC. An additional control that has been implemented is the self-imposed mandatory speed limit of 40kph from the New England Highway to the Quarry entrance for all trucks. Appropriate delineation already exists along the guardrail.	Self-imposed 40 kph speed limit imposed immediately. The line marking was completed on the 11 <sup>th</sup> July 2019.

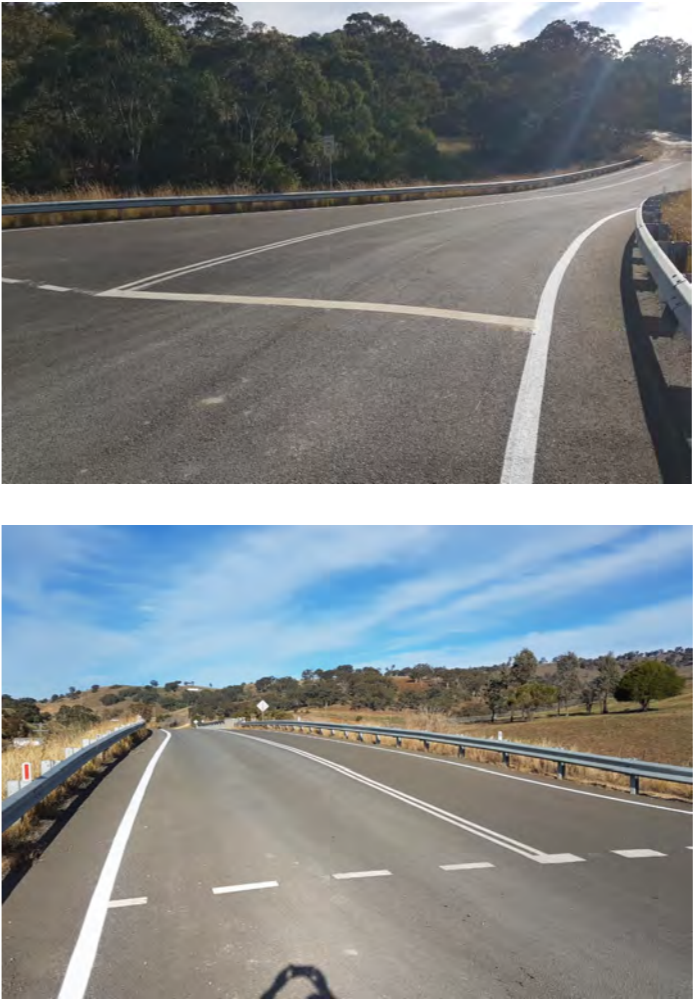
RSA report identification number	Location / category	Description of risk to road safety	Specific actions Daracon commit to undertake	Completion date (if complete) with comments	Evidence of completion	If not complete, status update as at <b>24<sup>th</sup> March 2023</b>
16	High Street Approach to St Stephen Street Intersection Eastbound and Westbound Delineation	At the intersection of High Street and St Stephen Street, the existing delineated is faded. This may lead to readability issues for a driver and increase the likelihood of a vehicle failing to give way / stop at the intersection. The likelihood of this risk may increase at night and / or adverse weather conditions. This may lead to vehicle crashes and injury to occupants of a vehicle(s).	As agreed with LPSC representative, all existing line marking will be renewed by Daracon if not completed recently by LPSC.	Completed on the 11 <sup>th</sup> July 2019.

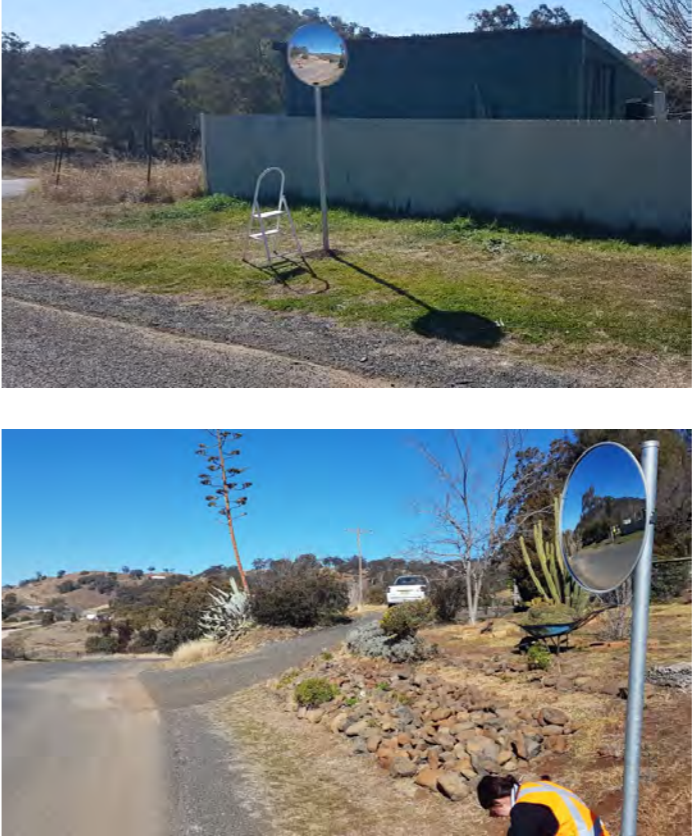
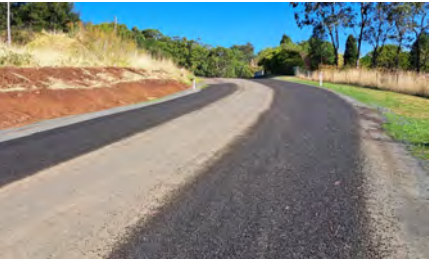
17	St Stephen Street Northbound and Southbound Road alignment and cross section	The road carriageway width along St Stephens Street does not appear suitable for vehicles to pass (i.e. trucks passing other trucks and / or cars). The travel lane widths may limit a driver's manoeuvrability and increase the likelihood of readability issues to oncoming vehicles. Narrow travel lane may also limit the available road width for wide vehicle loads and restrict vehicles in the opposing direction. This may result in drivers striking oncoming vehicles or objects within the clear zone and lead to rapid deceleration of the vehicle. This may result in serious injury (not limited to) to occupants of a vehicle(s).	As agreed with LPSC representative, Daracon will consult with the three residents along Warra and St Stephen Streets to discuss the potential installation of convex mirrors at strategic locations and will install as agreed. Daracon has also implemented a self-imposed mandatory speed limit of 40kph from the New England Highway to the Quarry entrance as well as a mandatory "call up" protocol for St Stephens and Warra St's as detailed in the TTMP.	Complete with the self-imposed mandatory speed limit of 40kph from the New England Highway to the Quarry entrance for all trucks was imposed immediately. The call up protocol for St Stephens and Warra St's was also implemented immediately as detailed in the TTMP. The residents along Warra and St Stephens St were also consulted with and agreed that the installation of "convex mirrors" located in strategic locations would assist to mitigate the issues identified. The "convex mirrors" were installed on the 15 <sup>th</sup> August 2019 as shown in the images.

As of the 24 <sup>th</sup> March 2023 and in consultation with LPSC, the widening of the access road at this location is complete (as approved by LPSC), which permanently resolves this issue.

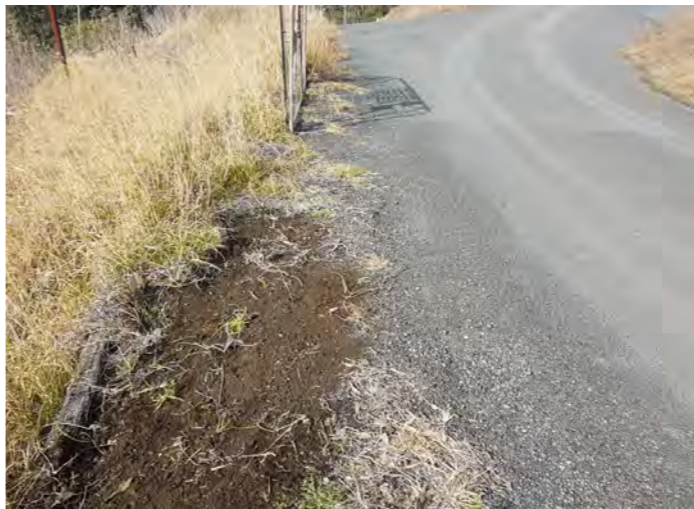
19	Warra Street Northbound and Southbound Road alignment and cross section	The road carriageway width along Warra Street does not appear suitable for vehicles to pass (i.e. trucks passing other trucks and / or cars). The travel lane widths may limit a driver's manoeuvrability and increase the likelihood of readability issues to oncoming vehicles. Narrow travel lane may also limit the available road width for wide vehicle loads and restrict vehicles in the opposing direction. This may result in drivers striking oncoming vehicles or objects within the clear zone and lead to rapid deceleration of the vehicle. This may result in serious injury (not limited to) to occupants of a vehicle(s).	Refer to RSA CAR #17.	Refer to RSA CAR #17.		N/A
20	Warra Street Near the quarry entrance Southbound Pavement And Road alignment And cross section	Near the entrance to the quarry and part of Warra Road the existing pavement is deteriorated and shoulder show evidence of erosion. This may lead to soft shoulders and may be unstable for heavy vehicle to use if divers need to move their vehicle to avoid oncoming traffic. This may result in injury to occupants of a vehicle(s), not limited to.	As agreed with LPSC representative, Daracon proposes to investigate and repair the shoulder as described in the RSA.	Completed 20 <sup>th</sup> March 2019.

<p>As of the 24<sup>th</sup> March 2023 and in consultation with LPSC, the widening of the access road at this location is complete (as approved by LPSC), which permanently resolves this issue.</p>
