# ARDGLEN QUARRY

## 2022 Annual Environmental Management Report (AEMR)

PROJECT APPROVAL MP 06\_0264 - MOD 2

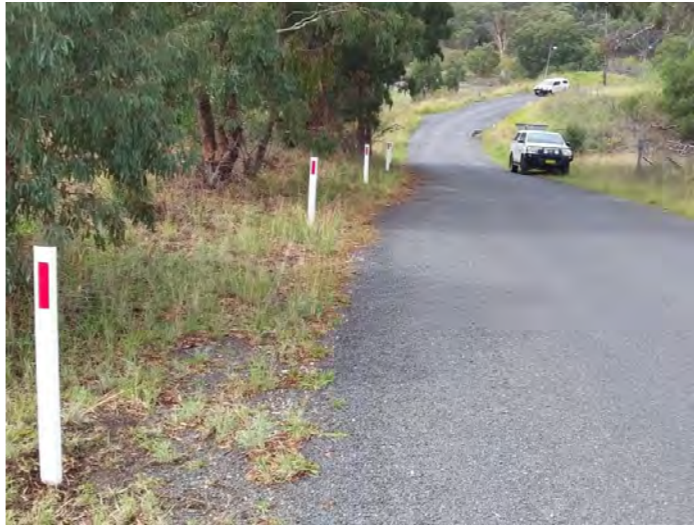
RSA report identification number	Location / category	Description of risk to road safety	Specific actions Daracon commit to undertake	Completion date (if complete) with comments	Evidence of completion	If not complete, status update as at 24 <sup>th</sup> March 2023
21	Warra Street Northbound and Southbound Roadside hazards	Along Warra Street the auditors observed trees within clear zone as well as narrow carriageway. Errant vehicles at these locations may have a reduced ability to gain control of their vehicle and strike the trees within the clear zone which may lead to rapid deceleration of the vehicle. This may be due to the narrow carriageway width of the road and / or drivers swerving to avoid striking oncoming vehicles. The likelihood of this risk may increase at night and / or adverse weather conditions. This may result in vehicle crashes and injury to occupants of a vehicle(s), not limited to.	As agreed with LPSC representative, Daracon proposes to install delineation in the form of additional guideposts adjacent to the roadway to highlight the presence of the trees. Daracon has implemented a self-imposed mandatory speed limit of 40kph from the New England Highway to the Quarry entrance as well as a mandatory “call up” protocol for St Stephens and Warra St’s as detailed in the TTMP.	Guidepost installation completed on the 26 <sup>th</sup> March 2019.

As of the 24 <sup>th</sup> March 2023 and in consultation with LPSC, guardrail has been installed at this location (as approved by LPSC), which permanently resolves this issue.

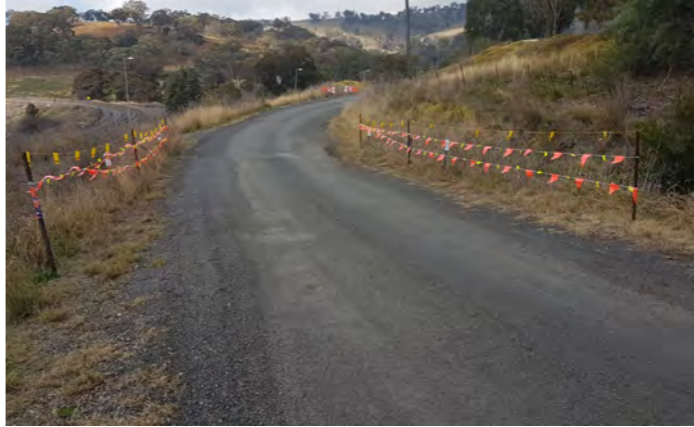
22	Warra Street Northbound and Southbound Roadside hazards	Approximately 50m from the entrance of the quarry there is an existing culvert headwall with drop-off within the clear zone. Errant vehicles at these locations may have a reduced ability to gain control of their vehicle impact with the existing headwall and / or surrounding objects within the clear zone. This may be due to the narrow carriageway width of the road and / or drivers swerving to avoid striking oncoming vehicles. The likelihood of this risk may increase at night and / or adverse weather conditions. This may result in vehicle crashes and serious injury to occupants of a vehicle(s).	As agreed with LPSC representative, Daracon proposes to install a temporary barrier (type F concrete or similar) to highlight the presence of the existing culvert and minimise the likelihood of interaction with the roadside hazard. Additionally, <b>LPSC have committed to investigating the option of extending the existing storm water pipe</b> to permit widening of the formation thus eliminating the roadside hazard.	The self-imposed mandatory speed limit of 40kph from the New England Highway to the Quarry entrance for all trucks was imposed immediately. The call up protocol for St Stephens and Warra St’s was also implemented immediately as detailed in the TTMP. Temporary delineation was installed on the 1 <sup>st</sup> April 2019 as shown in the image. These are considered appropriate short term rectification measures due to the fact that this location exists beyond the section of Warra St that requires private vehicular access and only quarry traffic utilises this section of road.

As of the 24 <sup>th</sup> March 2023 and in consultation with LPSC, the widening of the culvert and installation of guardrail at this location is complete (as approved by LPSC), which permanently resolves this issue.

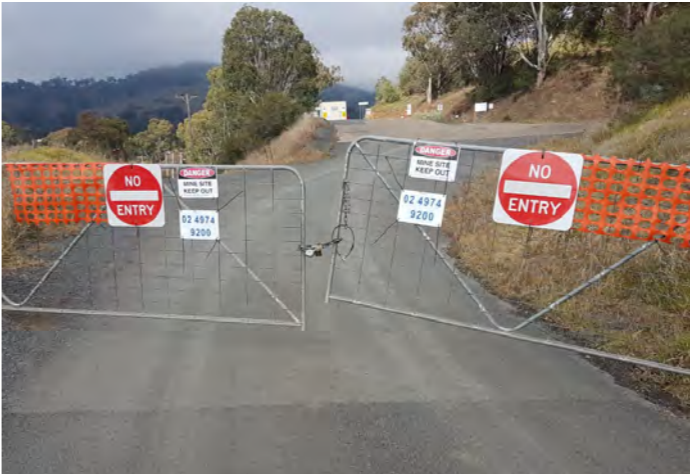
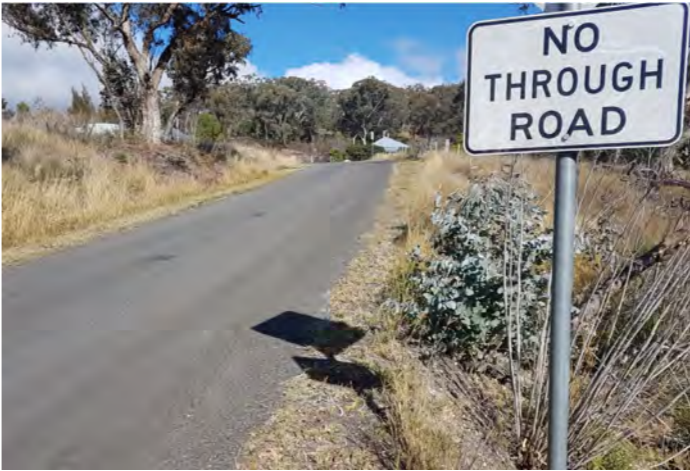
RSA report identification number	Location / category	Description of risk to road safety	Specific actions Daracon commit to undertake	Completion date (if complete) with comments	Evidence of completion	If not complete, status update as at 24 <sup>th</sup> March 2023
23	Warra Street Quarry entrance Northbound and Southbound Road alignment and cross section	At the site entry of the quarry, the entry appears narrow, lack of carriageway width for drivers to turn around as well as lack of restriction signage / no through road. This may lead to driver frustration and confusion which may contribute to driver error. The likelihood of this risk may increase at night and / or adverse weather conditions. This may result in vehicle crashes and serious injury to occupants of a vehicle(s).	As agreed with LPSC representative, Daracon has implemented a self-imposed mandatory speed limit of 40kph from the New England Highway to the Quarry entrance as well as a mandatory “call up” protocol for St Stephens and Warra St’s as detailed in the TTMP.	The self-imposed mandatory speed limit of 40kph from the New England Highway to the Quarry entrance for all trucks was imposed immediately. The call up protocol for St Stephens and Warra St’s was also implemented immediately as detailed in the TTMP. Additional “no entry” and “no through road” signage was installed on the 11 <sup>th</sup> July 2019.

<p>As of the 24<sup>th</sup> March 2023 and in consultation with LPSC, the widening of the access road at this location is complete (as approved by LPSC), which permanently resolves this issue.</p>

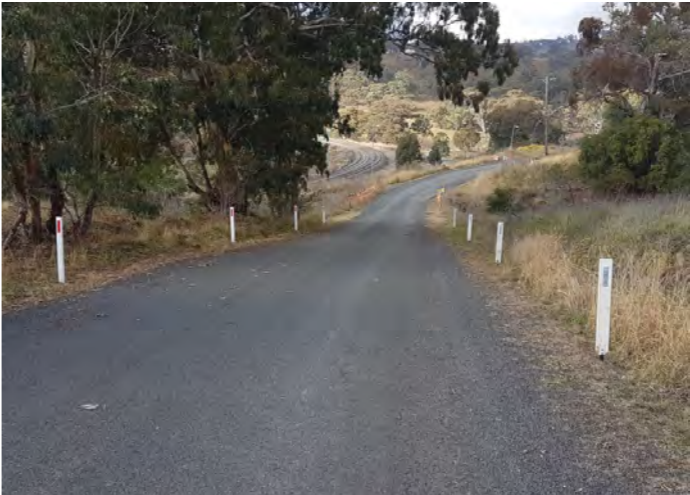
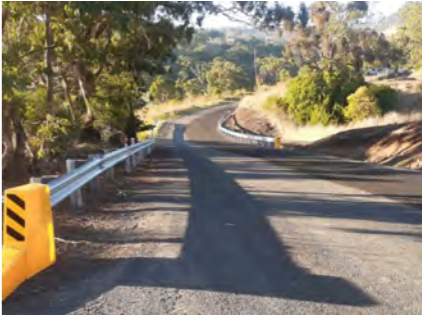
24	Warra Street Northbound and Southbound Delineation	It was noted that along Warra Street there is a lack of delineation. This may increase the likelihood of readability issues for drivers. The likelihood of this risk may increase at night and / or adverse weather conditions. This may result in vehicle crashes and injury to occupants of a vehicle(s).	As agreed with LPSC representative, Daracon proposes to install delineation in the form of additional guideposts adjacent to the roadway.	Guidepost installation completed on the 11 <sup>th</sup> July 2019.

<p>As of the 24<sup>th</sup> March 2023 and in consultation with LPSC, the widening of the access road at this location is complete (as approved by LPSC), which permanently resolves this issue.</p>

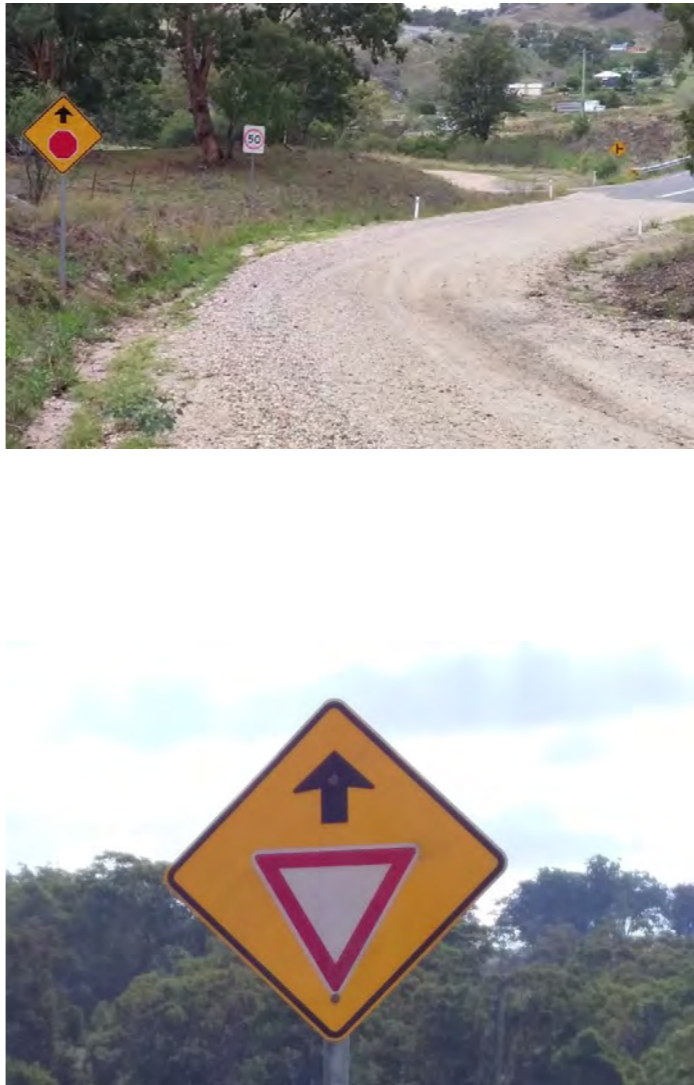
RSA report identification number	Location / category	Description of risk to road safety	Specific actions Daracon commit to undertake	Completion date (if complete) with comments	Evidence of completion	If not complete, status update as at <b>24<sup>th</sup> March 2023</b>
LPSC #1	Either side of the rail overpass bridge	<p>The two 'T' intersections either side of the rail overpass bridge are not your normal 'T' intersections in that the approach roads to the top of the 'T' have right away, whereas the thru road normally has right of way. Whilst 'Give Way' and 'Stop Signs' along with line marking (that needs maintaining) exists, I think advance warning 'Give Way Sign Ahead' and 'Stop Sign Ahead' signs (W3-1B and W3-2B) should be considered to forewarn road users along High Street and Swinging Ridges Road as the thru road(s).</p>	<p>Daracon agree to install additional advance warning 'Give Way Sign Ahead' and 'Stop Sign Ahead' signs (W3-1B and W3-2B) to forewarn road users along High Street and Swinging Ridges Road as the thru road(s)</p>	<p>Completed on the 20<sup>th</sup> March 2019.</p>

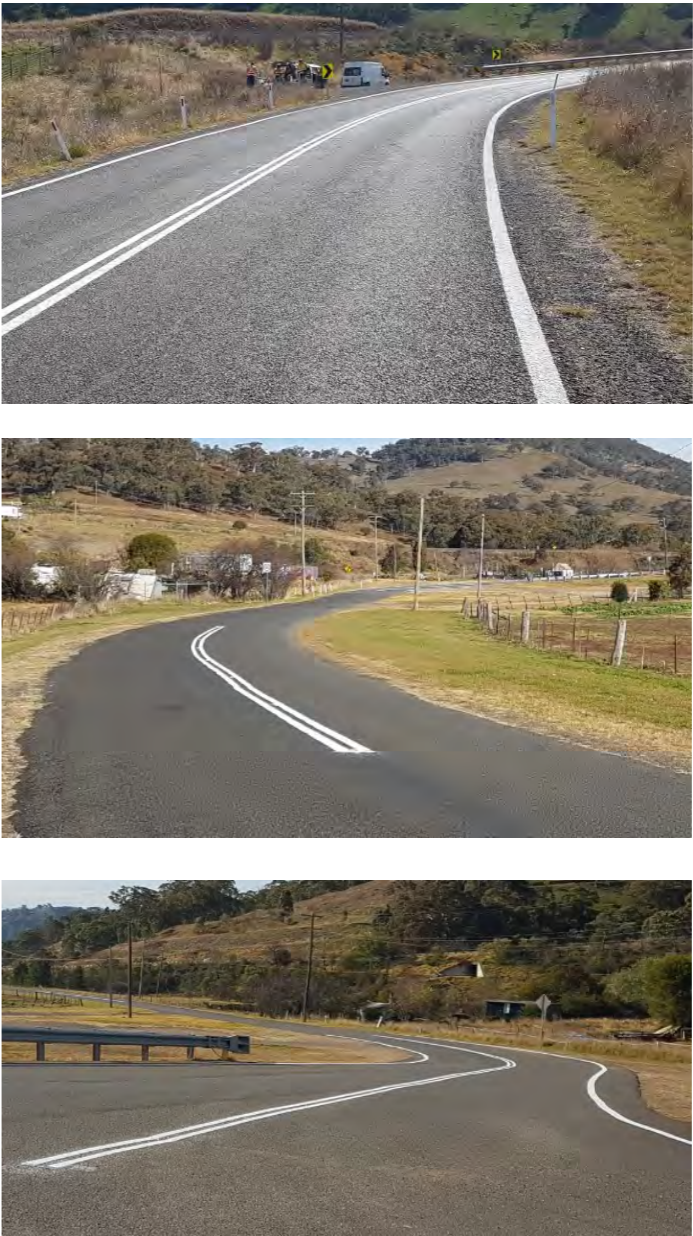
RSA report identification number	Location / category	Description of risk to road safety	Specific actions Daracon commit to undertake	Completion date (if complete) with comments	Evidence of completion	If not complete, status update as at <b>24<sup>th</sup> March 2023</b>
LPSC #2	Main Street	There is no centreline delineation along the Ardglen Road (it is being called Main Street in the RSA). High Street has centreline marking (albeit it is very faded and needs redoing). Given there are 2 curves along the Ardglen Road, the RSA should identify the lack of centreline marking along this road in greater detail.	Although the AADT would be less than 300 vehicles per day including the quarry operating at 500,000T by road per year as proposed (approximately 60 outbound and 60 inbound truck movements), it was agreed with LPSC to install additional line marking only at the curves either end of Main St. The straight section of Main St will remain with no line marking. All existing line marking will also be renewed if not completed recently by LPSC. An additional control that has been implemented is the self-imposed mandatory speed limit of 40kph from the New England Highway to the Quarry entrance for all trucks.	Completed on the 11 <sup>th</sup> July 2019.

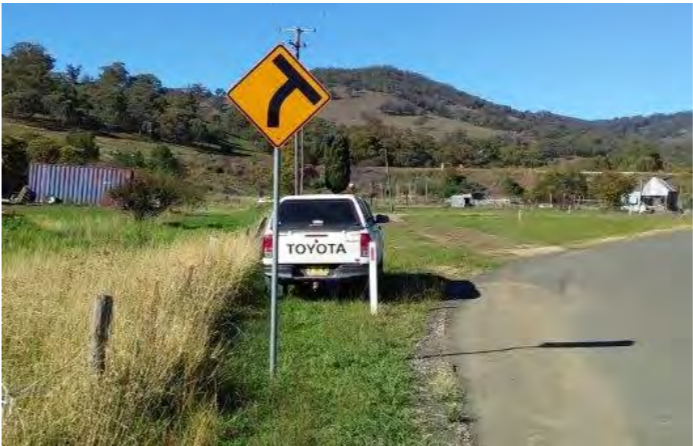
LPSC #3	Main Street	The advance 'T' junction warning sign on Ardglen Road on approach to High Street does not depict the road alignment on approach to the intersection. The approach to the intersection has a horizontal curve between the Advanced intersection Warning Sign and the intersection. The sign should be changed to a Curved Intersection (W2-14B) sign.	Daracon agrees to change the advance 'T' junction warning sign on Ardglen Road on approach to High Street to a Curved Intersection (W2-14B) sign.	Completed on the 3 <sup>rd</sup> April 2019.

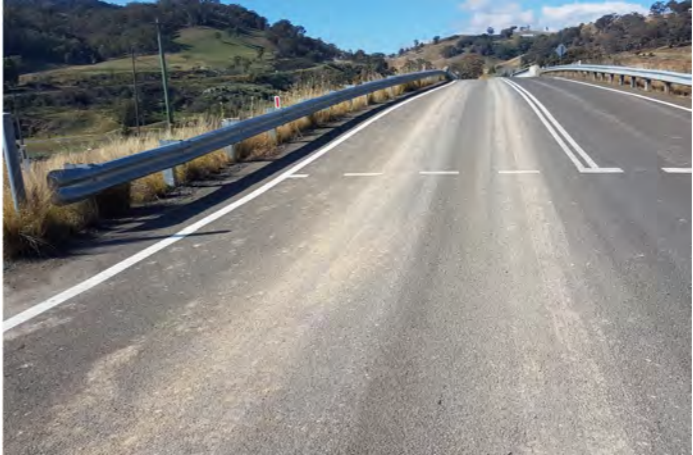
<p>Note – The dirt present on the road surface (as shown in the above image) was the result of LPSC unsealed road maintenance occurring along Swinging Ridges Rd and was in no way associated with truck movements to or from Ardglen Quarry.</p>	N/A

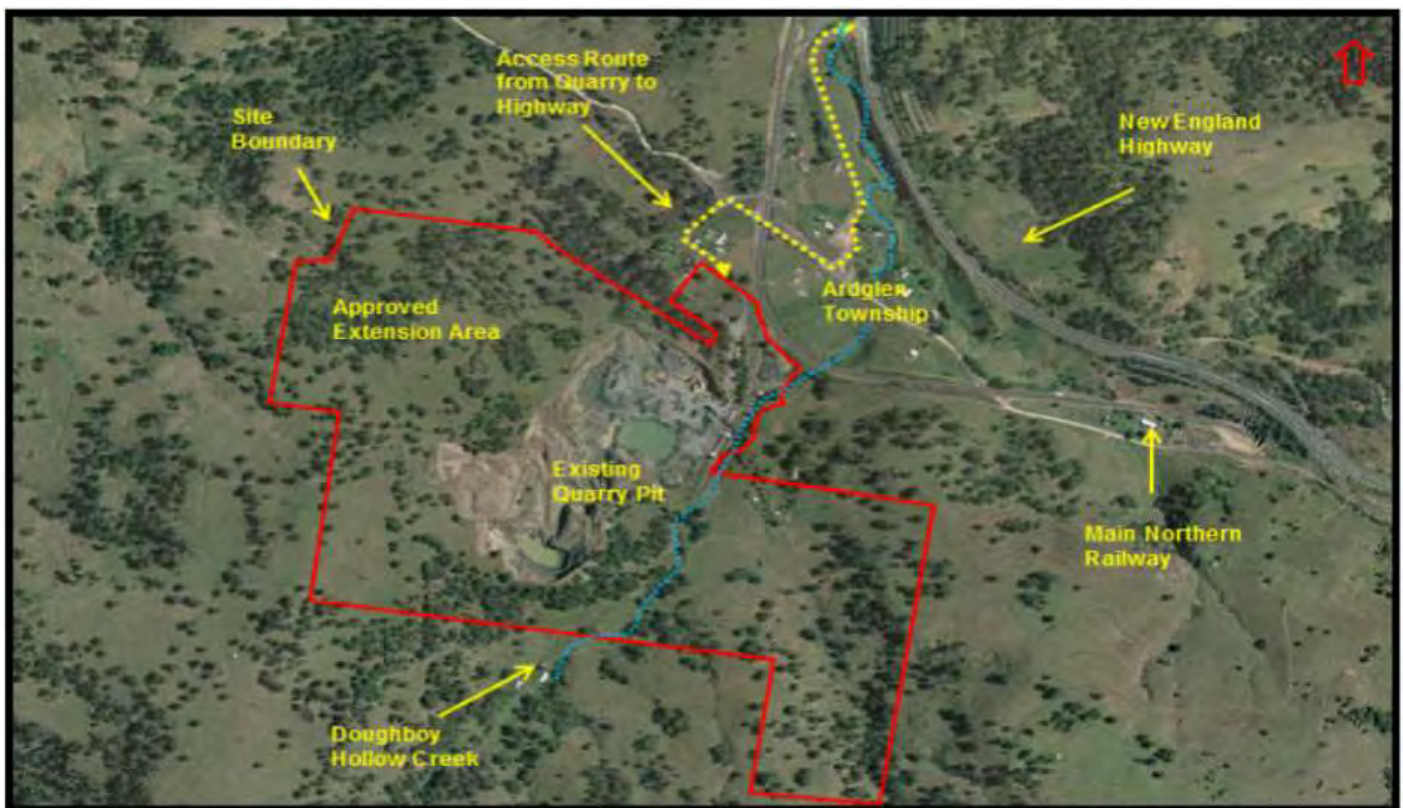
As previously advised, Ardglen quarry was temporarily re-opened to provide construction materials for the Scone Bypass Project (SBP) between August 2018 and January 2020. All materials exported to the SBP were sourced from stockpiles crushed prior to the 2012 closure and located within the 'Existing Quarry Pit'. The image below shows the current layout of the quarry including the 'Approved Extension Area', which has not yet been utilised.
