# ARDGLEN QUARRY

## 2023 Annual Environmental Management Report (AEMR)

PROJECT APPROVAL MP 06\_0264 - MOD 2

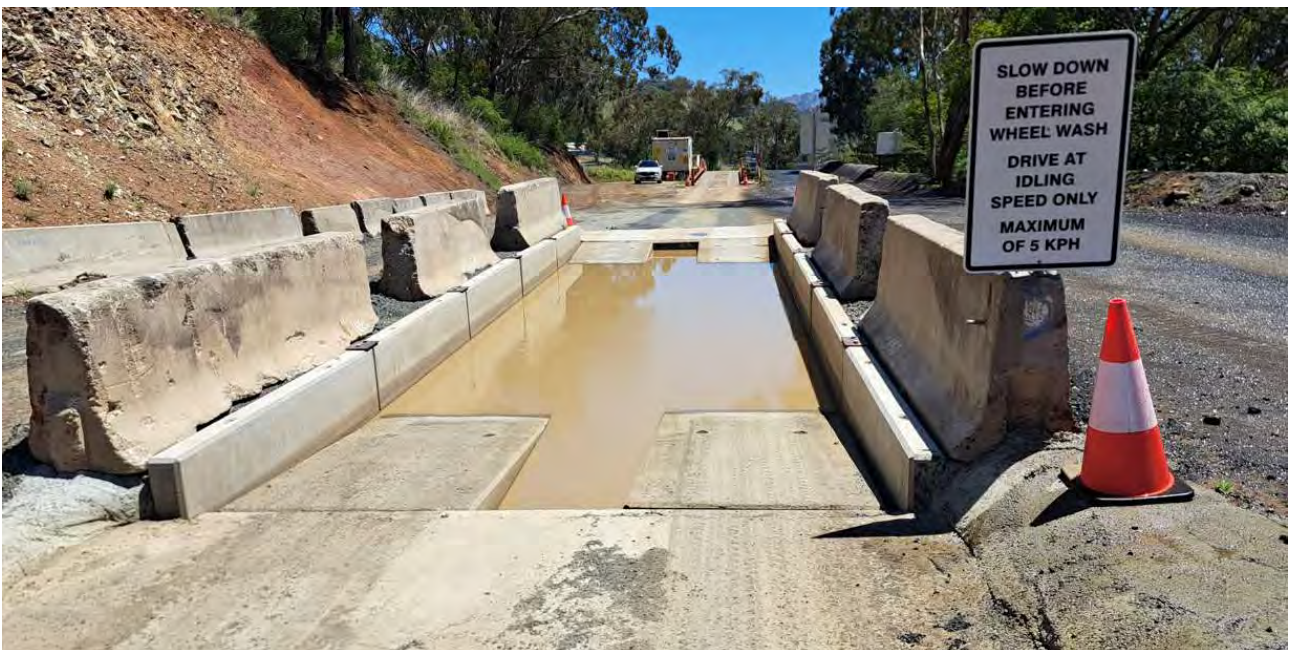
Photo 1: The new truck wheel-wash

- The demolition of the existing 'tertiary crushing plant' occurred in accordance with the relevant Council consent;
- The new truck wheel-wash was installed, commissioned and was operational as shown in **Photo 1** below;
- Following the decommissioning of the electrical substation in 2016, there's currently no external lighting associated with the operation of Ardglen Quarry, however if this was to change in the future, then Daracon would ensure compliance with Australian Standard AS4282 (INT) 1995;
- Daracon removed the truck remaining on site during the reporting period;

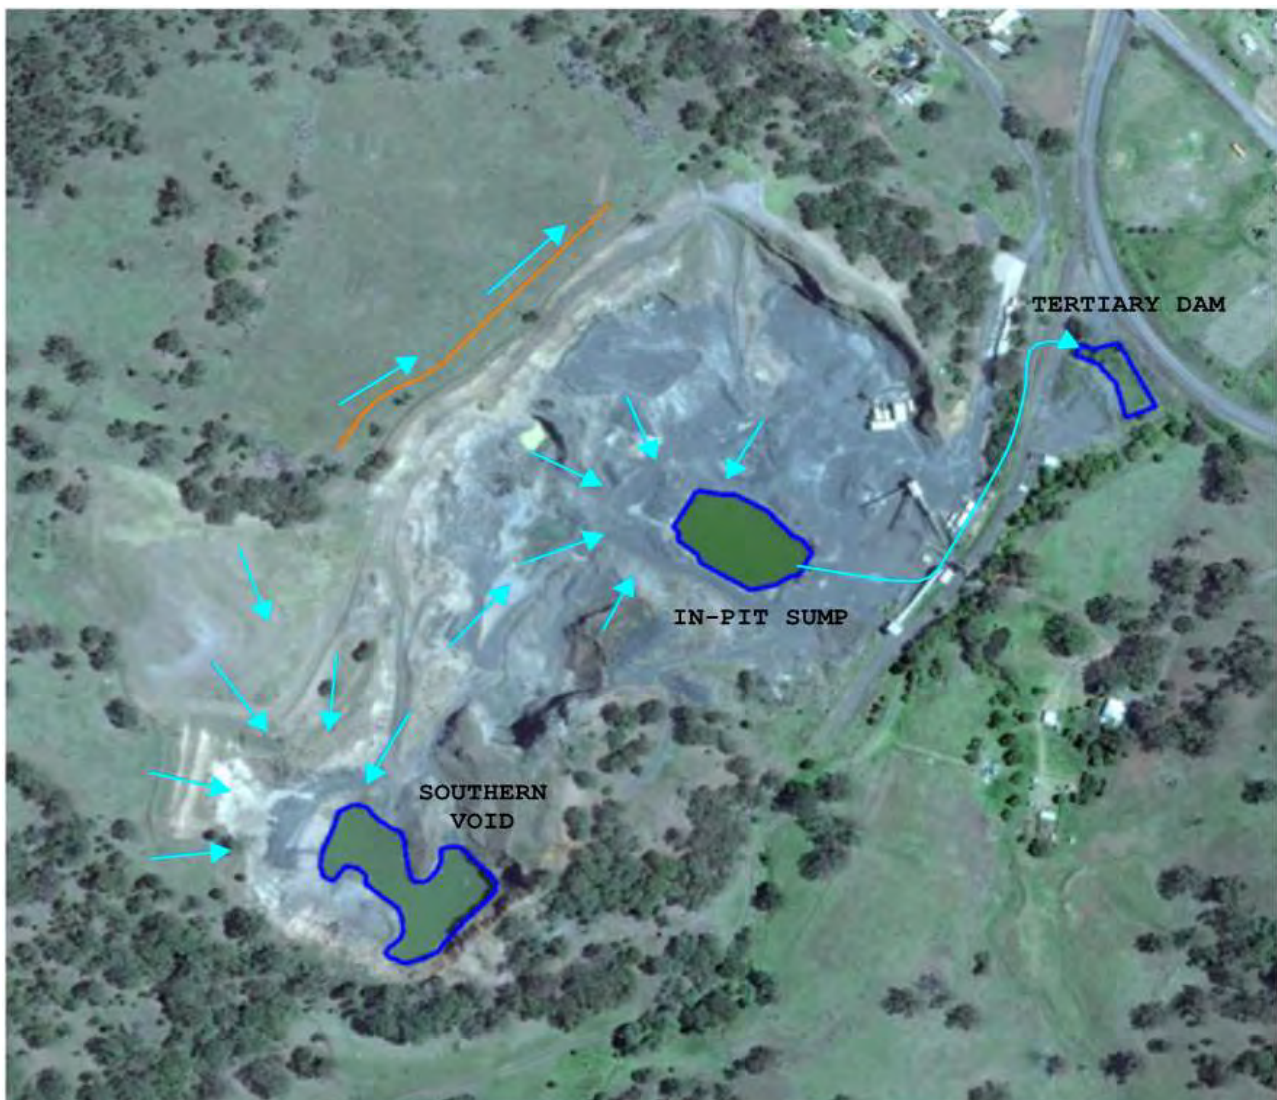
**Figure 3: Surface Water Management**

- An assessment of basin volumes is included as part of the revised SWMP;
- An assessment of the reliability of the water supply to the operation is included as part of the SWMP;
- Operational and maintenance activities that could cause soil erosion and sediment generation are identified and described in the SWMP;
- Procedures to manage unforeseen water quality impacts;
- Water treatment processes to enable discharge as required (in accordance with the revised EPL);
- The proposed strategy to monitor and subsequently manage any groundwater interactions on site;

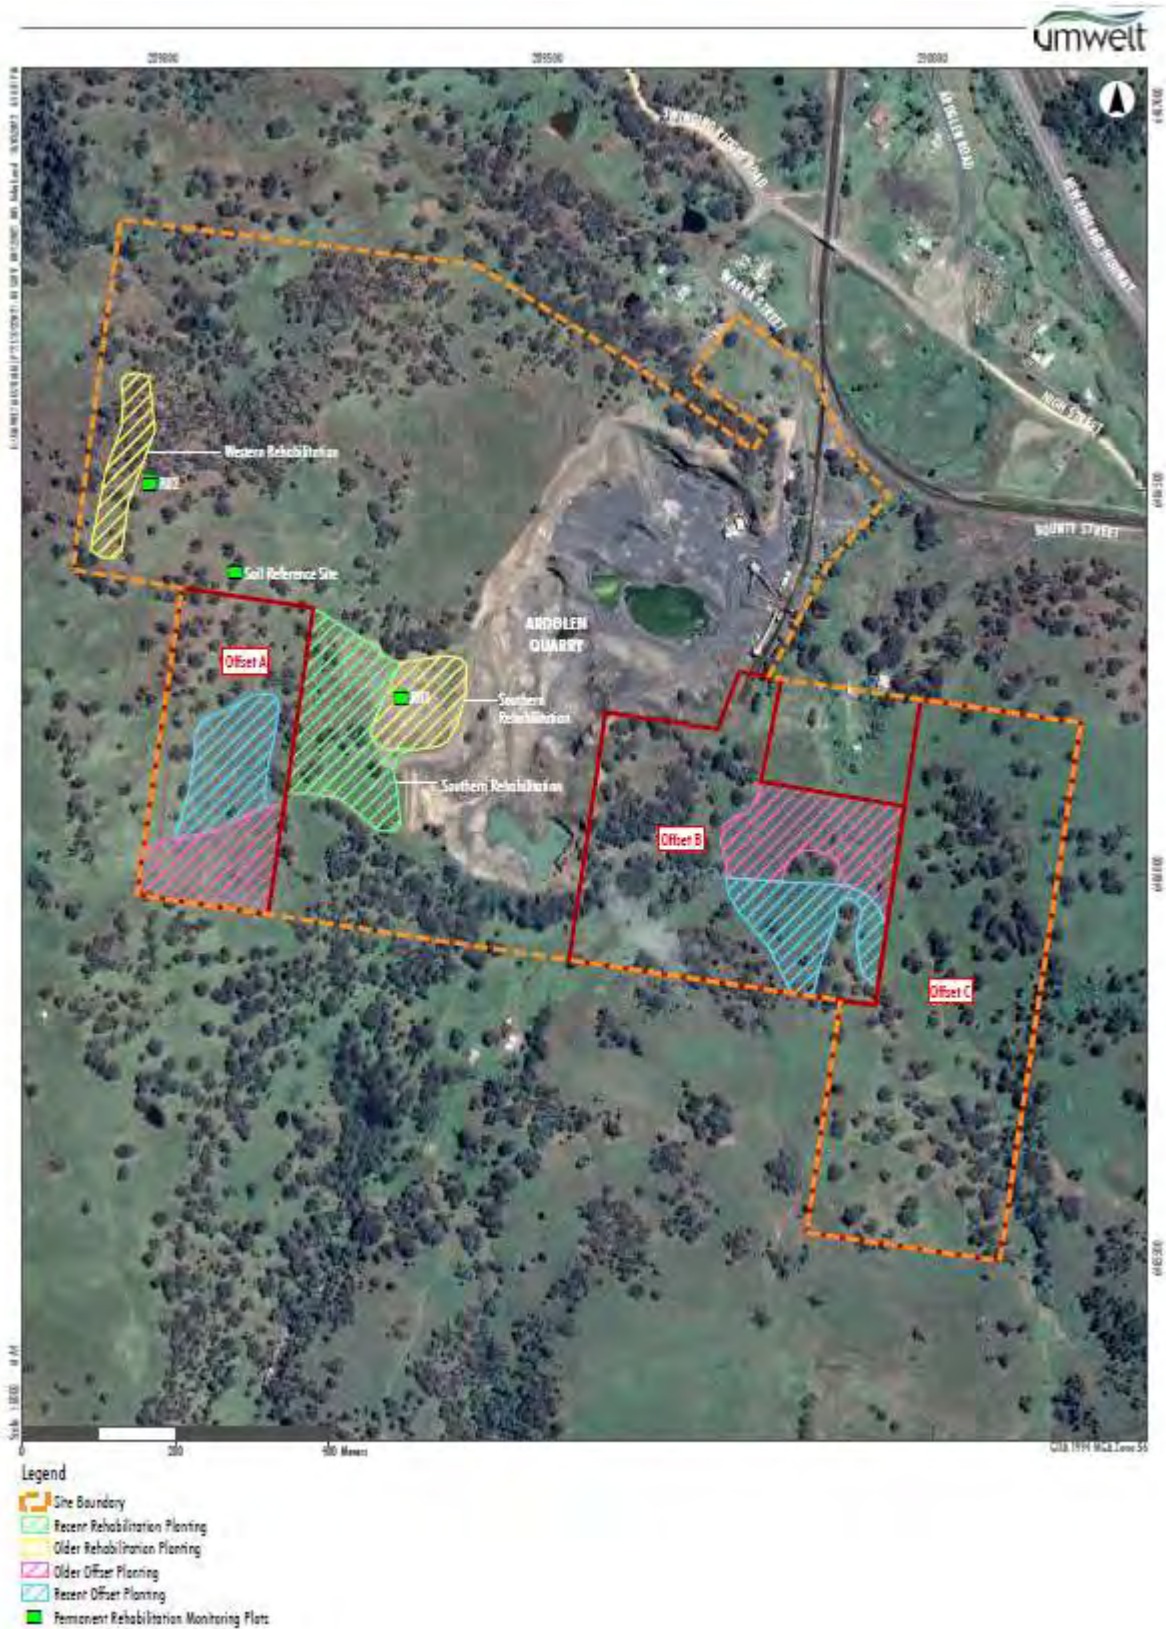
Figure 5: Rehabilitation planting areas (all completed prior to the current reporting period)

Please also refer to **Figure 5**, **Figure 6** and Section 4.4.4 for further details regarding the rehabilitation progress and suggested actions.

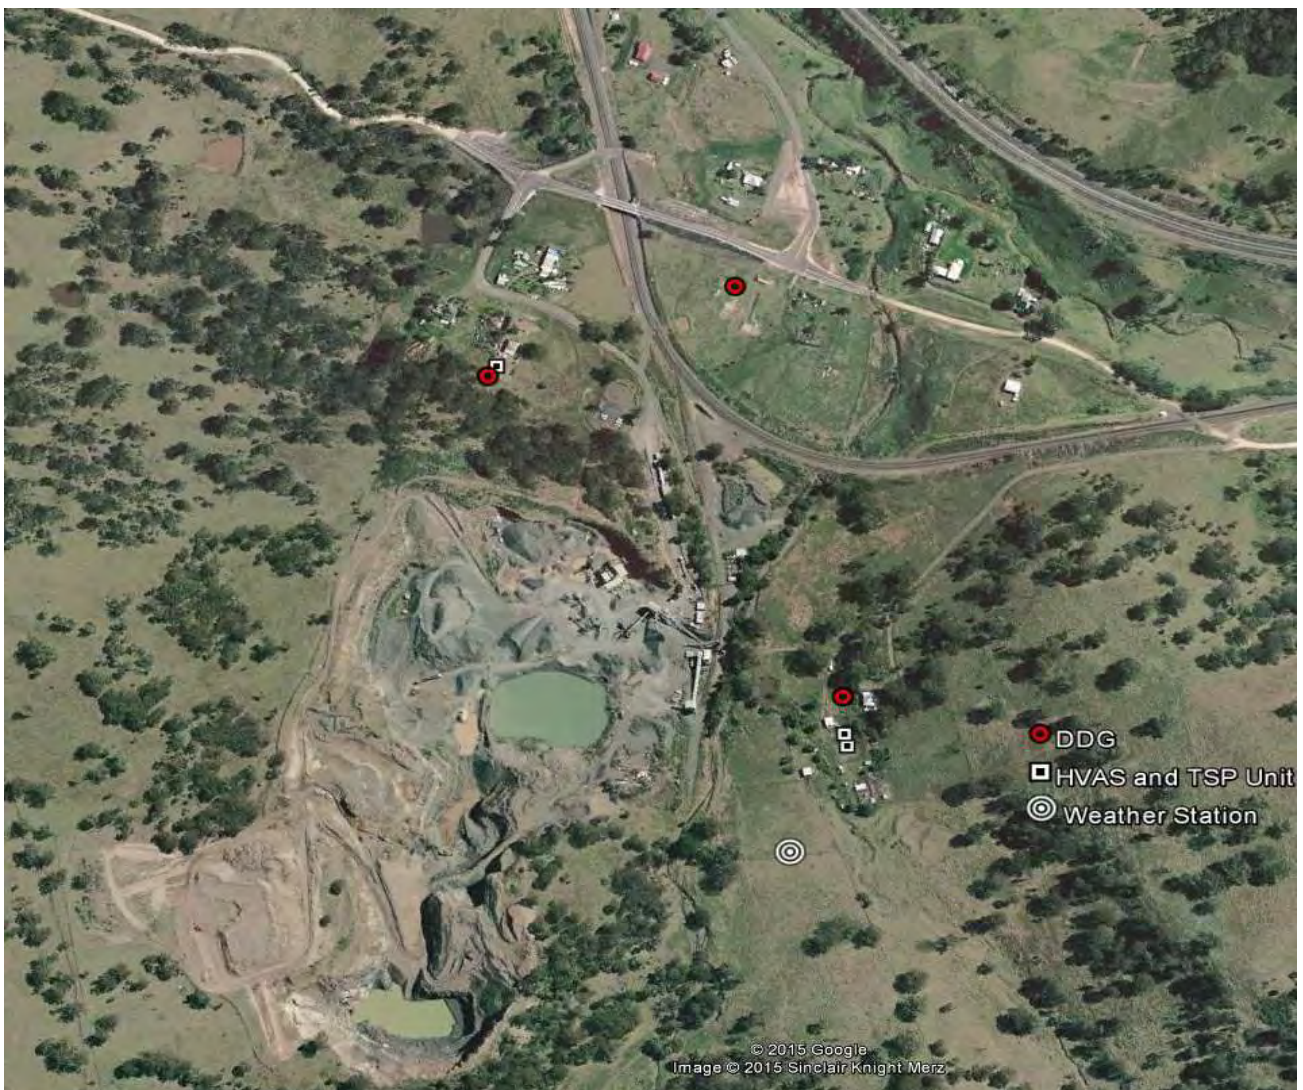
**Figure 10: Air Quality Monitoring and Weather Station Locations**

Condition 18 of the Approval requires that a meteorological station to operate in the vicinity of the project site for the life of the project. Daracon has installed a meteorological station (**Figure 10**), ensuring that the meteorological station complies with the requirements in the “Approved Methods for Sampling of Air Pollutants in New South Wales Guideline”.

The location of the air quality monitoring equipment (primarily to the North-East and East of the Quarry) was deduced from the location of the surrounding residences.

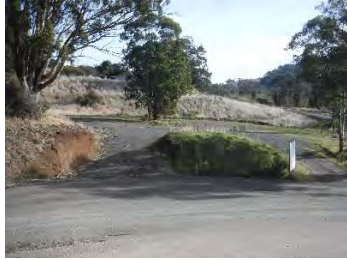
| CLIENT | Daracon Group | REPORT DATE | 9 <sup>th</sup> June 2023 | REPORT NO. | 7 | REPORT TO: | Geoff Reeves, Luke Robinson, Jason Gorton – Daracon Group |
|---|---|---|---|---|---|---|---|
| 1. | Local roads and U-turn bay. | Upon approach to the quarry site, we noted chipseal repairs to the adjacent local road network including pavement repairs and verge widening. In addition, a U-turn bay for heavy vehicles together with an auxiliary parking area has been established adjacent to the quarry entrance. The U-turn bay is stabilised with quarry aggregate and the remainder of the parking area is partially stabilised with emerging vegetation. | The area is generally stabilised, and no actions were required. | | | | |

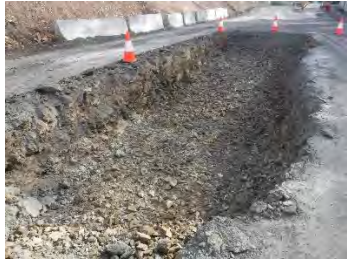
| CLIENT | Daracon Group | REPORT DATE | 9 <sup>th</sup> June 2023 | REPORT NO. | 7 | REPORT TO: | Geoff Reeves, Luke Robinson, Jason Gorton – Daracon Group |
|---|---|---|---|---|---|---|---|
| 3. | Proposed wheel wash. | The excavation work for the wheel wash has commenced and the precast components are on hand for imminent installation. An outward bound light vehicle access will also be established between the wheel wash and the adjacent batter. | Discussions with site controllers confirmed that traffic barriers or a control berm should be installed along the toe of the cut batter to control errant rock or coarse sediment impacting the light vehicle departure road. | | | | |

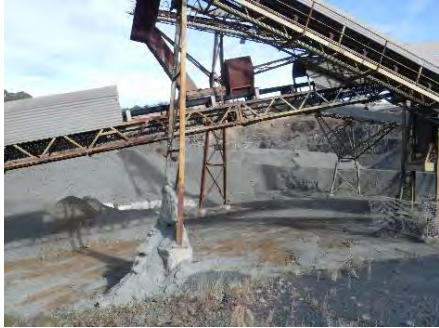
| ISSUE NO. | LOCATION | ISSUE/MATTER | RECOMMENDATION/COMMENT | PHOTOGRAPH |
|---|--|---|--|---|
| 4. | Crushing infrastructure – main quarry floor. | The majority of the crushing infrastructure located in the southern sector of the quarry floor is proposed to be demolished. The area will then be re-formed and graded to form an orbital haul road that will provide access to the western quarry workings. | As discussed, the areas should be locally re-graded during earthworks to maximise the diversion of runoff to the main central dam. | |

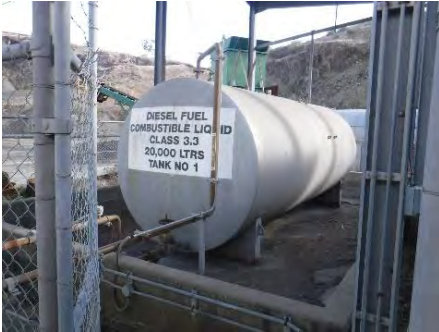
| ISSUE NO. | LOCATION | ISSUE/MATTER | RECOMMENDATION/COMMENT | PHOTOGRAPH |
|---|--|---|--|---|
| 5. | Lube shed and fuel storage area. | The lube shed area has remained dormant with adequate bund storage and controls provided. The existing static fuel tanks in the bunded areas, and the bitumen tanks in the southern sector have been emptied, and they are not anticipated to be recommissioned when operations recommence. | Continue maintain the area and visually monitor water quality in the surrounding areas. | |

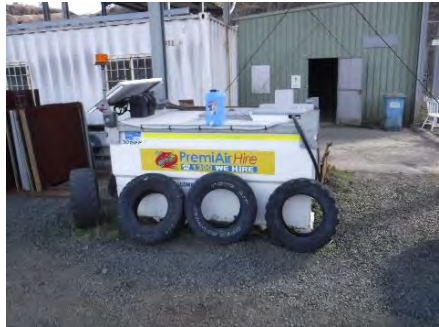
| ISSUE NO. | LOCATION | ISSUE/MATTER | RECOMMENDATION/COMMENT | PHOTOGRAPH |
|---|--|---|--|---|
| 6. | Lube shed and fuel storage area. | As noted above, the existing fuel and bitumen tanks are not anticipated to be recommissioned when operations recommence. The fuel storage requirements will be addressed with the use of prefabricated, portable, bunded fuel tanks which can be relocated as required. | As above. | |

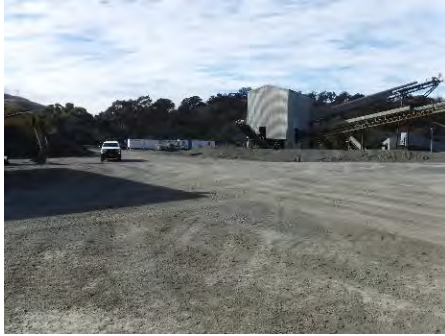
| ISSUE NO. | LOCATION | ISSUE/MATTER | RECOMMENDATION/COMMENT | PHOTOGRAPH |
|---|--|--|--|---|
| 7. | Main quarry floor and drainage lines. | Discussions occurred regarding the demolition of crushing infrastructure and the drainage lines in the northern and western areas of the quarry floor. | As discussed, we recommend regrading the quarry floor as required and implementing drainage to minimise areas of ponding and to maximise runoff to the main central dam. | |

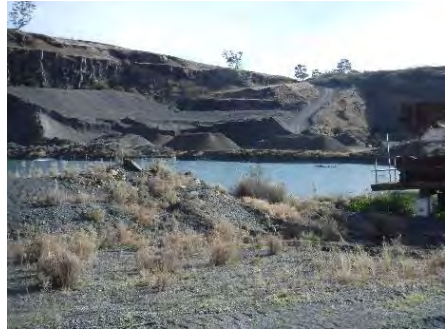
| ISSUE NO. | LOCATION | ISSUE/MATTER | RECOMMENDATION/COMMENT | PHOTOGRAPH |
|---|--|--|--|---|
| 8. | Main central dam. | Runoff from the quarry slopes and floor continues to be directed to the main central dam, which discharges via an overland drainage line to the rail corridor area. The visual water quality of the central dam was very good with very low turbidity levels. | Discussions occurred regarding the proposed expansion of the dam prior to the quarry extension works commencing. As discussed, we recommend consideration be given to the installation of a sub-soil, low-flow discharge pipe that would extend under the proposed re-aligned haul road and divert flows away from the stockpile area. | |

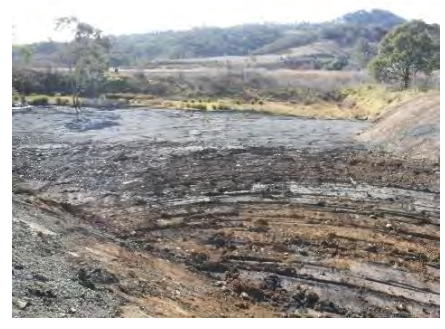
| ISSUE NO. | LOCATION | ISSUE/MATTER | RECOMMENDATION/COMMENT | PHOTOGRAPH |
|---|--|--|--|---|
| 9. | Sediment basin adjacent rail corridor. | The rail corridor sediment basin was inspected. Earthworks were nearing completion that have significantly increased the capacity of the sediment basin. The vegetated batter and sediment basin floor in the eastern sector have been retained whilst the dam has been expanded to the south. | As discussed, the retained vegetation in the eastern section of the sediment basin should rapidly colonise the recently completed areas. Following the completion of works, the sediment basin floor could be hand seeded with a cover crop mix to promote the stabilisation of the basin invert. | |

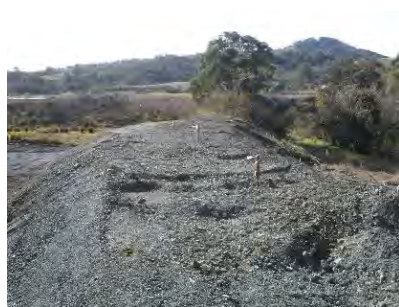
| ISSUE NO. | LOCATION | ISSUE/MATTER | RECOMMENDATION/COMMENT | PHOTOGRAPH |
|---|--|--|---|--|
| 10. | Sediment basin adjacent rail corridor. | As noted above, earthworks were underway for the sediment basin expansion. At the time of the inspection, the spillway location was marked however the works to construct the spillway had not commenced. | As discussed, we recommend that the spillway invert is lined with an impervious material such as heavy grade plastic, industrial rubber matting, etc., prior to the placement of the proposed geotextile overlay and scour rock. In addition, we recommend consideration be given to the use of a low porosity geotextile such as 'Texel' or similar product. | |

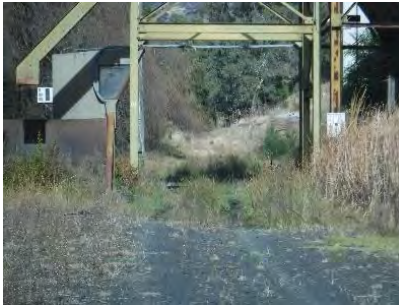
| ISSUE NO. | LOCATION | ISSUE/MATTER | RECOMMENDATION/COMMENT | PHOTOGRAPH |
|---|--|--|---|--|
| 11. | Rail loading area. | The rail loading area is largely colonised by ground cover vegetation and pasture grasses. Runoff from the upper quarry areas is filtered by vegetation along the length of the drainage line. | Continue to monitor the drainage lines and undertake periodic weed suppression in the area as required. | |

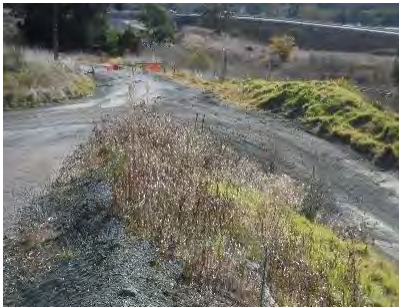
| ISSUE NO. | LOCATION | ISSUE/MATTER | RECOMMENDATION/COMMENT | PHOTOGRAPH |
|---|--|--|---|--|
| 12. | Weed control – main quarry. | As noted on previous inspections, the weed suppression program has been implemented regularly within the quarry surrounds. Evidence of die back of previously treated areas was noted in several areas. In general, outbreaks of weeds are being regularly suppressed and no significant weed outbreaks were noted in the main quarry floor and surrounds. | Continue to monitor the quarry working area and perimeter areas and implement periodic weed control as required. | |

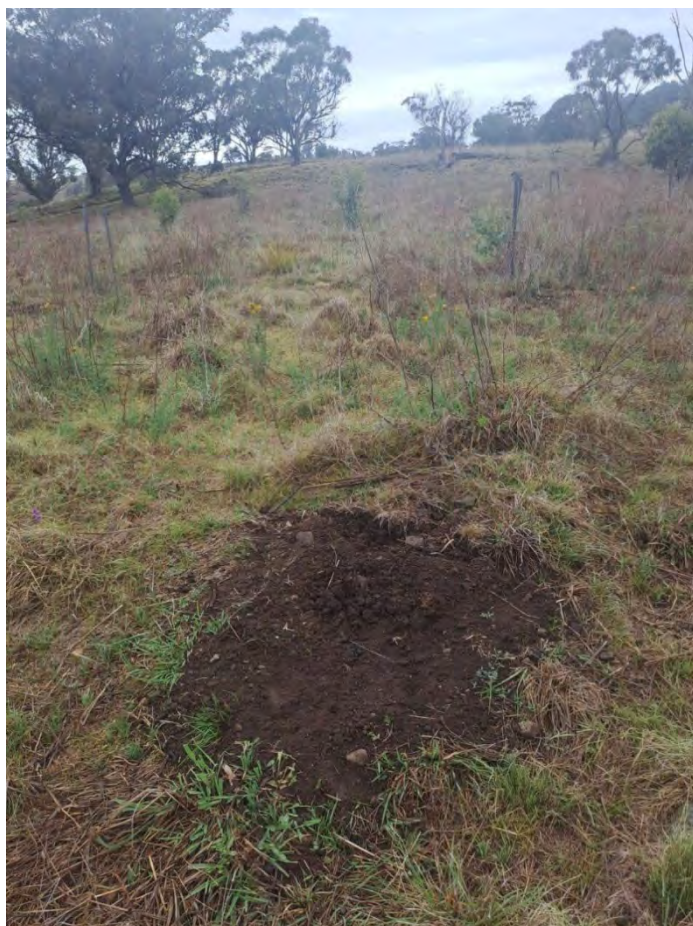
**Photo 4.1 Pig Damage in Offset B**

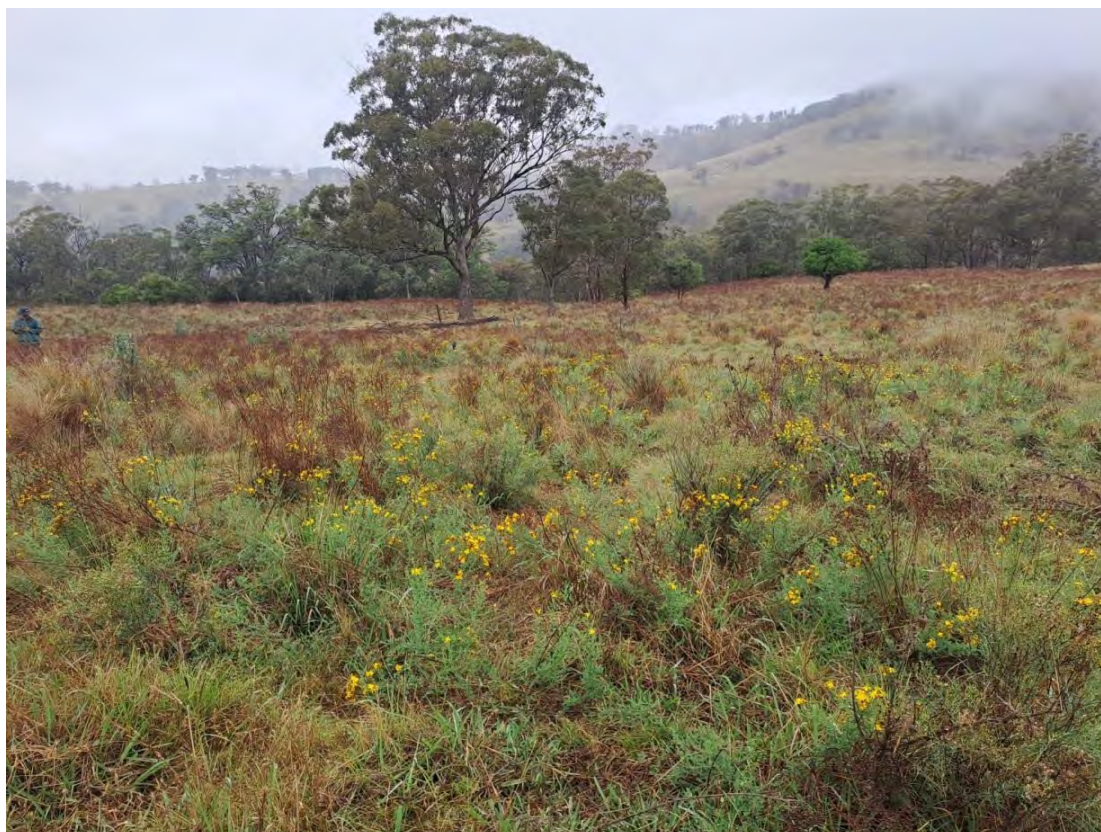
**Photo 4.2** High coverage of St John's Wort (*Hypericum perforatum*) present in Offset A

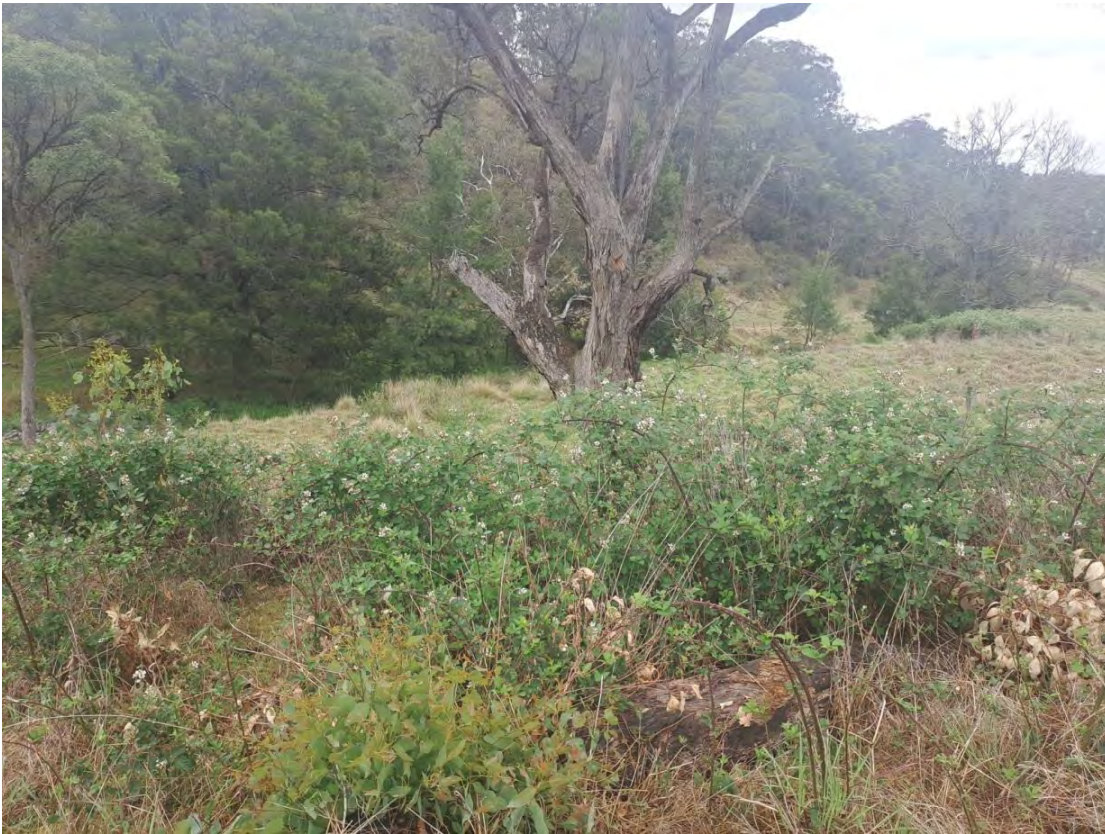
Daracon have reviewed and revised the Environmental Management Strategy (EMS) in accordance with Schedule 5, Condition 1 the approved consent. The revised EMS has been developed by using the Daracon Integrated Facility Management Plan (IFMP). Daracon have also implemented a strategy to ensure the various management plans are reviewed, revised and updated (if necessary) in accordance with the Approval. At the time of this report, the DPHI approval of the IFMP was awaiting the completion of the outstanding sub-plans (LMP and SWMP) before it could be resubmitted for approval.

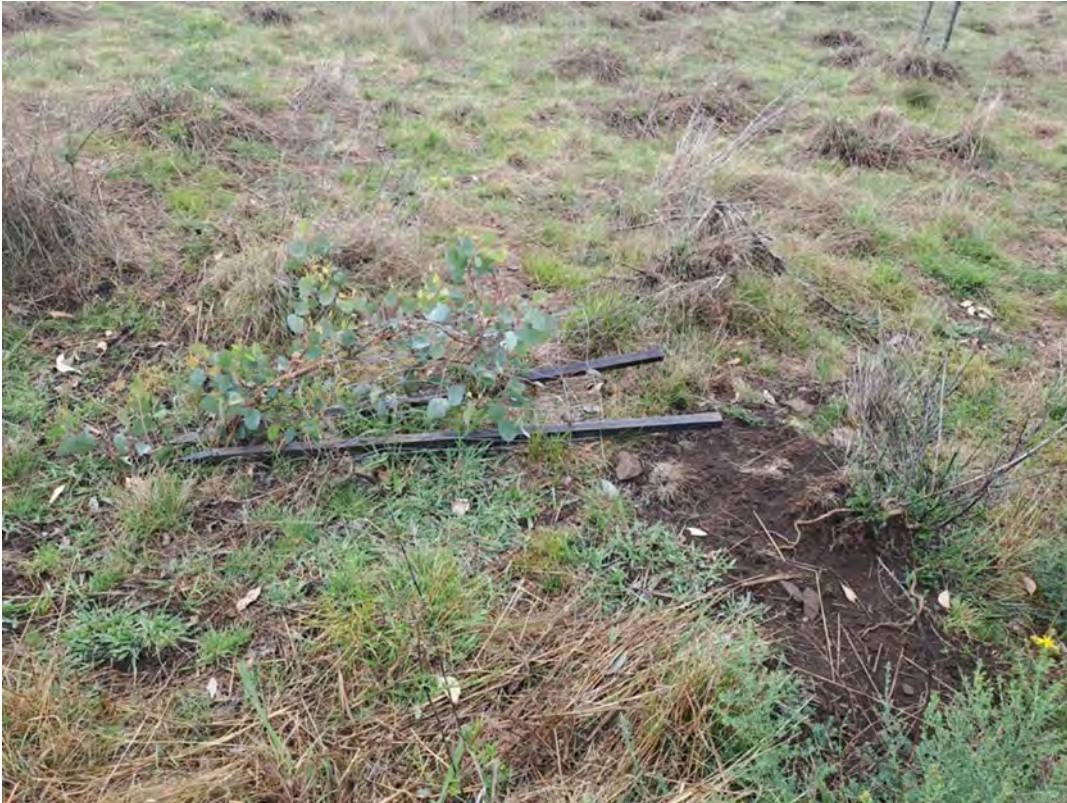
**Photo 4.6** Plantings in Offset B – Example of pig rooting and damage to tree guards

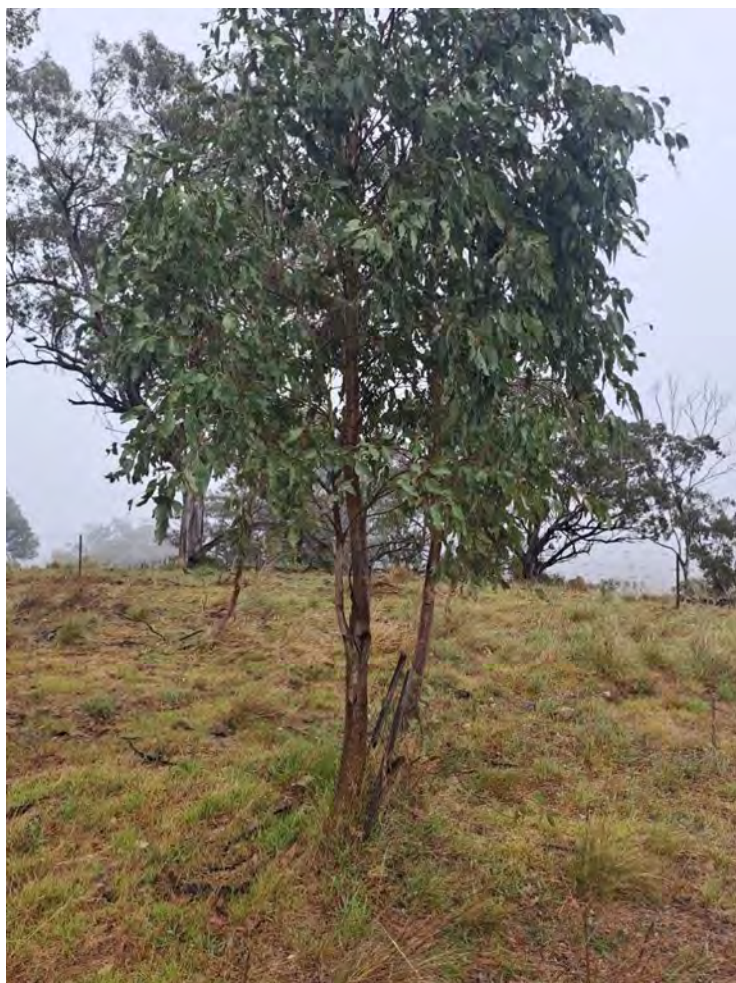
**2.11 Product Transportation**

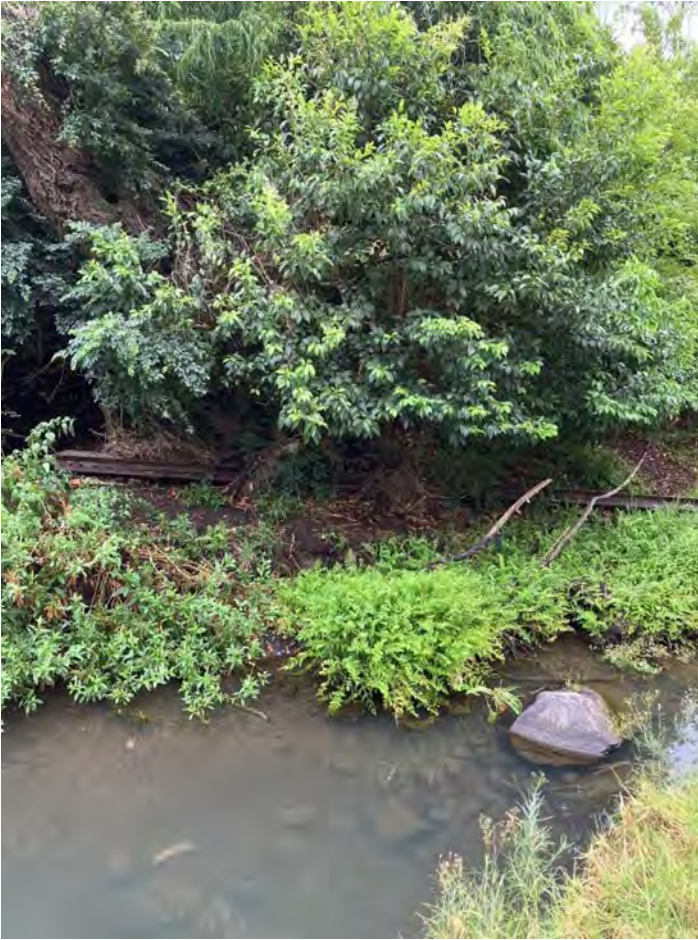
**Photo 4.9** Scrap metal in Doughboy Hollow Creek Study Area

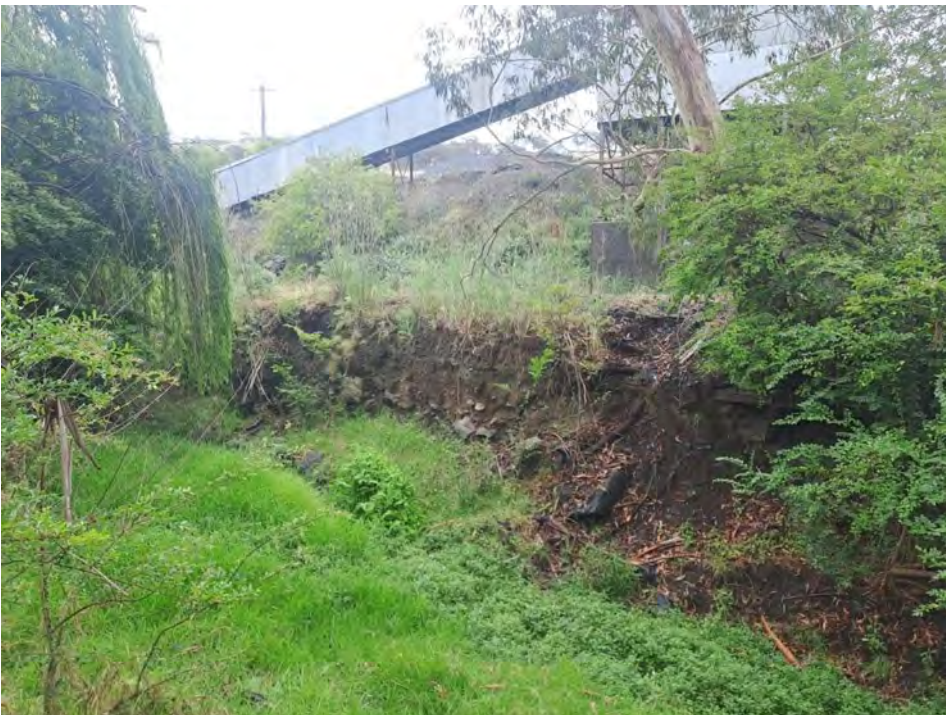
| Land Owners and Residents | |
|--|---|
| Mr D J Burraston | Ms M Taylor |

Firstly, it's worth noting that due to the reduced presence of COVID-19 and subsequent reduction in the restrictions imposed by the government, all Community Consultative Committee (CCC) meetings that occurred during 2023 were completed face-to-face.

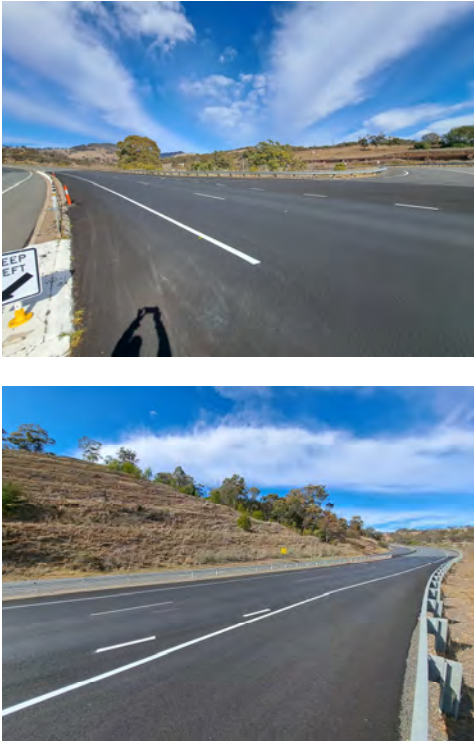
| RSA report identification number | Location / category | Description of risk to road safety | Specific actions Daracon commit to undertake | Completion date (if complete) with comments | Evidence of completion | Final status update as at 28 <sup>th</sup> June 2023 |
|---|---|---|---|---|---|---|
| 1 | Intersection of Main Street and New England Highway Northbound and Southbound Delineation | The approach to the intersection of Main Street and New England Highway is missing delineation (i.e. RRPMS) and has faded line marking. This may increase the likelihood of readability issues for a driver. The likelihood of this risk may increase at night and / or adverse weather conditions. This may result in vehicle crashes and injury to occupants of a vehicle(s). | RMS Response – New England Highway (NEH) work will be addressed by works for Daracon | Final tasks completed by TfNSW in May and June 2023. Completed. | | As of the 28 <sup>th</sup> June 2023, we've completed the access road widening and construction work (as approved by LPSC) and TfNSW recently completed the New England Highway asphalt replacement scope as shown in the images. |

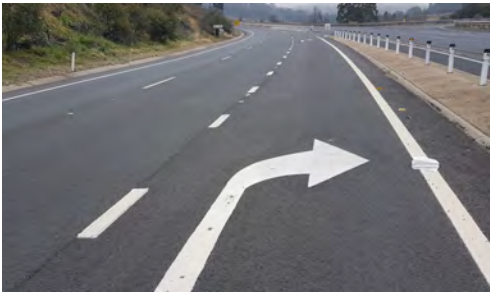
| RSA report identification number | Location / category | Description of risk to road safety | Specific actions Daracon commit to undertake | Completion date (if complete) with comments | Evidence of completion | Final status update as at 28 <sup>th</sup> June 2023 |
|---|---|---|---|---|---|---|
| 2 | New England Highway Southbound Delineation | The existing right turn bay into Main Street is missing right turn pavement arrows, which may lead to readability issues for approaching vehicles. The likelihood of this risk may increase at night and / or adverse weather conditions. This may confuse oncoming drivers for the purpose of lane and cause late lane change decisions. This may result in vehicle crashes and injury to occupants of a vehicle(s). | RMS Response – RMS to install missing Right Turn Arrows. RMS to arrange to be included in this year's AC linemarking program. | Completed by RMS prior to July 2019. | | N/A |

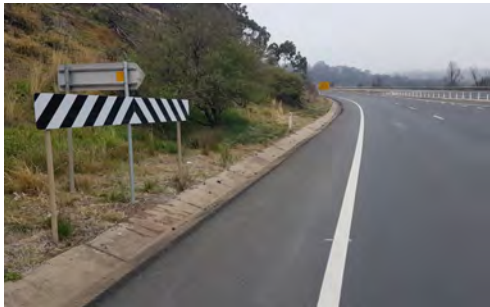
| RSA report identification number | Location / category | Description of risk to road safety | Specific actions Daracon commit to undertake | Completion date (if complete) with comments | Evidence of completion | Final status update as at <b>28<sup>th</sup> June 2023</b> |
|---|---|---|---|--|---|--|
| 3 | New England Highway Southbound Traffic signs | The advanced warning signage on approach to Main Street appears damaged, does not provide advanced warning to approaching vehicles, and has a reduced readability due to sightlines being obscured on the horizontal curve approach. This may lead to driver confusion and increase the likelihood of drivers slowing too early prior to the intersection and may result in vehicle crashes and serious injury to occupants of a vehicle(s). | RMS Response – <b>RMS to repair signs</b> from Routine Maintenance | Completed by RMS prior to July 2019. | | N/A |

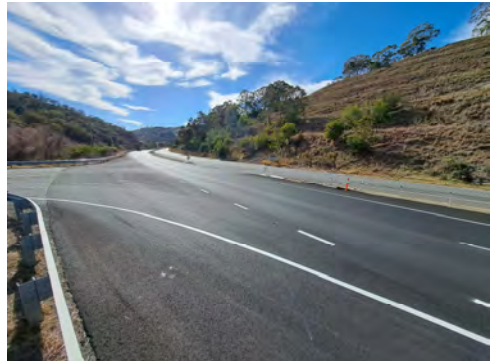
| RSA report identification number | Location / category | Description of risk to road safety | Specific actions Daracon commit to undertake | Completion date (if complete) with comments | Evidence of completion | Final status update as at <b>28<sup>th</sup> June 2023</b> |
|---|---|---|---|--|---|--|
| 4 | Intersection of Main Street and New England Highway Northbound and Southbound Delineation and Road pavement | At the intersection New England Highway and Main Street there is a combination of damaged / deformed pavement, loose gravel in the mouth of the intersection and faded delineation. The faded delineation may cause drivers readability issues. The loose gravel and damaged pavement may increase the likelihood of vehicles being unable to gain the required traction when entering Ardglan Road from New England Highway. The likelihood of this risk may increase during adverse weather conditions. This may result in vehicle crashes and serious injury to occupants of a vehicle(s). | RMS Response – New England Highway (NEH) work will be addressed by works for Daracon. | <b>Complete as at the 28<sup>th</sup> June 2023. Completed.</b> | | <b>As of the 28<sup>th</sup> June 2023, we've completed the access road widening and construction work (as approved by LPSC) and TfNSW recently completed the New England Highway asphalt replacement scope as shown in the image.</b> |

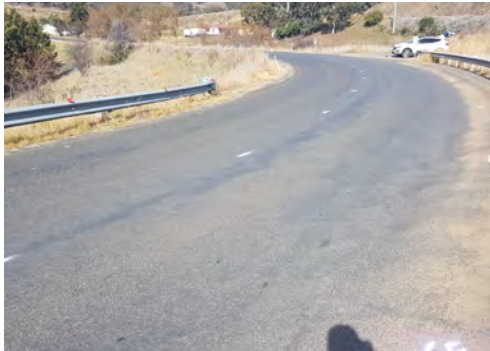
| RSA report identification number | Location / category | Description of risk to road safety | Specific actions Daracon commit to undertake | Completion date (if complete) with comments | Evidence of completion | Final status update as at <b>28<sup>th</sup> June 2023</b> |
|---|---|---|---|--|---|--|
| 5 | Main Street South of the Intersection on the outside of the curve Northbound Road pavement | At the Main Street / rail site compound access and in front of the existing w-beam safety barrier there is loose gravel on the outside of the horizontal curve. This may lead to reduced skid resistance for an errant vehicle. The likelihood of this risk may increase at night and / or adverse weather conditions. This may result in vehicle crashes and serious injury to occupants of a vehicle(s). | As agreed with LPSC representative, the loose gravel on the outside of the curve will be removed by appropriate means by Daracon. | Daracon completed this on the 3 <sup>rd</sup> April 2019 with street sweeper on site. Additional gravel removal on the 11 <sup>th</sup> July 2019 before the line marking was installed. | | N/A |

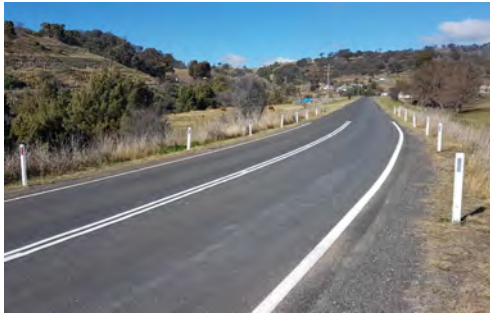
| RSA report identification number | Location / category | Description of risk to road safety | Specific actions Daracon commit to undertake | Completion date (if complete) with comments | Evidence of completion | Final status update as at <b>28<sup>th</sup> June 2023</b> |
|---|---|--|--|---|--|---|
| 6 | Main Street – South of the intersection of New England Highway Northbound and Southbound Roadside hazards | 200m along Main Street from the intersection of New England highway, there is an existing culvert with steep embankments within the clear zone. The combination of narrow shoulder widths, steep batters, culvert headwalls within the clear zone, may limit a driver’s manoeuvrability to avoid striking an object or have a reduced ability to gain control of their vehicle and strike objects within the clear zone. Narrow shoulders may also limit the available road width for wide vehicle loads and restrict vehicles in the opposing direction. This may increase the likelihood of drivers encroaching into the opposing travel lane and / or vehicles driving within the road shoulder / verge area to avoid a stationary object on the road. This may result in drivers striking the object or another object within the clear zone and lead to rapid deceleration of the vehicle. This may result in serious injury (not limited to) to occupants of a vehicle(s). | As agreed with LPSC representative, Daracon proposes to install a temporary barrier (type F concrete or similar) to highlight the presence of the existing culvert and minimise the likelihood of interaction with the roadside hazard. Subject to the ongoing operation of the quarry, Daracon may choose to install a permanent barrier (guardrail or similar) at some time in the future. | Completed on the 24 <sup>th</sup> March 2023. | | Guardrail complete as shown below.<br> |

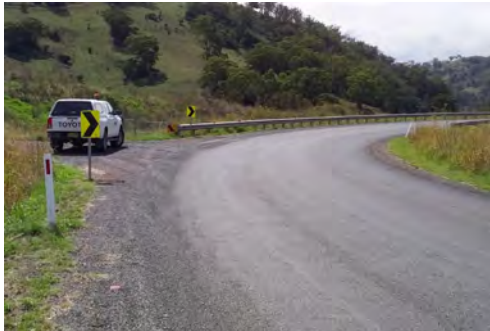
| RSA report identification number | Location / category | Description of risk to road safety | Specific actions Daracon commit to undertake | Completion date (if complete) with comments | Evidence of completion | Final status update as at <b>28<sup>th</sup> June 2023</b> |
|---|---|--|--|---|--|---|
| 7 | Main Street – Rail site compound access Northbound Road alignment and cross section and delineation | Approximately 150m from the intersection of New England Highway along Main Street there is an access track to a rail site compound. At the access there is a lack of delineation on the horizontal curve. This may give the oncoming driver the impression that the Main Street continues through rather than traveling to the right, especially at night. This may cause a driver to make a late change in direction. The combination of loose gravel on the outside of the curve and the late change in direction may result in crashes with other vehicles and result in injury to occupants of a vehicle(s). | As agreed with LPSC representative, Daracon proposes to install additional guide posts (or similar) to delineate the outside of the horizontal curve. | Completed on the 26 <sup>th</sup> March 2019. | | N/A |

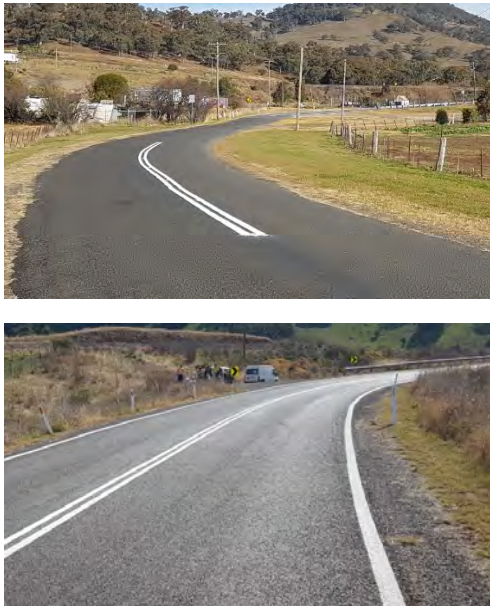
| RSA report identification number | Location / category | Description of risk to road safety | Specific actions Daracon commit to undertake | Completion date (if complete) with comments | Evidence of completion | Final status update as at <b>28<sup>th</sup> June 2023</b> |
|---|---|--|---|---|---|--|
| 8 | Main Street Northbound and Southbound Road pavement And Road alignment and cross section | The road carriageway width does not appear suitable for vehicles to pass (i.e. trucks passing other trucks and / or cars). The travel lane widths may limit a driver's manoeuvrability and increase the likelihood of readability issues to oncoming vehicles. Narrow travel lane may also limit the available road width for wide vehicle loads and restrict vehicles in the opposing direction. This may result in drivers striking oncoming objects or another object within the clear zone and lead to rapid deceleration of the vehicle. This may result in injury to occupants of a vehicle(s). | Please also refer to LPSC point #2 below. Although the AADT would be less than 300 vehicles per day including the quarry operating at 500,000T by road per year as proposed (approximately 60 outbound and 60 inbound truck movements), it was agreed with LPSC to install additional line marking only at the curves either end of Main St. The straight section of Main St will remain with no line marking. All existing line marking will also be renewed if not completed recently by LPSC. An additional control that has been implemented is the self-imposed mandatory speed limit of 40kph from the New England Highway to the Quarry entrance for all trucks. | Completed on the 11 <sup>th</sup> July 2019. | | N/A |

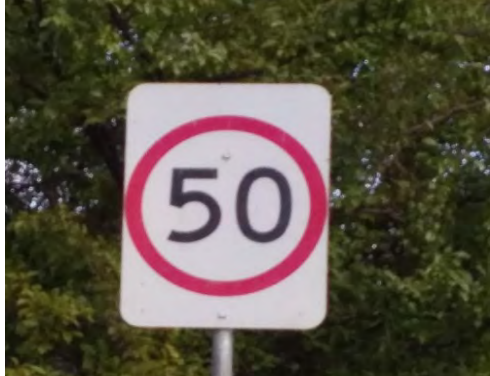
| RSA report identification number | Location / category | Description of risk to road safety | Specific actions Daracon commit to undertake | Completion date (if complete) with comments | Evidence of completion | Final status update as at <b>28<sup>th</sup> June 2023</b> |
|---|---|--|---|---|---|--|
| 9 | Main Street Intersection with Ardglen Road Northbound and Southbound Traffic signs | On Main Street approach to Ardglen Road, the existing speed zone repeater signage appears faded. This may increase the likelihood of readability issues for drivers, and increase the likelihood of a driver failing to travel to the sign posted speed limit. The likelihood of this risk may increase at night and / or adverse weather conditions. This may lead to vehicle crashes and injury to occupants of a vehicle(s). | As agreed with LPSC representative, Daracon proposes to install new speed limit signage as the existing sign is faded. | Completed on the 20 <sup>th</sup> March 2019. | | N/A |

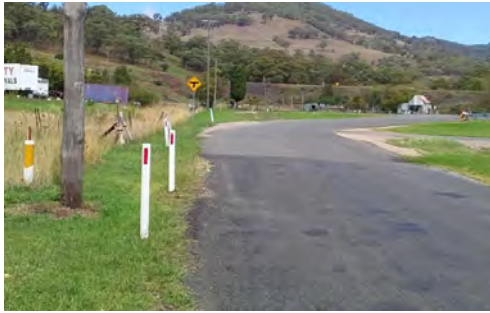
| RSA report identification number | Location / category | Description of risk to road safety | Specific actions Daracon commit to undertake | Completion date (if complete) with comments | Evidence of completion | Final status update as at <b>28<sup>th</sup> June 2023</b> |
|---|---|--|---|---|---|--|
| 10 | Main Street Approaching the Intersection with Ardglen Road Northbound and Southbound Roadside hazards | On Main Road approach to Ardglen Road, there is an existing power pole and fence posts within the clear zone. Errant vehicles at these locations may have a reduced ability to gain control of their vehicle and strike the power pole or fence post within the clear zone which may lead to rapid deceleration of the vehicle. This may be due to the combination of horizontal and / or vertical alignment of the road and / or drivers swerving to avoid striking an animal (i.e. animal carcass). The likelihood of this risk may increase at night and / or adverse weather conditions. This may result in vehicle crashes and injury to occupants of a vehicle(s), not limited to. | As agreed with LPSC representative, Daracon proposes to install delineation in the form of additional guideposts adjacent to the roadway to highlight the presence of the existing power pole. | Completed on the 26 <sup>th</sup> March 2019. | | N/A |

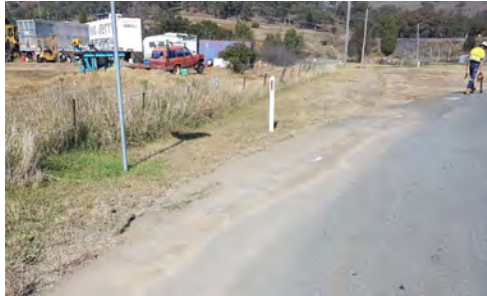
| RSA report identification number | Location / category | Description of risk to road safety | Specific actions Daracon commit to undertake | Completion date (if complete) with comments | Evidence of completion | Final status update as at <b>28<sup>th</sup> June 2023</b> |
|---|---|--|---|--|---|--|
| 11 | Main Street Approaching the Intersection with Ardglen Road Northbound and Southbound Pavement | Approximately 65m along Main Road from the intersection of Main Road and High Road, there is loose gravel on the outside of the horizontal curve. This may lead to reduced skid resistance for an errant vehicle. The likelihood of this risk may increase at night and / or adverse weather conditions. This may result in vehicle crashes and serious injury to occupants of a vehicle(s). | As agreed with LPSC representative, the loose gravel on the outside of the curve will be removed by appropriate means by Daracon. | Completed on the 3 <sup>rd</sup> April 2019 with street sweeper on site. Additional gravel removal occurred on the 11 <sup>th</sup> July 2019 before the line marking was installed. | | N/A |

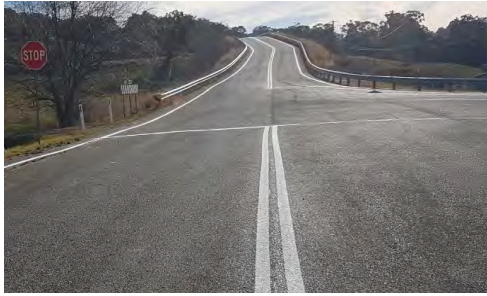
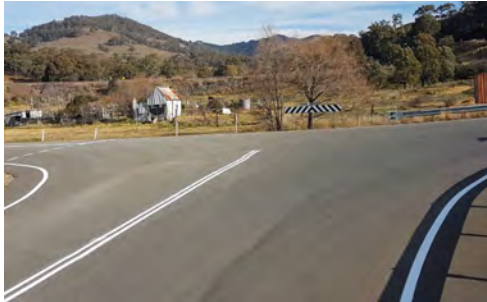
| RSA report identification number | Location / category | Description of risk to road safety | Specific actions Daracon commit to undertake | Completion date (if complete) with comments | Evidence of completion | Final status update as at <b>28<sup>th</sup> June 2023</b> |
|---|---|--|---|--|---|--|
| 12 | Main Street Intersection with High Street Delineation | At the intersection of Main Street and High Street, the existing delineation is faded. This may lead to readability issues for a driver and increase the likelihood of a vehicle failing to give way at the intersection. The likelihood of this risk may increase at night and / or adverse weather conditions. This may lead to vehicle crashes and injury to occupants of a vehicle(s). | As agreed with LPSC representative, Daracon proposes to refresh the existing line marking. | Completed on the 11 <sup>th</sup> July 2019. | <br> | N/A |

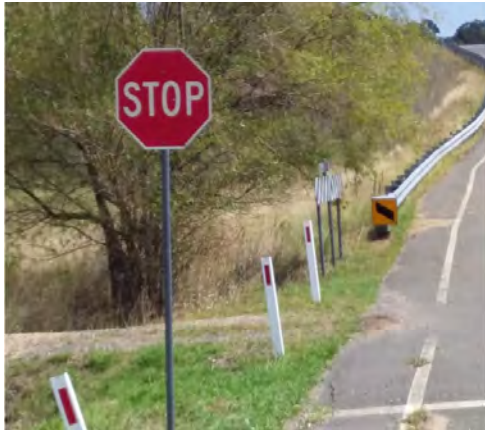
| RSA report identification number | Location / category | Description of risk to road safety | Specific actions Daracon commit to undertake | Completion date (if complete) with comments | Evidence of completion | Final status update as at <b>28<sup>th</sup> June 2023</b> |
|---|---|---|---|---|---|--|
| 13 | Main Street Intersection with High Street Westbound Traffic signs | Approaching the intersection of Main Street and High Street from the south eastern side traveling west there is a missing Stop sign. This may increase the likelihood of readability issues for drivers and lead to drivers failing to stop to oncoming vehicles. This may increase the likelihood of vehicle crashes, especially during adverse weather conditions. This could lead to crashes with other vehicles, thus may result in serious injury to occupants of a vehicle(s). | As agreed with LPSC representative, Daracon proposes to reinstate the existing stop sign. | Completed on the 20 <sup>th</sup> March 2019. | | N/A |

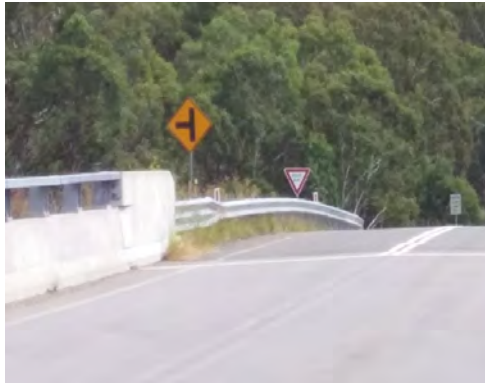
| RSA report identification number | Location / category | Description of risk to road safety | Specific actions Daracon commit to undertake | Completion date (if complete) with comments | Evidence of completion | Final status update as at <b>28<sup>th</sup> June 2023</b> |
|---|---|---|---|---|---|--|
| 14 | High Street Approach to St Stephen Street intersection Westbound Traffic signs | On the south eastern side of the intersection of High Street and St Stephen Street, the advanced warning of T-intersection signage is loose, which has caused the sign to point in the wrong direction. This may increase the likelihood of readability issues for drivers and lead to drivers failing to negotiate the intersection. This may increase the likelihood of vehicle crashes, especially during adverse weather conditions. This could lead to crashes with other vehicles, thus may result in serious injury to occupants of a vehicle(s). | As agreed with LPSC representative, Daracon proposes to reinstate the existing T intersection sign. | Completed on the 26 <sup>th</sup> March 2019. | | N/A |
