# ARDGLEN QUARRY

## 2023 Annual Environmental Management Report (AEMR)

PROJECT APPROVAL MP 06\_0264 - MOD 2

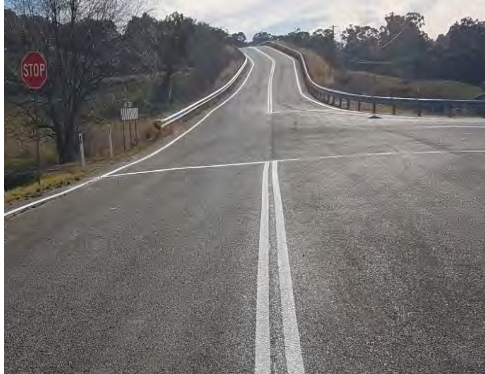
| RSA report identification number | Location / category | Description of risk to road safety | Specific actions Daracon commit to undertake | Completion date (if complete) with comments | Evidence of completion | Final status update as at <b>28<sup>th</sup> June 2023</b> |
|---|---|---|---|---|---|--|
| 15 | High street Rail overpass bridge Eastbound and Westbound Road alignment and cross section | Traveling west along High Street towards the rail overpass bridge, the travel lanes appear to narrow and there is a kink in the alignment of the road. The narrow travel lane widths may limit a driver's manoeuvrability and increase the likelihood of readability issues to oncoming vehicles. Narrow travel lane may also limit the available road width for wide vehicle loads and restrict vehicles in the opposing direction. This may result in drivers striking oncoming vehicles or safety barriers and lead to rapid deceleration of the vehicle. This may result in serious injury (not limited to) to occupants of a vehicle(s). | As agreed with LPSC representative, all existing line marking will be renewed if not completed recently by LPSC. An additional control that has been implemented is the self-imposed mandatory speed limit of 40kph from the New England Highway to the Quarry entrance for all trucks. Appropriate delineation already exists along the guardrail. | Self-imposed 40 kph speed limit imposed immediately. The line marking was completed on the 11 <sup>th</sup> July 2019. Completed. | | N/A |

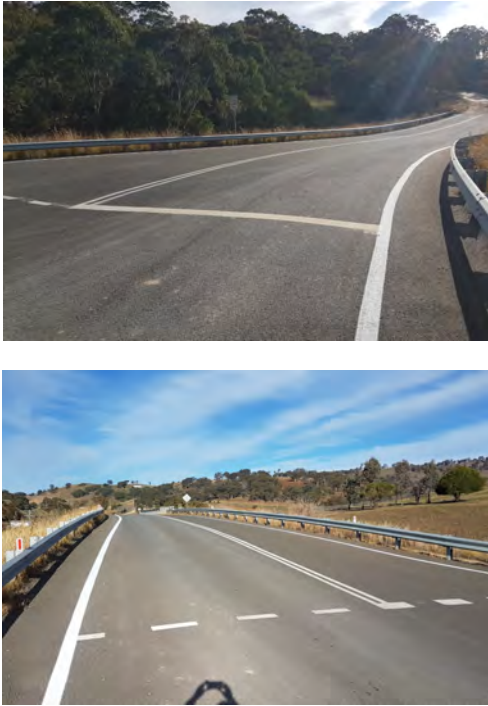
| RSA report identification number | Location / category | Description of risk to road safety | Specific actions Daracon commit to undertake | Completion date (if complete) with comments | Evidence of completion | Final status update as at <b>28<sup>th</sup> June 2023</b> |
|---|--|--|---|---|--|---|
| 16 | High Street Approach to St Stephen Street Intersection Eastbound and Westbound Delineation | <p>At the intersection of High Street and St Stephen Street, the existing delineated is faded. This may lead to readability issues for a driver and increase the likelihood of a vehicle failing to give way / stop at the intersection. The likelihood of this risk may increase at night and / or adverse weather conditions. This may lead to vehicle crashes and injury to occupants of a vehicle(s).</p> | <p>As agreed with LPSC representative, all existing line marking will be renewed by Daracon if not completed recently by LPSC.</p> | <p>Completed on the 11<sup>th</sup> July 2019.</p> | | <p>N/A</p> |

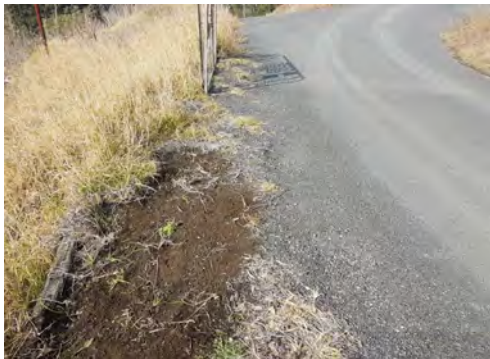
| RSA report identification number | Location / category | Description of risk to road safety | Specific actions Daracon commit to undertake | Completion date (if complete) with comments | Evidence of completion | Final status update as at <b>28<sup>th</sup> June 2023</b> |
|---|---|---|--|---|---|---|
| 20 | Warra Street Near the quarry entrance Southbound Pavement And Road alignment And cross section | Near the entrance to the quarry and part of Warra Road the existing pavement is deteriorated and shoulder show evidence of erosion. This may lead to soft shoulders and may be unstable for heavy vehicle to use if divers need to move their vehicle to avoid oncoming traffic. This may result in injury to occupants of a vehicle(s), not limited to. | As agreed with LPSC representative, Daracon proposes to investigate and repair the shoulder as described in the RSA. | Completed 20 <sup>th</sup> March 2019. | | Road widening complete as shown below.<br> |

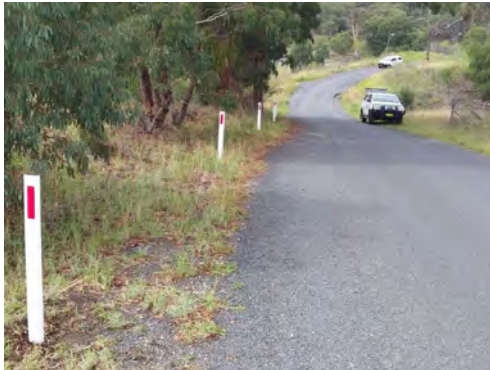
| RSA report identification number | Location / category | Description of risk to road safety | Specific actions Daracon commit to undertake | Completion date (if complete) with comments | Evidence of completion | Final status update as at <b>28<sup>th</sup> June 2023</b> |
|---|---|--|--|---|--|---|
| 21 | Warra Street Northbound and Southbound Roadside hazards | <p>Along Warra Street the auditors observed trees within clear zone as well as narrow carriageway. Errant vehicles at these locations may have a reduced ability to gain control of their vehicle and strike the trees within the clear zone which may lead to rapid deceleration of the vehicle. This may be due to the narrow carriageway width of the road and / or drivers swerving to avoid striking oncoming vehicles. The likelihood of this risk may increase at night and / or adverse weather conditions. This may result in vehicle crashes and injury to occupants of a vehicle(s), not limited to.</p> | <p>As agreed with LPSC representative, Daracon proposes to install delineation in the form of additional guideposts adjacent to the roadway to highlight the presence of the trees. Daracon has implemented a self-imposed mandatory speed limit of 40kph from the New England Highway to the Quarry entrance as well as a mandatory “call up” protocol for St Stephens and Warra St’s as detailed in the TTMP.</p> | <p>Complete as at the 24<sup>th</sup> March 2023.</p> | | <p>Guardrail complete as shown below.</p> |

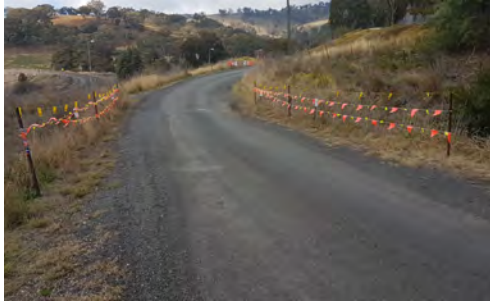
| RSA report identification number | Location / category | Description of risk to road safety | Specific actions Daracon commit to undertake | Completion date (if complete) with comments | Evidence of completion | Final status update as at <b>28<sup>th</sup> June 2023</b> |
|---|---|--|--|---|--|---|
| 22 | Warra Street Northbound and Southbound Roadside hazards | <p>Approximately 50m from the entrance of the quarry there is an existing culvert headwall with drop-off within the clear zone. Errant vehicles at these locations may have a reduced ability to gain control of their vehicle impact with the existing headwall and / or surrounding objects within the clear zone. This may be due to the narrow carriageway width of the road and / or drivers swerving to avoid striking oncoming vehicles. The likelihood of this risk may increase at night and / or adverse weather conditions. This may result in vehicle crashes and serious injury to occupants of a vehicle(s).</p> | <p>As agreed with LPSC representative, Daracon proposes to install a temporary barrier (type F concrete or similar) to highlight the presence of the existing culvert and minimise the likelihood of interaction with the roadside hazard. Additionally, <b>LPSC have committed to investigating the option of extending the existing storm water pipe</b> to permit widening of the formation thus eliminating the roadside hazard.</p> | <p>Complete as at the 24<sup>th</sup> March 2023.</p> | | <p>Road widening and guardrail complete as shown below.</p> |

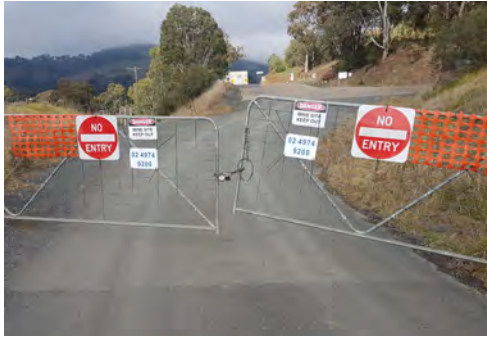
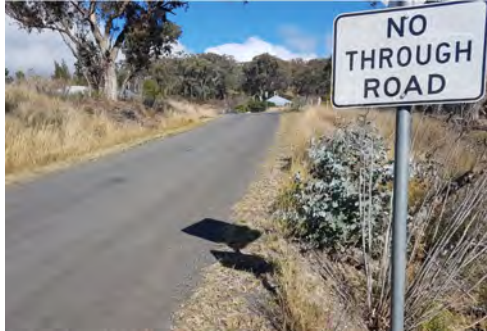
| RSA report identification number | Location / category | Description of risk to road safety | Specific actions Daracon commit to undertake | Completion date (if complete) with comments | Evidence of completion | Final status update as at <b>28<sup>th</sup> June 2023</b> |
|---|---|--|---|---|---|---|
| 23 | Warra Street Quarry entrance Northbound and Southbound Road alignment and cross section | At the site entry of the quarry, the entry appears narrow, lack of carriageway width for drivers to turn around as well as lack of restriction signage / no through road. This may lead to driver frustration and confusion which may contribute to driver error. The likelihood of this risk may increase at night and / or adverse weather conditions. This may result in vehicle crashes and serious injury to occupants of a vehicle(s). | As agreed with LPSC representative, Daracon has implemented a self-imposed mandatory speed limit of 40kph from the New England Highway to the Quarry entrance as well as a mandatory “call up” protocol for St Stephens and Warra St’s as detailed in the TTMP. | Complete as at the 24 <sup>th</sup> March 2023. | | Road widening and guardrail complete as shown below.<br> |

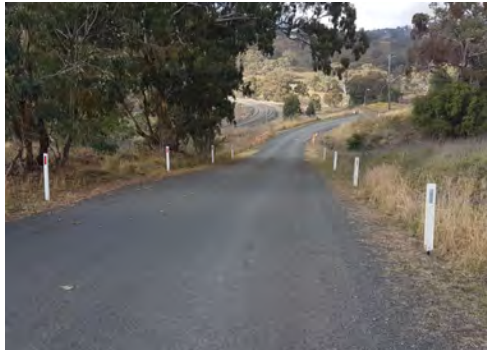
| RSA report identification number | Location / category | Description of risk to road safety | Specific actions Daracon commit to undertake | Completion date (if complete) with comments | Evidence of completion | Final status update as at <b>28<sup>th</sup> June 2023</b> |
|---|---|--|---|---|---|---|
| 24 | Warra Street Northbound and Southbound Delineation | It was noted that along Warra Street there is a lack of delineation. This may increase the likelihood of readability issues for drivers. The likelihood of this risk may increase at night and / or adverse weather conditions. This may result in vehicle crashes and injury to occupants of a vehicle(s). | As agreed with LPSC representative, Daracon proposes to install delineation in the form of additional guideposts adjacent to the roadway. | Complete as at the 24 <sup>th</sup> March 2023. | | Road widening and guardrail complete as shown below.<br> |

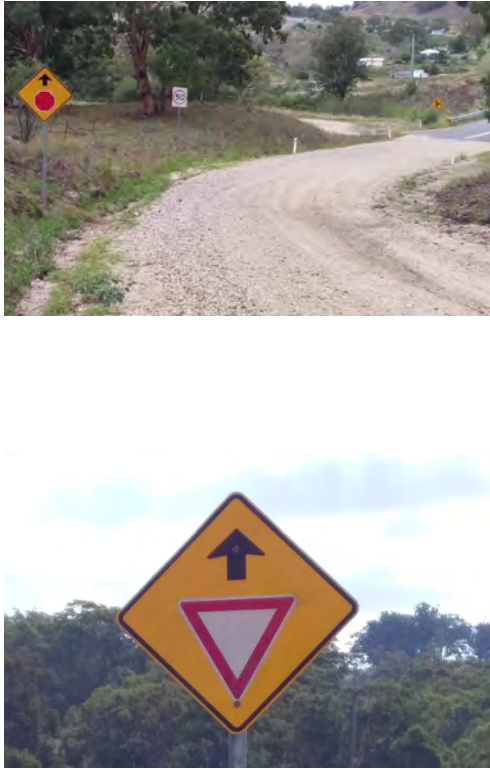
| RSA report identification number | Location / category | Description of risk to road safety | Specific actions Daracon commit to undertake | Completion date (if complete) with comments | Evidence of completion | Final status update as at <b>28<sup>th</sup> June 2023</b> |
|---|---|---|--|---|--|--|
| LPSC #1 | Either side of the rail overpass bridge | <p>The two 'T' intersections either side of the rail overpass bridge are not your normal 'T' intersections in that the approach roads to the top of the 'T' have right away, whereas the thru road normally has right of way. Whilst 'Give Way' and 'Stop Signs' along with line marking (that needs maintaining) exists, I think advance warning 'Give Way Sign Ahead' and 'Stop Sign Ahead' signs (W3-1B and W3-2B) should be considered to forewarn road users along High Street and Swinging Ridges Road as the thru road(s).</p> | <p>Daracon agree to install additional advance warning 'Give Way Sign Ahead' and 'Stop Sign Ahead' signs (W3-1B and W3-2B) to forewarn road users along High Street and Swinging Ridges Road as the thru road(s)</p> | <p>Completed on the 20<sup>th</sup> March 2019.</p> | | <p>N/A</p> |

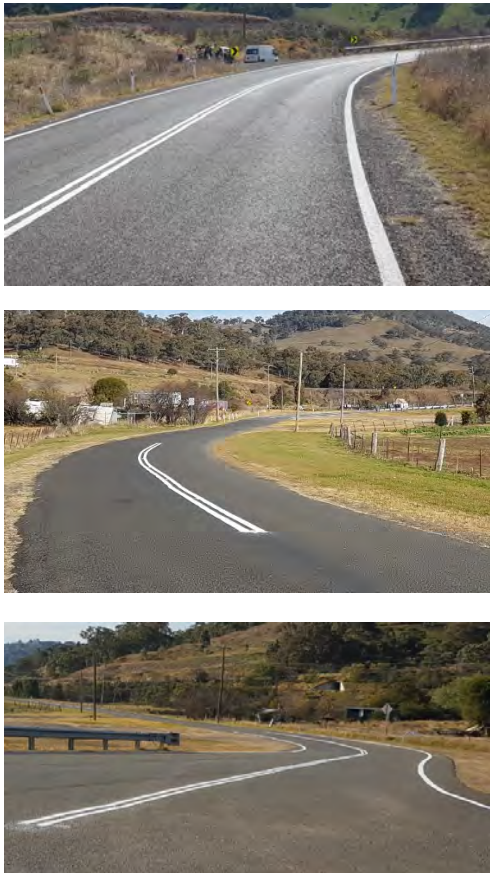
| RSA report identification number | Location / category | Description of risk to road safety | Specific actions Daracon commit to undertake | Completion date (if complete) with comments | Evidence of completion | Final status update as at <b>28<sup>th</sup> June 2023</b> |
|---|---|---|--|--|---|--|
| LPSC #2 | Main Street | <p>There is no centreline delineation along the Ardglan Road (it is being called Main Street in the RSA). High Street has centreline marking (albeit it is very faded and needs redoing). Given there are 2 curves along the Ardglan Road, the RSA should identify the lack of centreline marking along this road in greater detail.</p> | <p>Although the AADT would be less than 300 vehicles per day including the quarry operating at 500,000T by road per year as proposed (approximately 60 outbound and 60 inbound truck movements), it was agreed with LPSC to install additional line marking only at the curves either end of Main St. The straight section of Main St will remain with no line marking. All existing line marking will also be renewed if not completed recently by LPSC. An additional control that has been implemented is the self-imposed mandatory speed limit of 40kph from the New England Highway to the Quarry entrance for all trucks.</p> | <p>Completed on the 11<sup>th</sup> July 2019.</p> | | <p>N/A</p> |

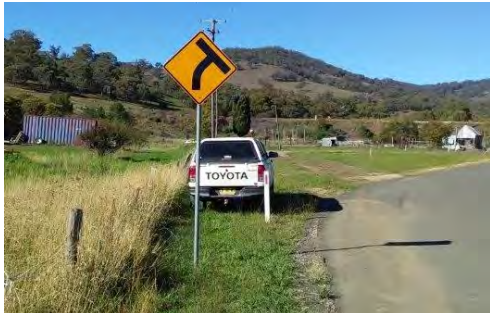
| RSA report identification number | Location / category | Description of risk to road safety | Specific actions Daracon commit to undertake | Completion date (if complete) with comments | Evidence of completion | Final status update as at <b>28<sup>th</sup> June 2023</b> |
|---|---|---|--|--|---|--|
| LPSC #3 | Main Street | <p>The advance 'T' junction warning sign on Ardglan Road on approach to High Street does not depict the road alignment on approach to the intersection. The approach to the intersection has a horizontal curve between the Advanced intersection Warning Sign and the intersection. The sign should be changed to a Curved Intersection (W2-14B) sign.</p> | <p>Daracon agrees to change the advance 'T' junction warning sign on Ardglan Road on approach to High Street to a Curved Intersection (W2-14B) sign.</p> | <p>Completed on the 3<sup>rd</sup> April 2019.</p> | | <p>N/A</p> |

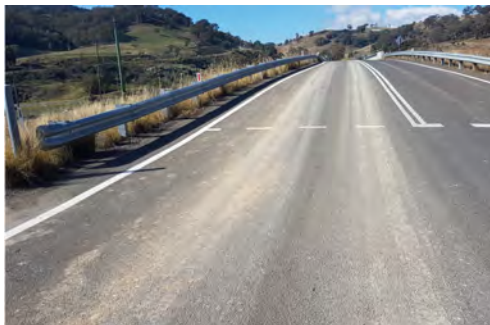
| RSA report identification number | Location / category | Description of risk to road safety | Specific actions Daracon commit to undertake | Completion date (if complete) with comments | Evidence of completion | Final status update as at 28 <sup>th</sup> June 2023 |
|---|---|---|---|---|--|--|
| Other observation #2 | St Stephen Street and Main Street | There is a gap in the existing w-beam safety barrier for rail corridor access at the intersection of St Stephen Street and High Street. The auditors observed that the point of need for safety barrier may not protect an errant vehicle from the hazard at this location. | <p>Ardglen Quarry has been operating as a hard rock quarry for over 100 years and Buttai Gravel (Daracon) has owned and operated Ardglen Quarry since 2005 after purchasing the quarry from the State Rail Authority. Sometime following Daracon's purchase of the quarry, ARTC commenced work on the construction of the rail overpass bridge which was completed sometime before 2009 (and whilst the quarry was still operating). With respect to the design and construction of the new rail overpass bridge, access road and associated structures, Daracon were not involved in the process and had no influence over the design parameters associated with the safety barriers associated with the new bridge and access roads. <b>However, Daracon and LPSC have recently renewed the line marking in this location which, combined with the additional signage and guideposts installed as well as the self-imposed mandatory speed limit of 40kph from the New England Highway to the Quarry entrance for all trucks, has significantly reduced the risk of an errant vehicle in this location.</b></p> | Completed on the 11 <sup>th</sup> July 2019. | <p>Note – The dirt present on the road surface (as shown in the above image) was the result of LPSC unsealed road maintenance occurring along Swinging Ridges Rd and was in no way associated with truck movements to or from Ardglen Quarry.</p> | N/A |
