BUTTAI QUARRY

ANNUAL ENVIRONMENTAL MANAGEMENT REPORT (AEMR)

2020

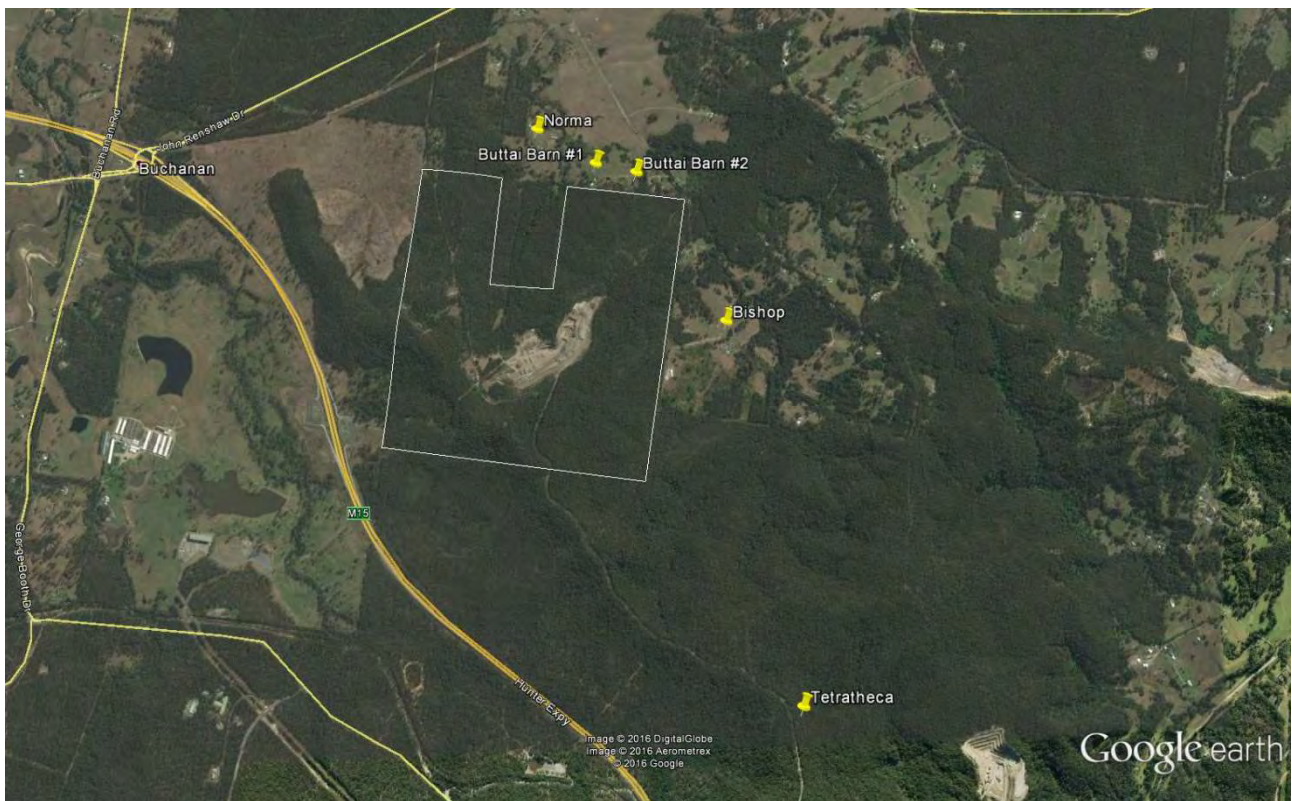
Figure 4: Air Quality Monitoring

The location of the air quality monitoring equipment (primarily to the North-East and East of the Quarry) was chosen due to the location of the adjacent private residences.

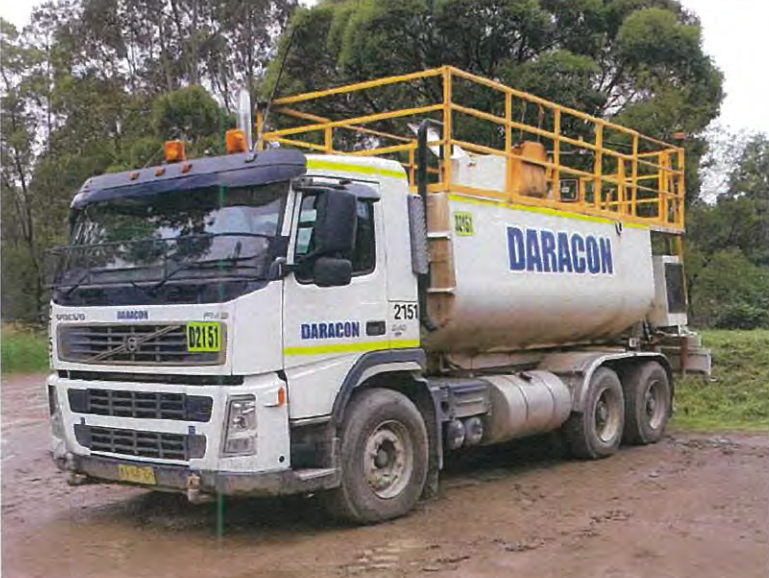
N/A	Nil – At the time of inspection, there was no evidence of dust generation on site. The water cart was available to be used on unsealed haulage paths if required however recent rain meant that it was not being used at the time of inspection – Positive observation.	N/A

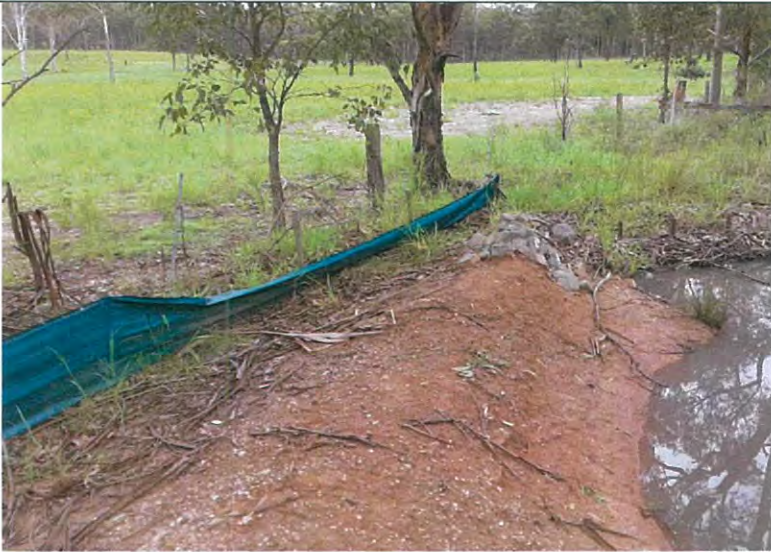
3	Sediment controls along the western boundary of Lot 75 (near main access gate)

Low	A few small sections of sediment fence require maintenance along the western boundary adjacent to the main access gate.	Repaired ✓ 23/3/20
4	The rock lined drainage channel adjacent to the main access gate

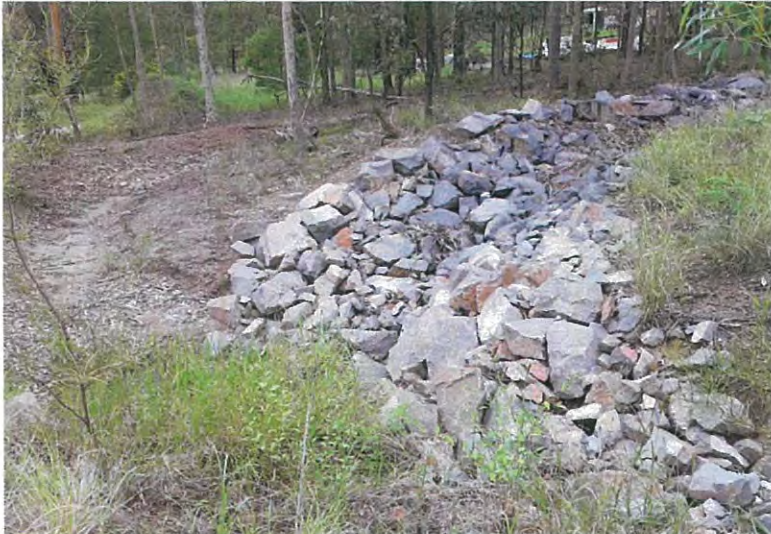
N/A	Nil – The rock lined drainage channel adjacent to the main access gate was effective and well maintained - Positive observation.	N/A

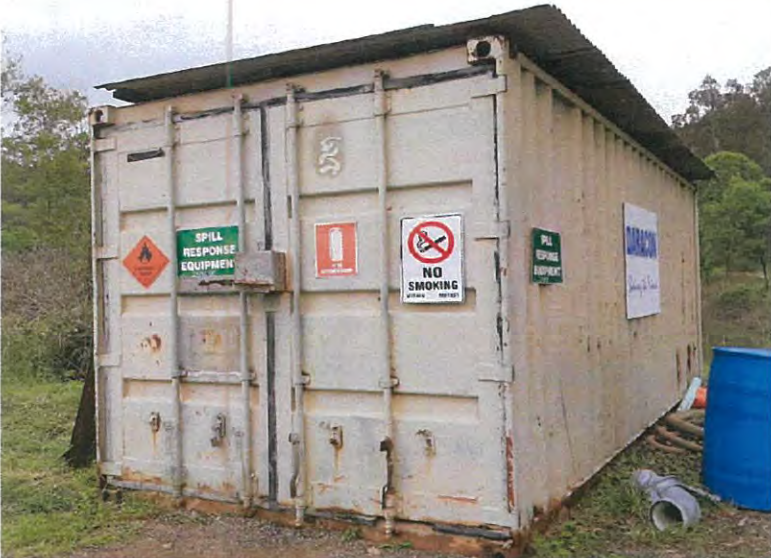
5	Chemical storage container

N/A	Nil – The chemical storage container was appropriately secured and sign posted - Positive observation.	N/A
6	Access road to Dam #4

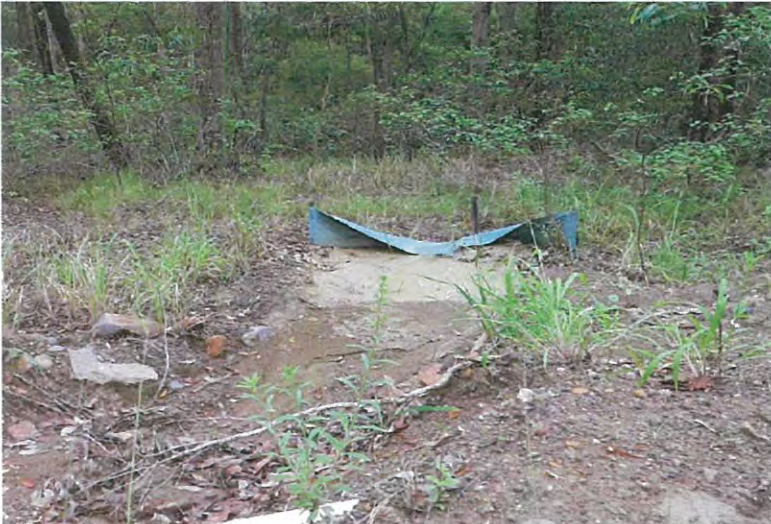
Low	A few small sections of sediment fence require maintenance along the access road down to Dam #4.	Repaired ✓ B 23/3/20

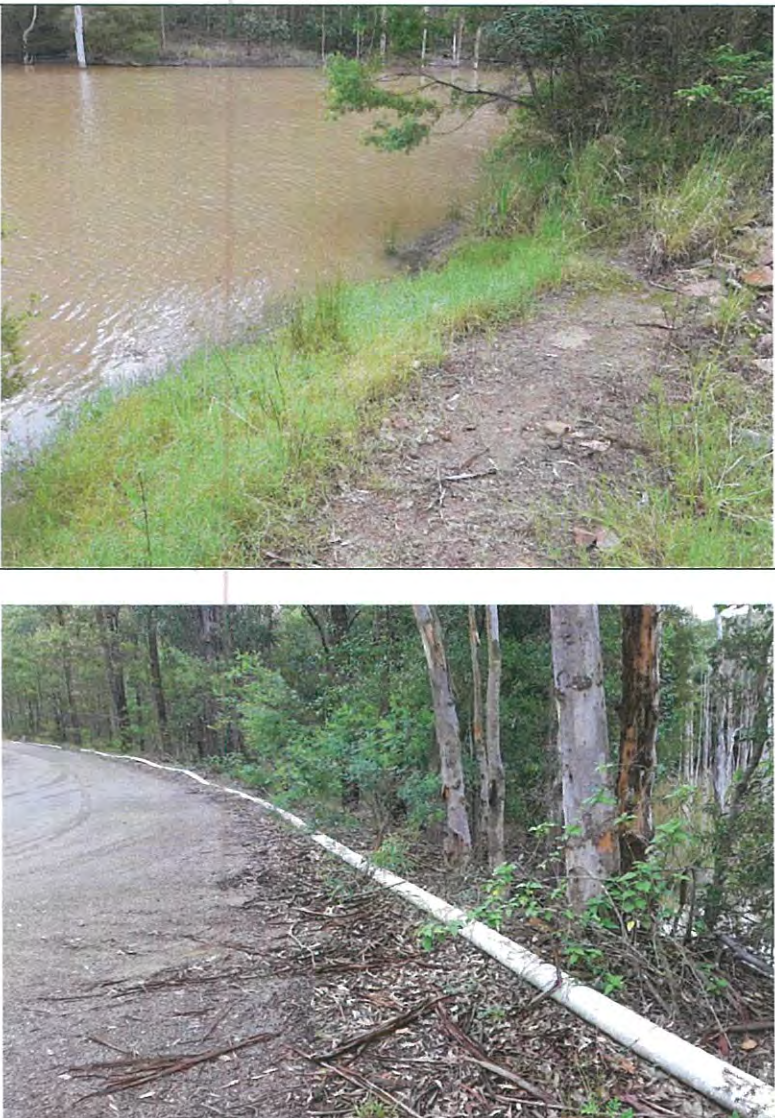
7	Dam #4 and associated water transfer piping

N/A	Nil – The water levels in Dam #4 are carefully managed to ensure there is enough water available for the site to operate effectively whilst also ensuring that water discharges from Dam #4 are curtailed – Positive observation.	N/A
---	---	---	-----	---	-----

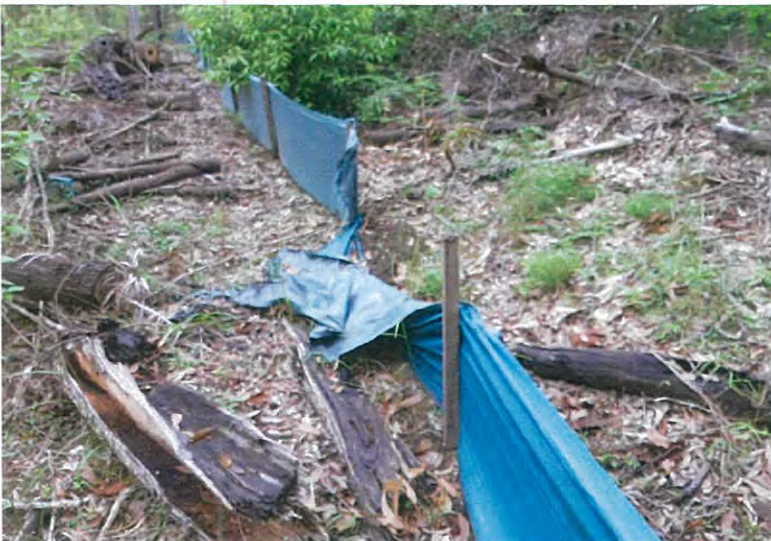
Low	A few small sections of sediment fence require maintenance along the eastern side of "Lot 76".	Repaired L 23/3/20

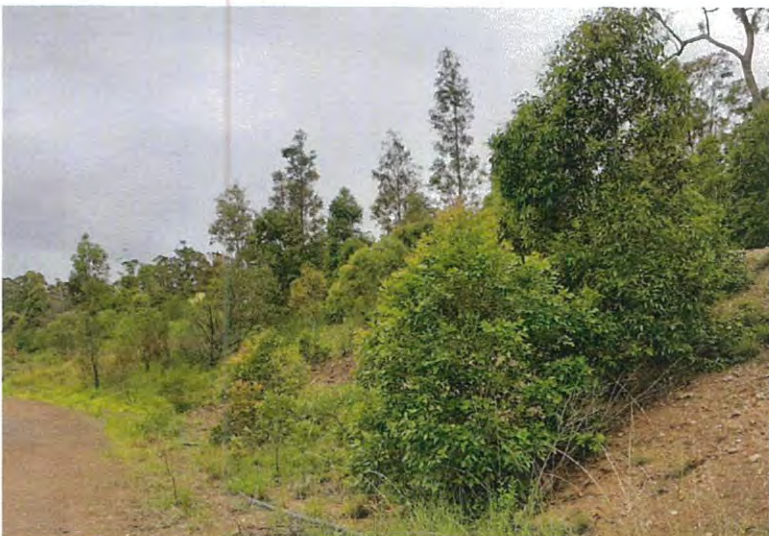
N/A	Nil – The revegetation work previously completed in this area is progressing well – Positive observation.	N/A

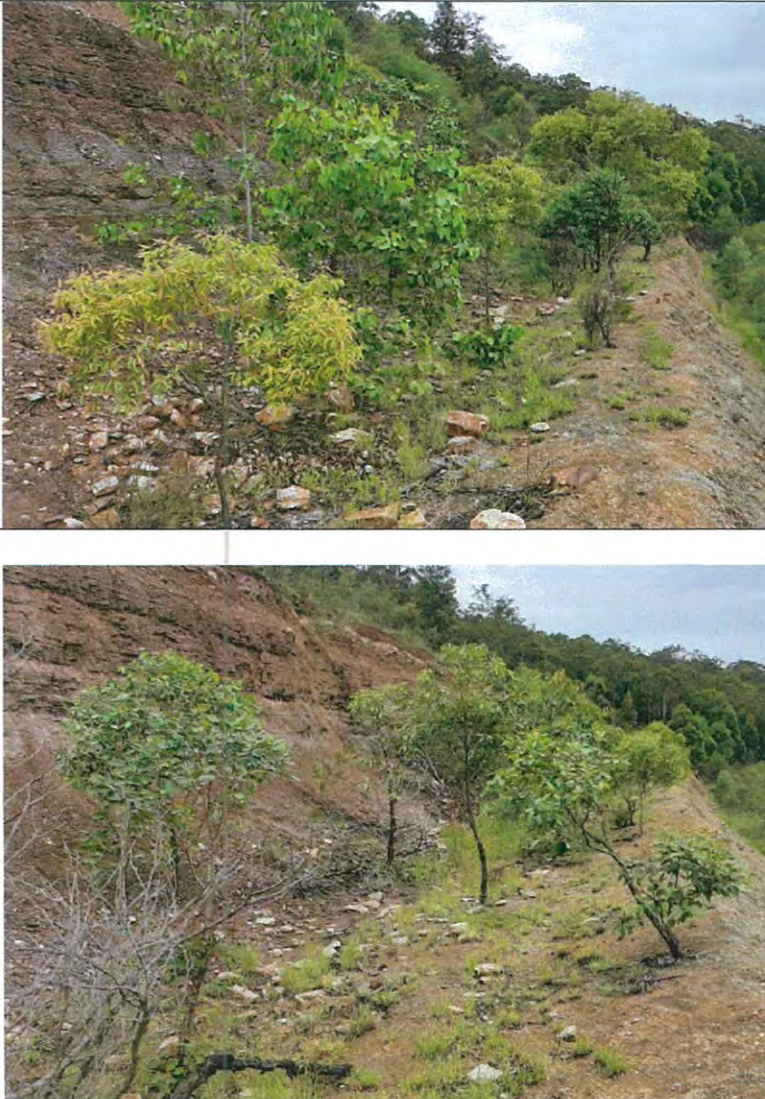
12	Bench #2 rehab' work

N/A	Nil – Bench #2 rehabilitation continues to progress and evolve with the older species selectively dying off and being replaced with natural regeneration over time – Positive observation.	N/A
----	----------------------	---	-----	--	-----

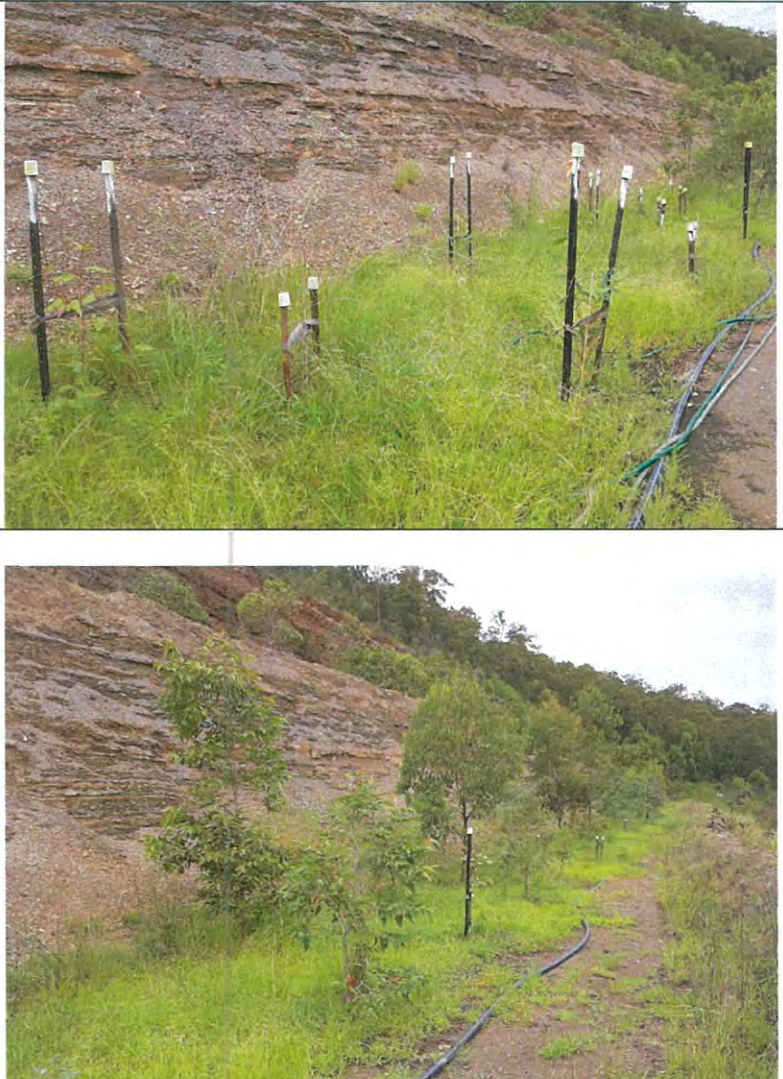
13	Bench #3 rehab' work

N/A	<p>Nil – Ongoing inspection and maintenance of the rehabilitation planting is continuing along Bench #3. An additional 9 mature plants were installed in early March 2020 with ongoing watering currently occurring – Positive observations.</p>	N/A
----	----------------------	---	-----	--	-----

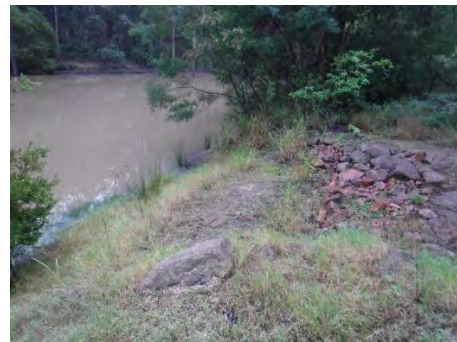
2.	Lower sediment basin and water cart loading area	The sediment basin spillway is stable, vegetated with no indication of any spill events since the previous inspection.	Continue to implement effective water transfer and dam storage management measures.

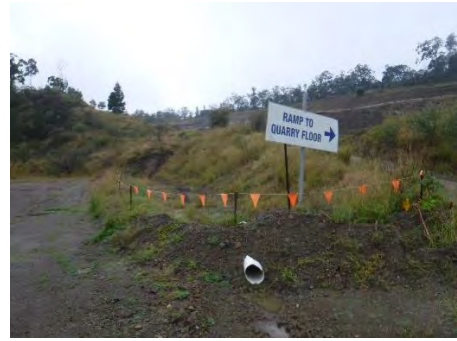
3.	Quarry floor	A series of additional control sumps and drains have been formed to maintain the diversion of runoff to the central dam.	Continue to implement, alter or upgrade diversions and other control structures in response to changes in conditions or operations.

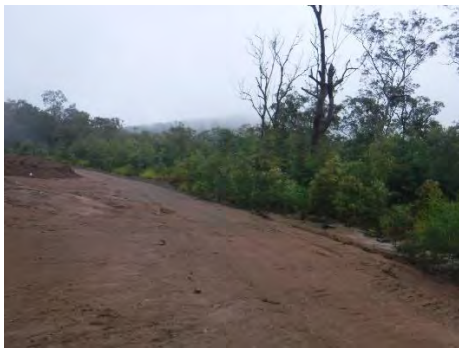
ISSUE NO.	LOCATION	ISSUE/MATTER	RECOMMENDATION/COMMENT	PHOTOGRAPH
4.	Revegetation on the control bund near the north-western highwall.	The revegetated area on the control bund near the north-western highwall was inspected. The vegetation structure is now well-established with a wide variety of native species that are growing vigorously.	The vegetation in the area has good canopy cover and surface cover, with minimal weed present. No actions required beyond targeted, periodic weed suppression

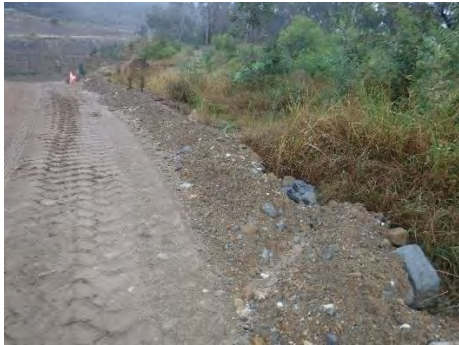
5.	Western Ramp	An access ramp has been established above the north-west high wall. A series of scribed mitre drains have been provided to drain runoff from the ramp to the adjacent vegetation.	Continue to implement drainage measures to reduce flows to control dams, minimise erosion in drainage lines and improve runoff water quality.

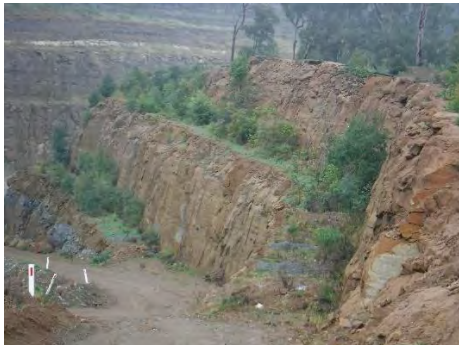
6.	North-western benches.	The benches formed during the north-west extension of workings have native vegetation vigorously establishing in the area.	No actions required beyond targeted, periodic weed suppression

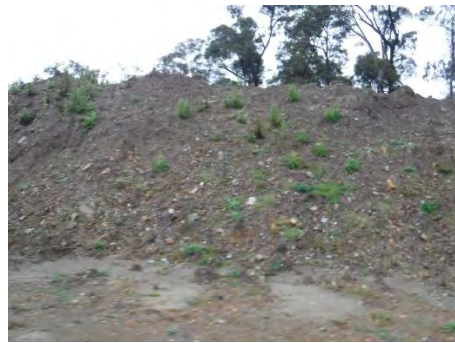
ISSUE NO.	LOCATION	ISSUE/MATTER	RECOMMENDATION/COMMENT	PHOTOGRAPH
7.	Eastern control bund	The control bund above the eastern highwall area was inspected. The majority of the area is vegetated however, an operational stockpile of general fill has establishing weed outbreaks.	As discussed, we recommend this area is scheduled for treatment during the next round of targeted, periodic weed suppression.

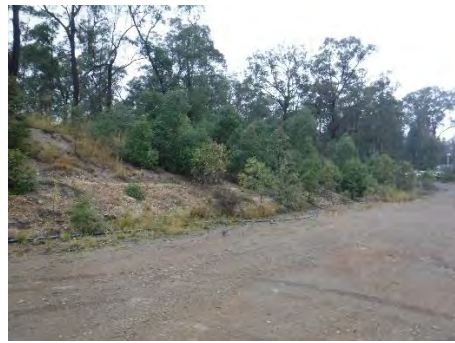
8.	Southern control bund	The control bund above the southern highwall area was inspected.	The southern section has well-established natives and low weed occurrence. No actions required.

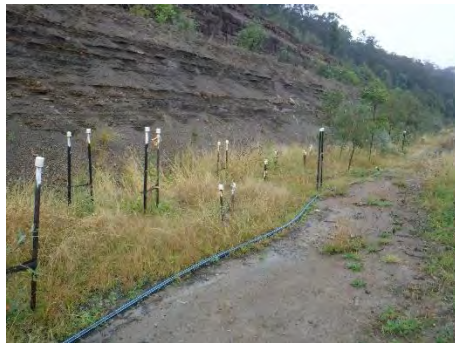
9.	Revegetation on the southern highwall benches.	The southern highwall benches were inspected. The native species on Benches 1 & 2 are continuing to establish, and additional tube stock plantings have been planted on Bench 3.	The area was recommended for targeted, periodic weed suppression.

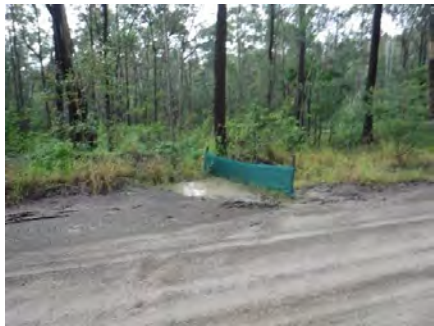
ISSUE NO.	LOCATION	ISSUE/MATTER	RECOMMENDATION/COMMENT	PHOTOGRAPH
10.	Sediment traps on the main access road.	As noted on previous inspections, a series of well-maintained sediment traps control run-off from the main access road.	As discussed, the traps should continue to be monitored and be desilted and reinstated as required.

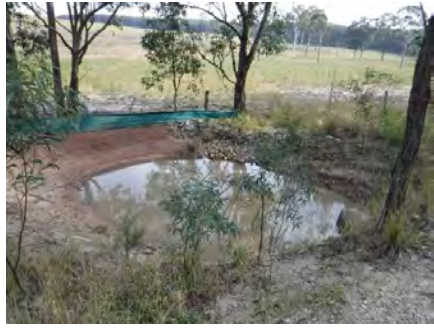
11.	Drainage structures on the western boundary at Main Gate.	The rock lined drainage system, sediment sumps and rock diffuser were inspected. The structures remain in good condition and are functioning correctly.	No actions required.

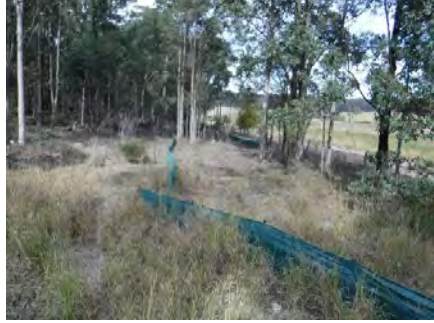
12.	Western boundary downslope from sealed access road.	As noted on previous inspections, a series of sediment fence controls have been established along the western boundary and mid-slope below the sealed access road.	The stands of sediment fence were inspected and continue to be in good condition and are well maintained.

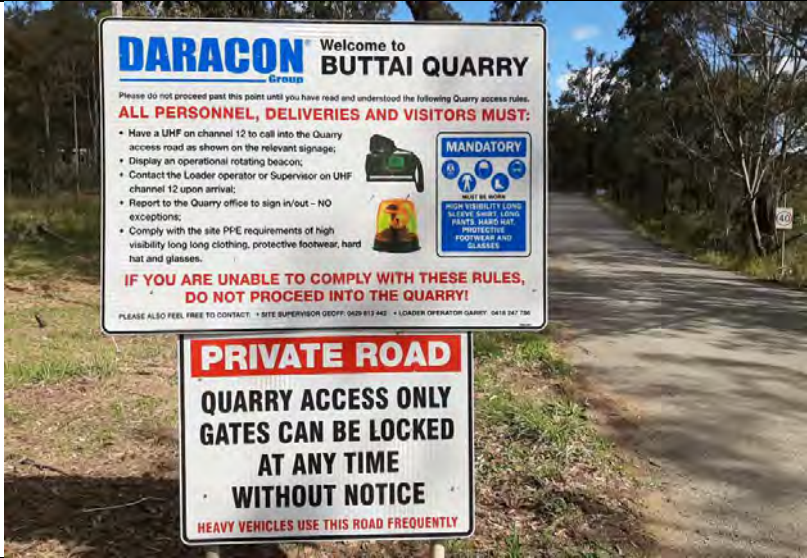
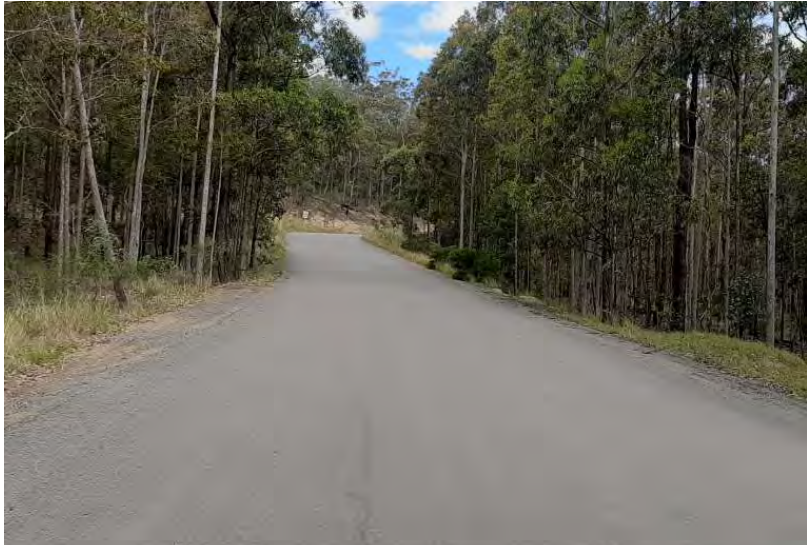
2	Access off Old Buttai Road and gate

N/A	<p>Nil – Appropriate signage is present and visible at the main entry. Additionally, the bitumen sealed sections of the access road are well maintained reducing the risk of erosion and dust generation.</p> <p>- Positive observations.</p>	N/A
---	-------------------------------------	--	-----	---	-----

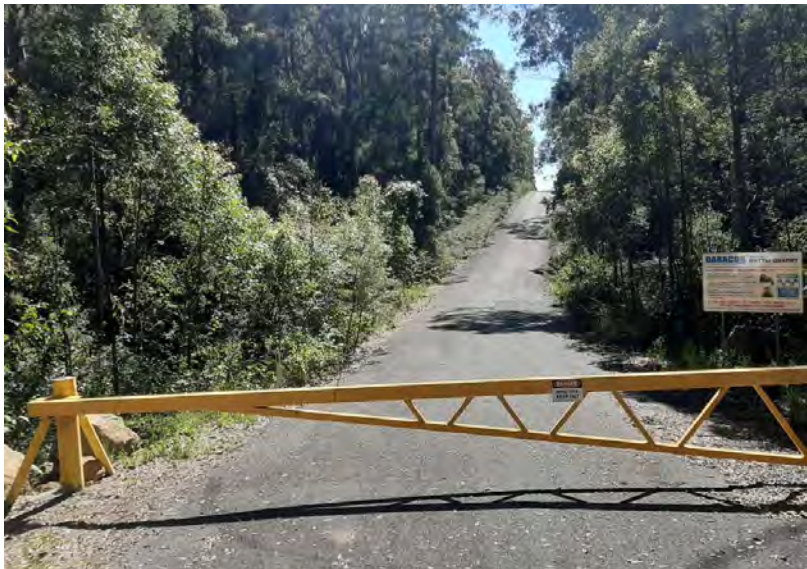
3	Unused access off George Booth Dve

High	<p>A recent instance of trespassing occurred with the security camera and alarm being activated at the top of the quarry. Police were notified and attended sometime later with no people found on site. Daracon gate was resecured and locks replaced. Subsequent inspection of the access road to George Booth Dve showed substantial evidence of illegal access and dumping.</p>	<p>NPWS were notified of the illegal access and dumping and we were informed that NPWS currently have covert cameras installed in this area and have recently been issuing fines.</p>
---	------------------------------------	--	------	---	---

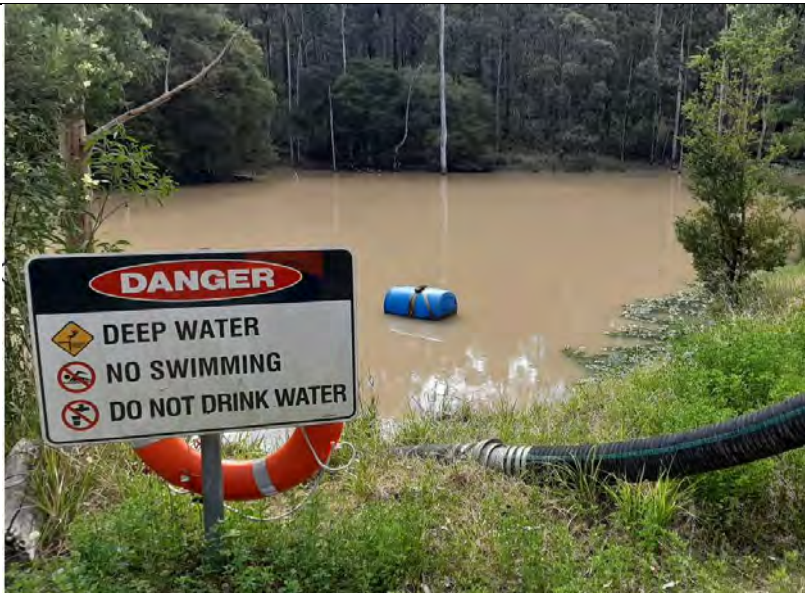
4	Dam #4

N/A	Nil –Dam #4 is carefully managed to ensure there is enough water available for the site to operate effectively whilst also ensuring that water does not discharge from Dam #4 – Positive observations.	N/A
5	Dam #1 and Dam #2

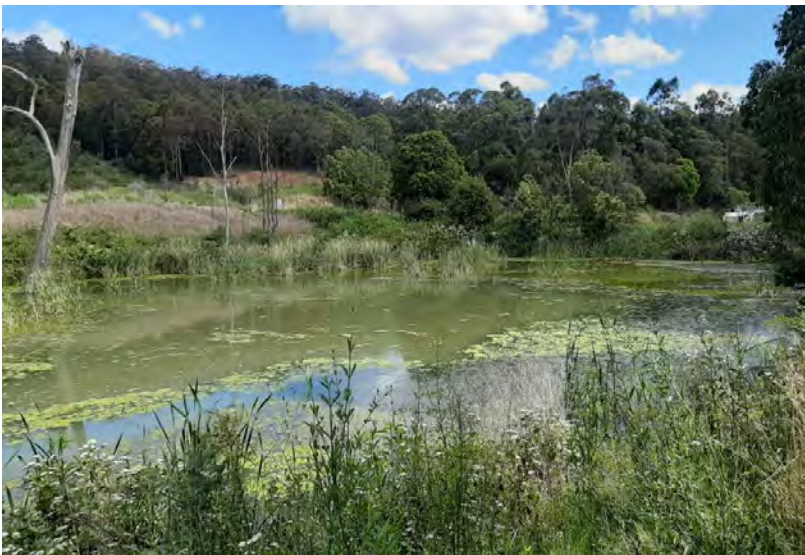
N/A	Nil – Dam #1 and Dam #2 are primarily used for operational purposes (pugmills and crushing equipment) with the water levels managed appropriately - Positive observation.	N/A

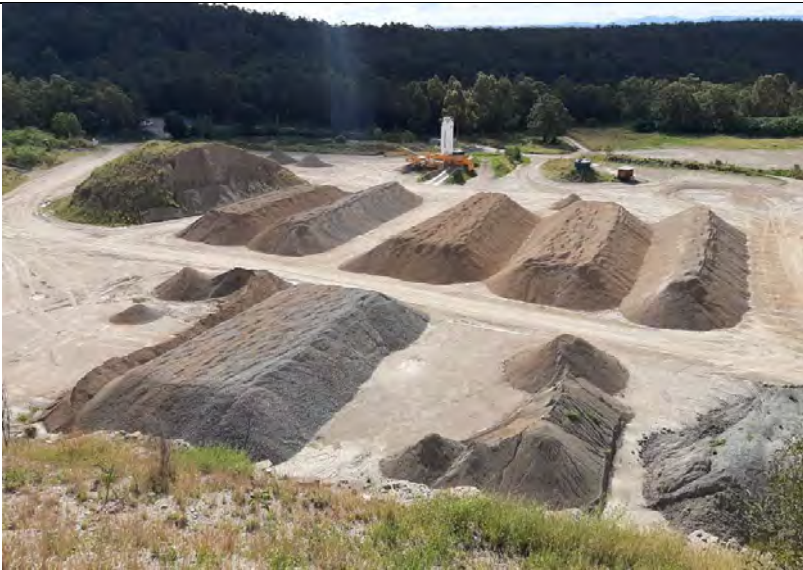
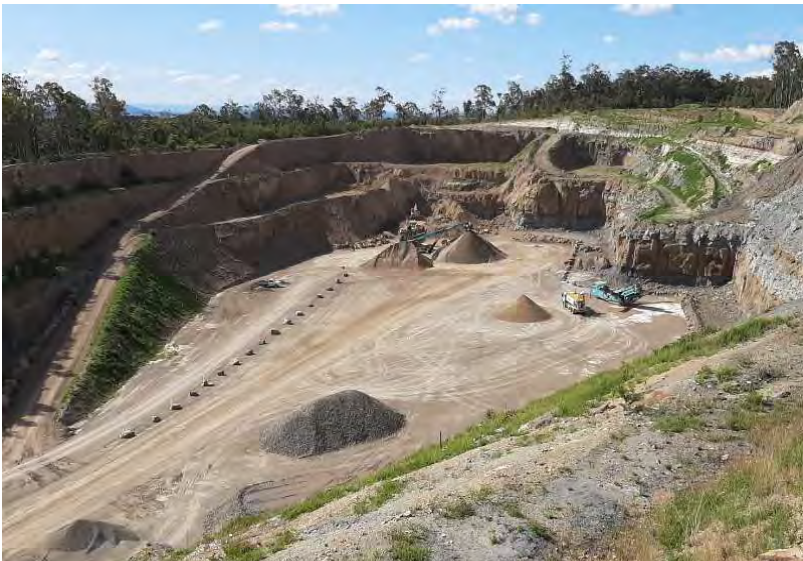
6	Stockpile and crushing areas

N/A	Nil – Both the stockpile and crushing areas were tidy with no evidence of dust generation at the time of inspection – Positive observations.	N/A
---	------------------------------	--	-----	--	-----

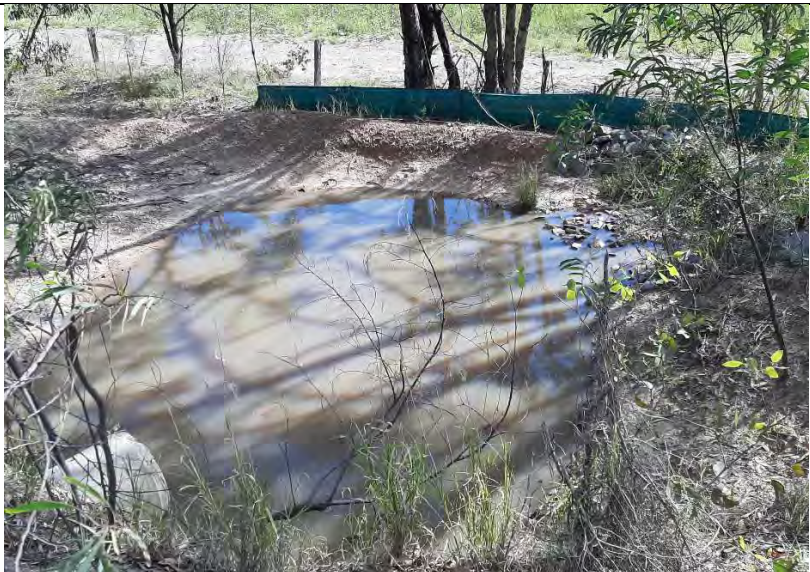
7	Sediment basin adjacent to main entrance

N/A	Nil - At the time of inspection, the sediment basin and fence was operating effectively at this location - Positive observation.	N/A
8	Rehab' planting on the upper western edge of the quarry pit "Lot 76" area

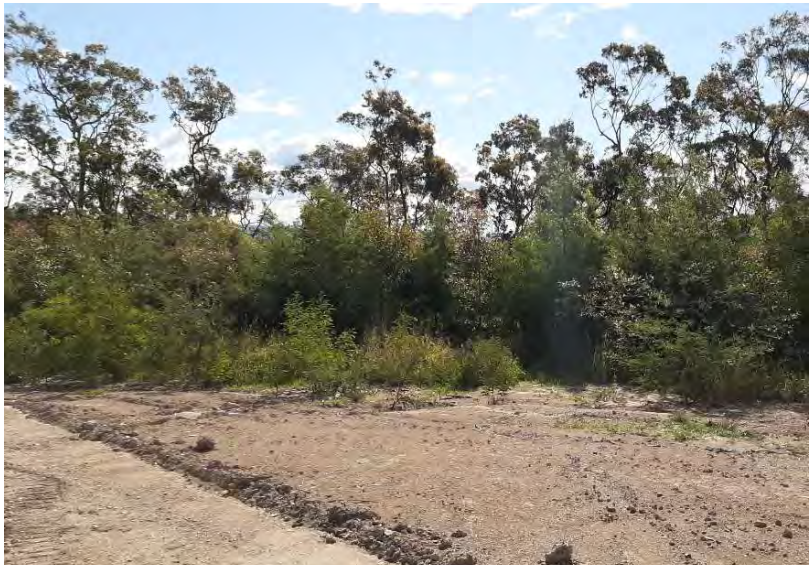
N/A	Nil – The revegetation work previously completed in this area is progressing well – Positive observation.	N/A

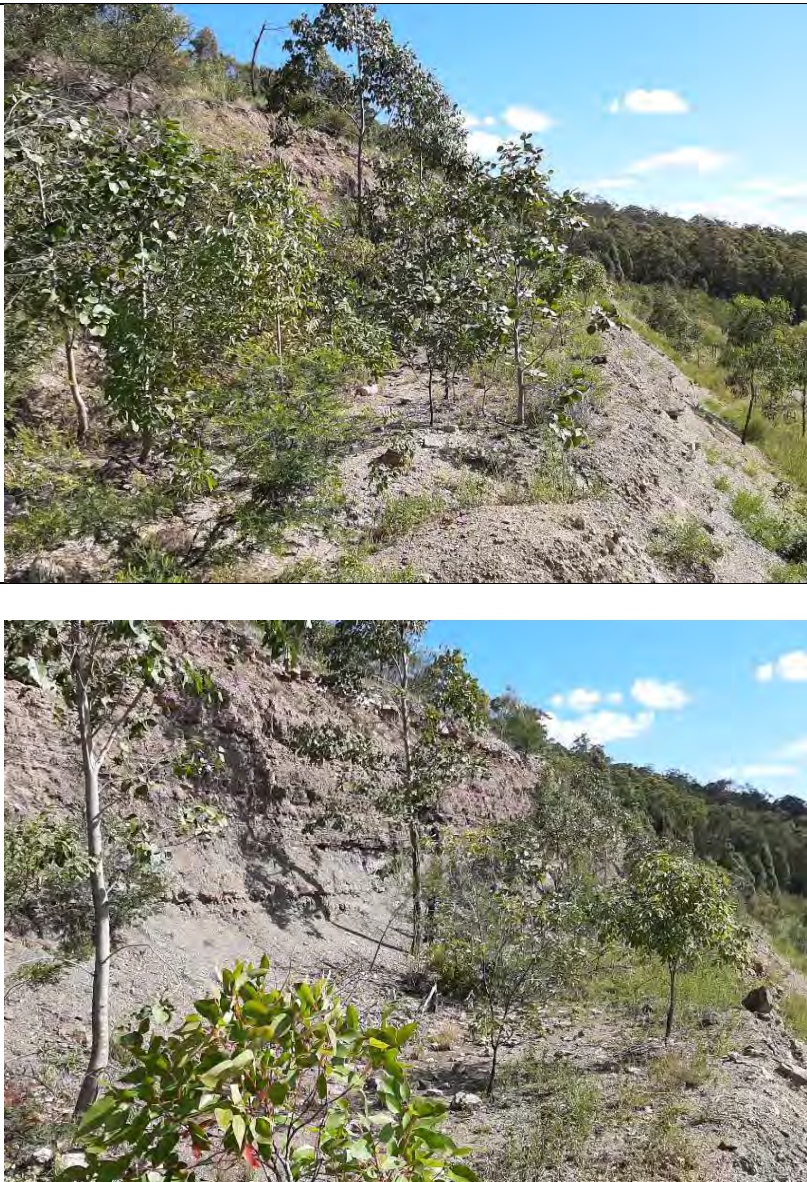
9	Bench #2 rehab' work

N/A	Nil – As before, Bench #2 rehabilitation continues to progress and evolve with the older species selectively dying off and being replaced with natural regeneration over time – Positive observation.	N/A
---	----------------------	---	-----	---	-----

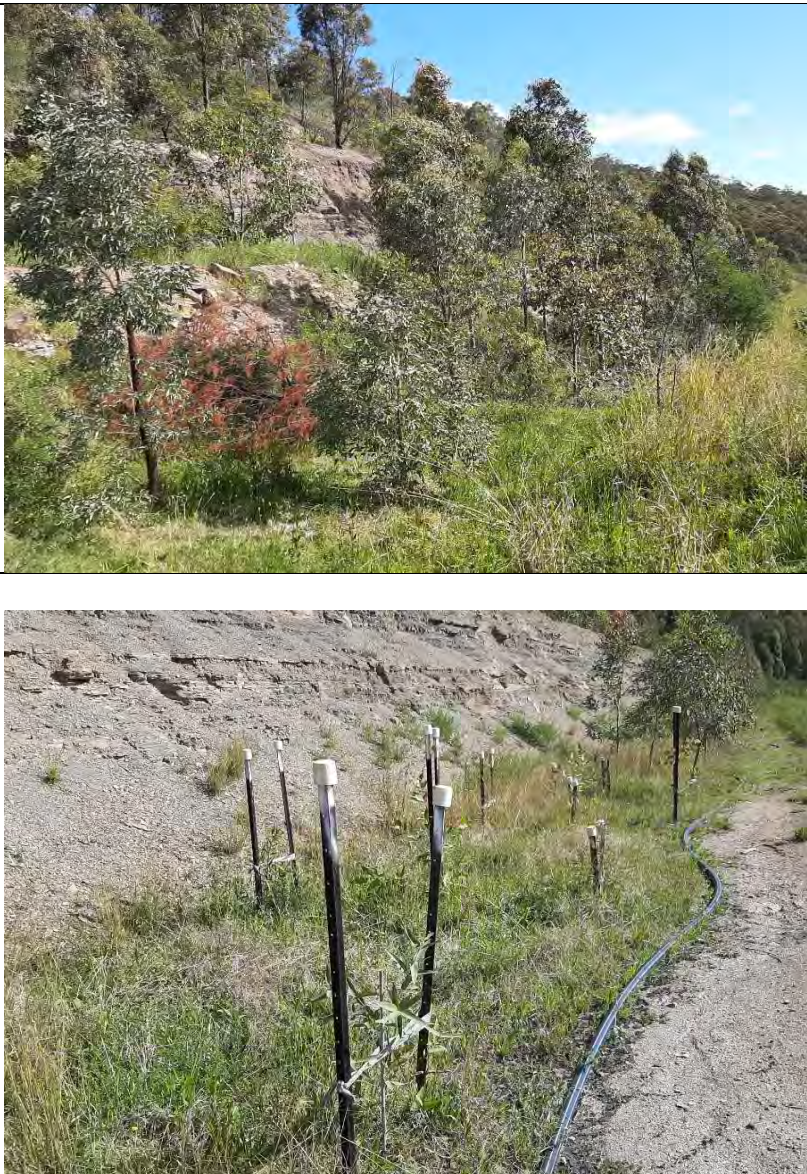
10	Bench #3 rehab' work

N/A	<p>Nil – Ongoing inspection and maintenance of the rehabilitation planting is continuing along Bench #3. The additional mature planting that occurred in early March 2020 survived through the winter period albeit with minimal growth due to the cooler temperatures – Positive observations.</p>	N/A
----	----------------------	---	-----	---	-----

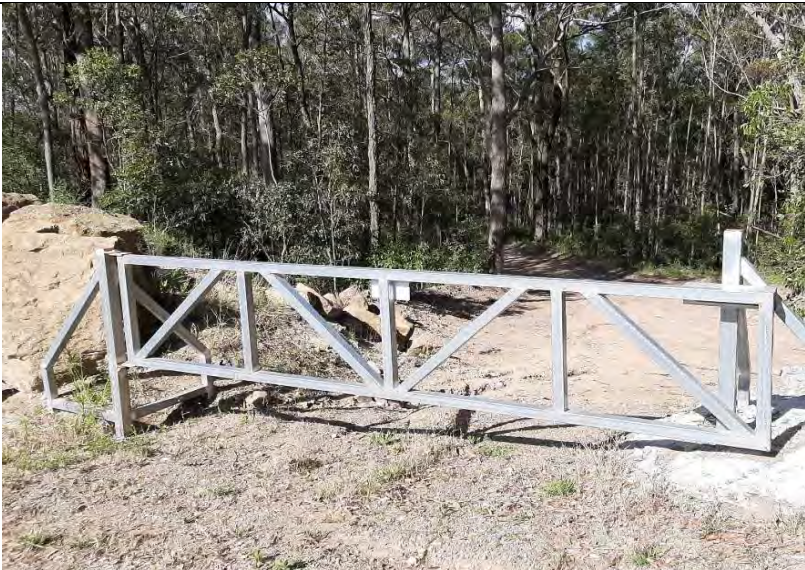
11	New gate installed for improved Rural Fire Service (RFS) access at top of quarry

N/A	Nil – The additional gate installed at the top of the quarry to improve RFS access to this part of the site is still functional and available if required – Positive observation.	N/A
12	Panoramic image of the quarry

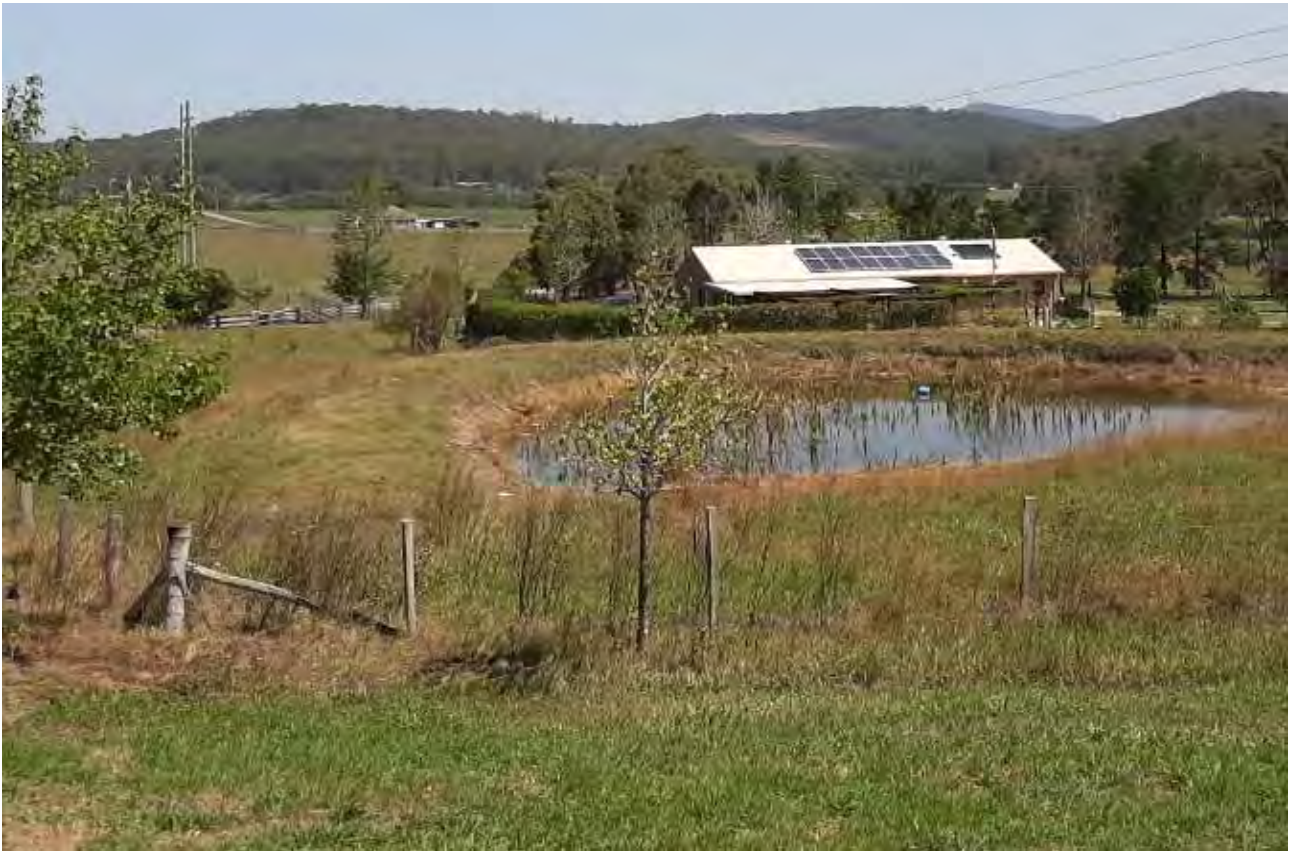
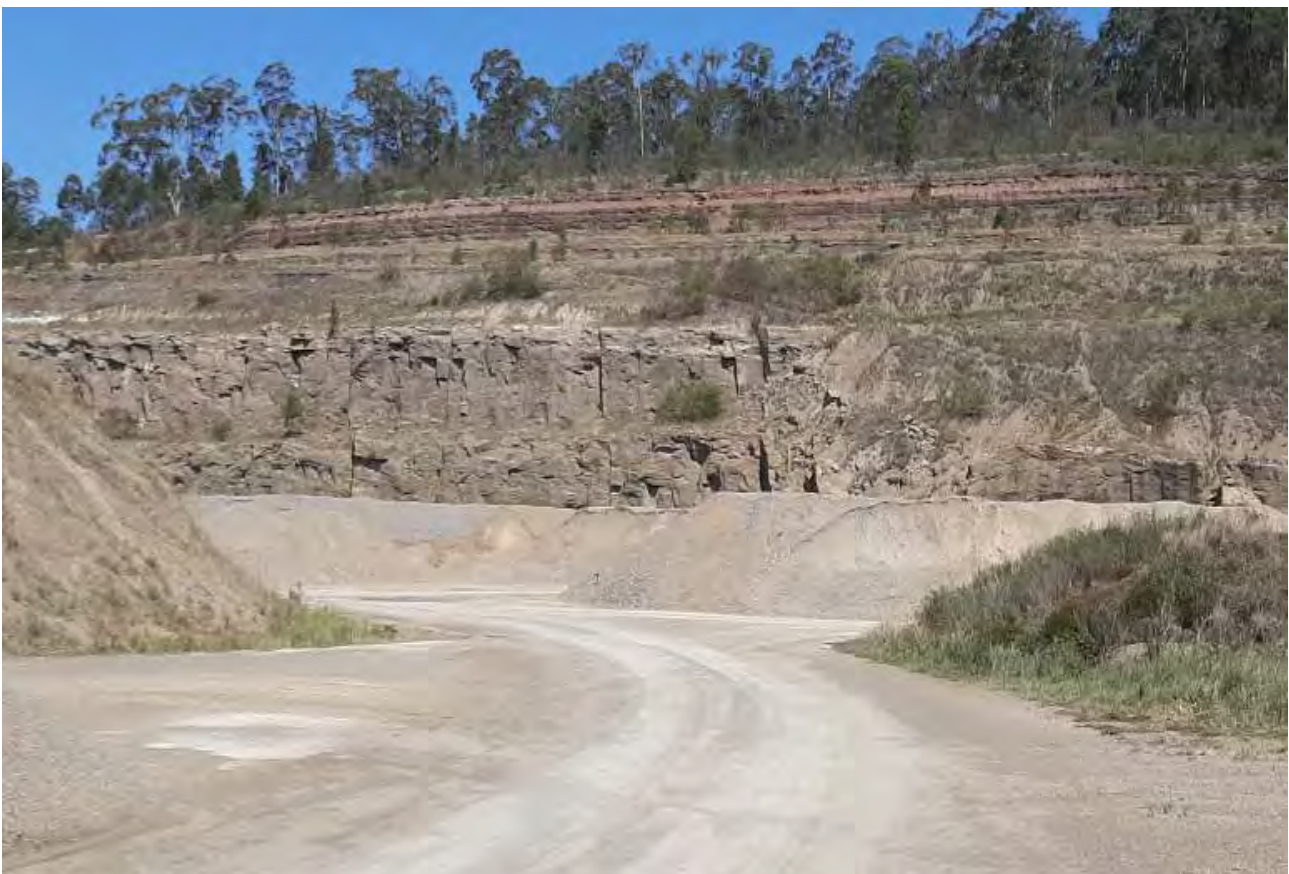
Rehabilitation images of the quarry (Lings Rd and quarry site) – January 2020

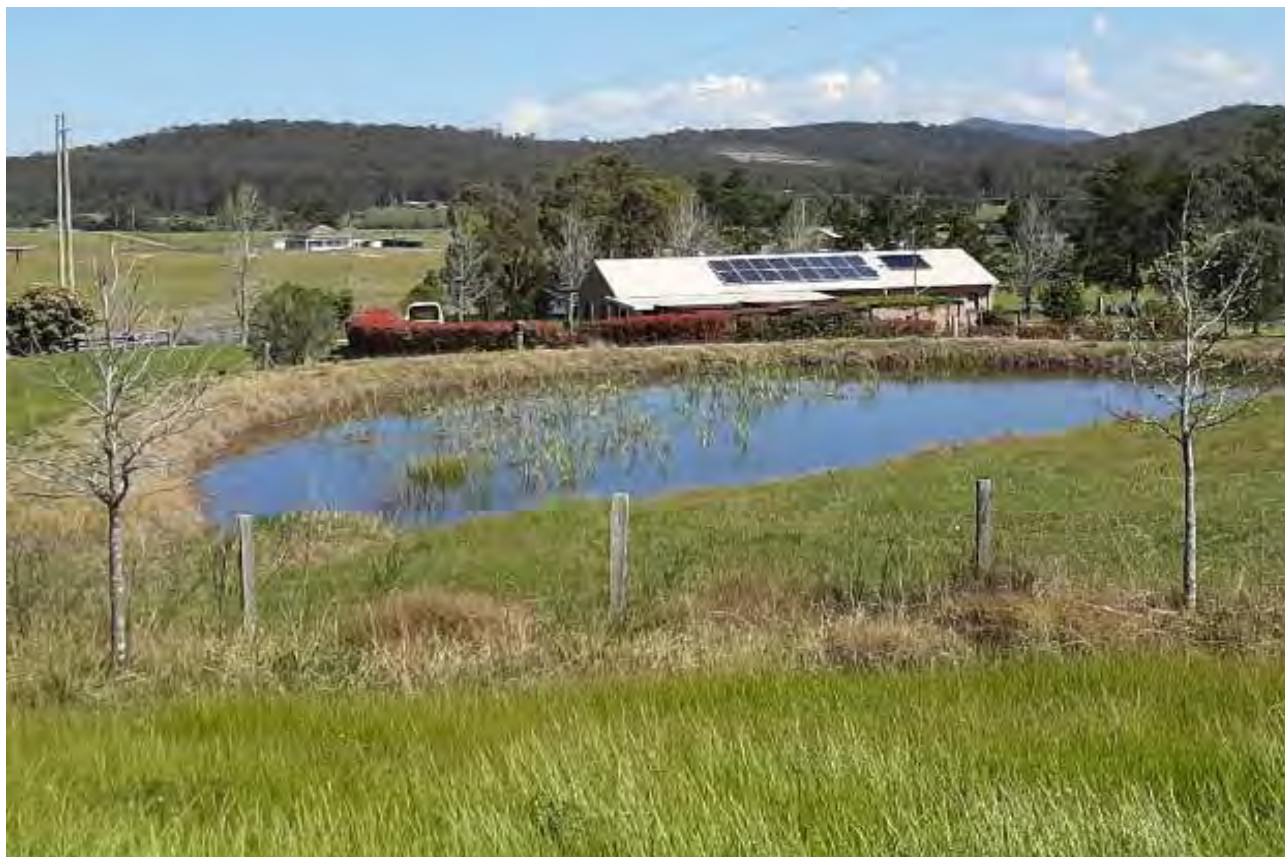
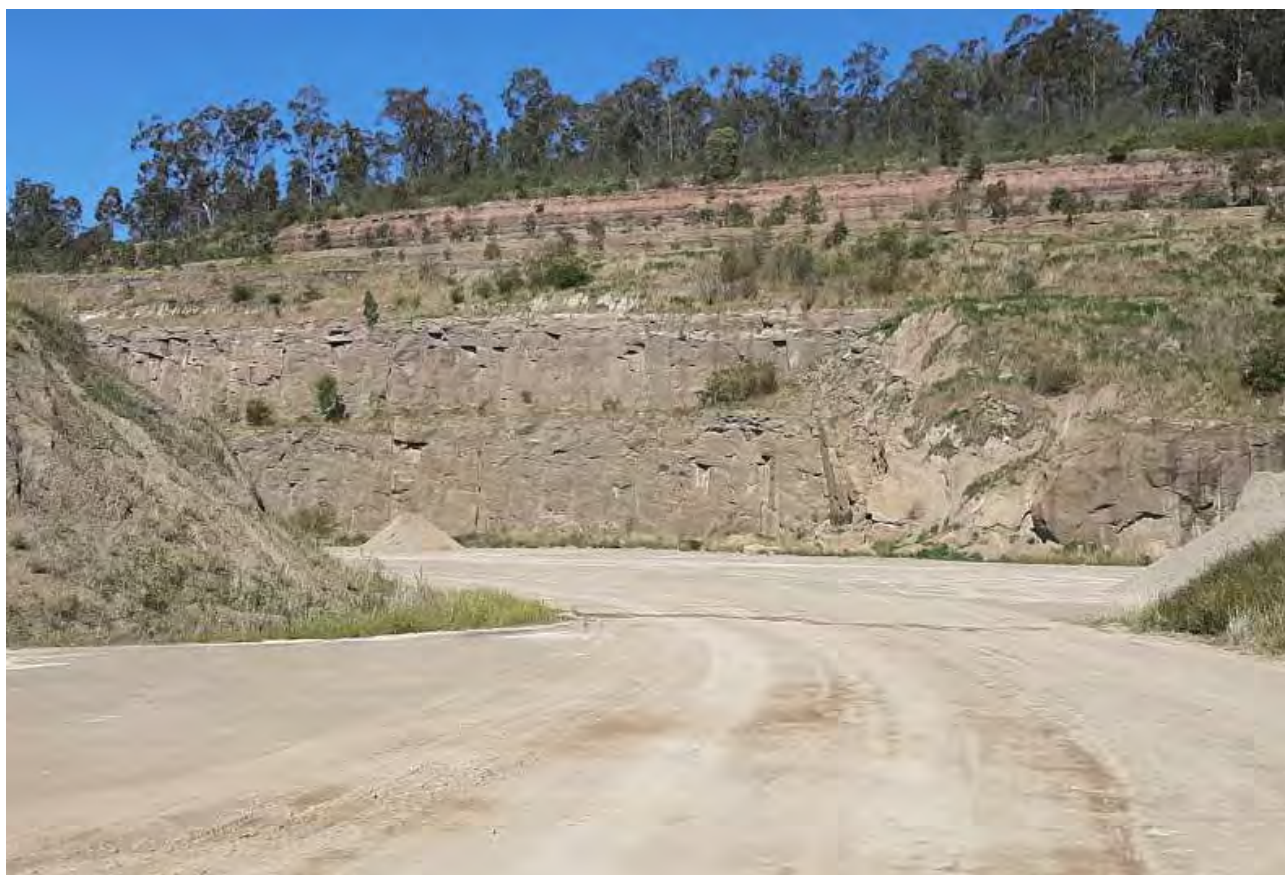
Rehabilitation images of the quarry (Lings Rd and quarry site) – September 2020

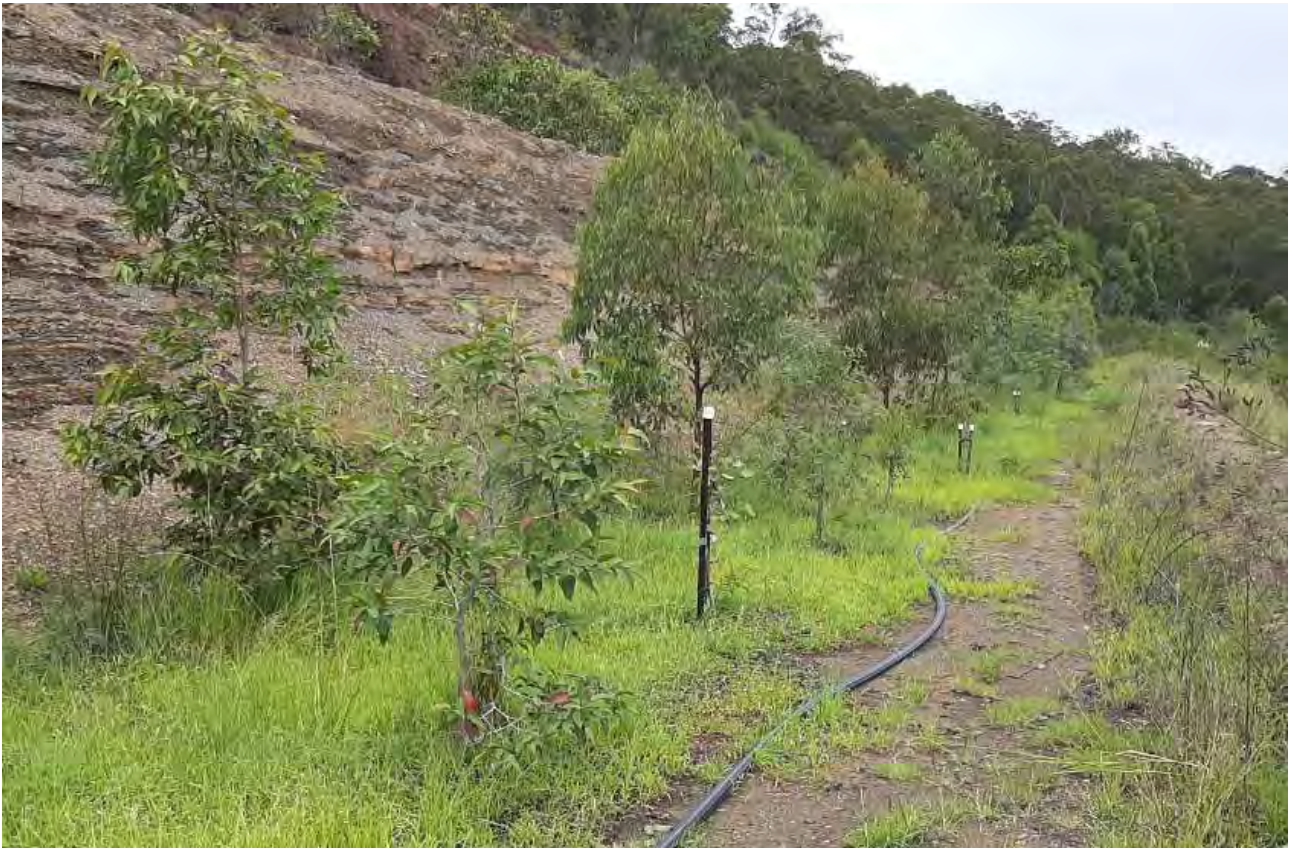
Buttai Quarry Bench #3 rehabilitation – March 2020
