BUTTAI QUARRY

ANNUAL ENVIRONMENTAL MANAGEMENT REPORT (AEMR)

2020

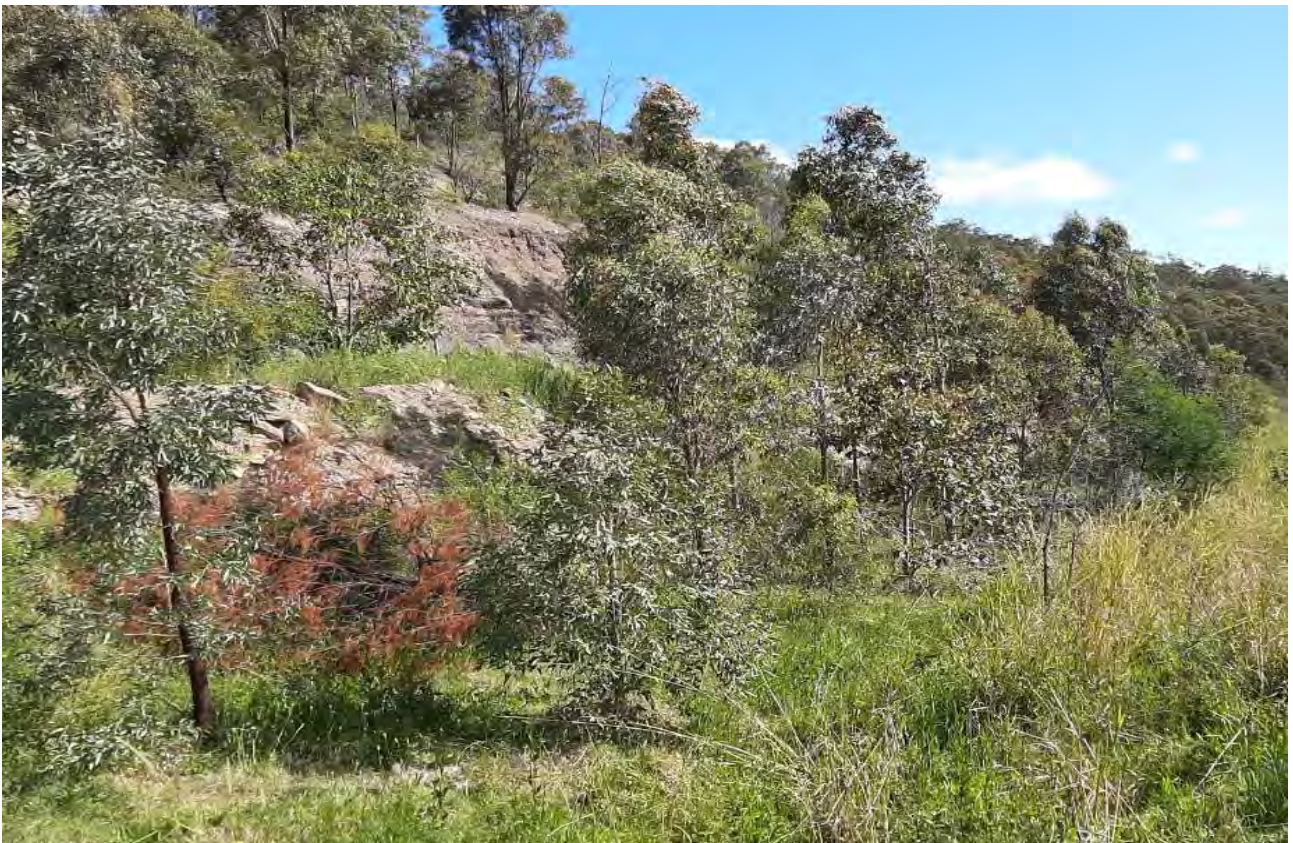
***Buttai Quarry Bench #3 rehabilitation – September 2020***
