BUTTAI QUARRY

ANNUAL ENVIRONMENTAL MANAGEMENT REPORT (AEMR)

2019

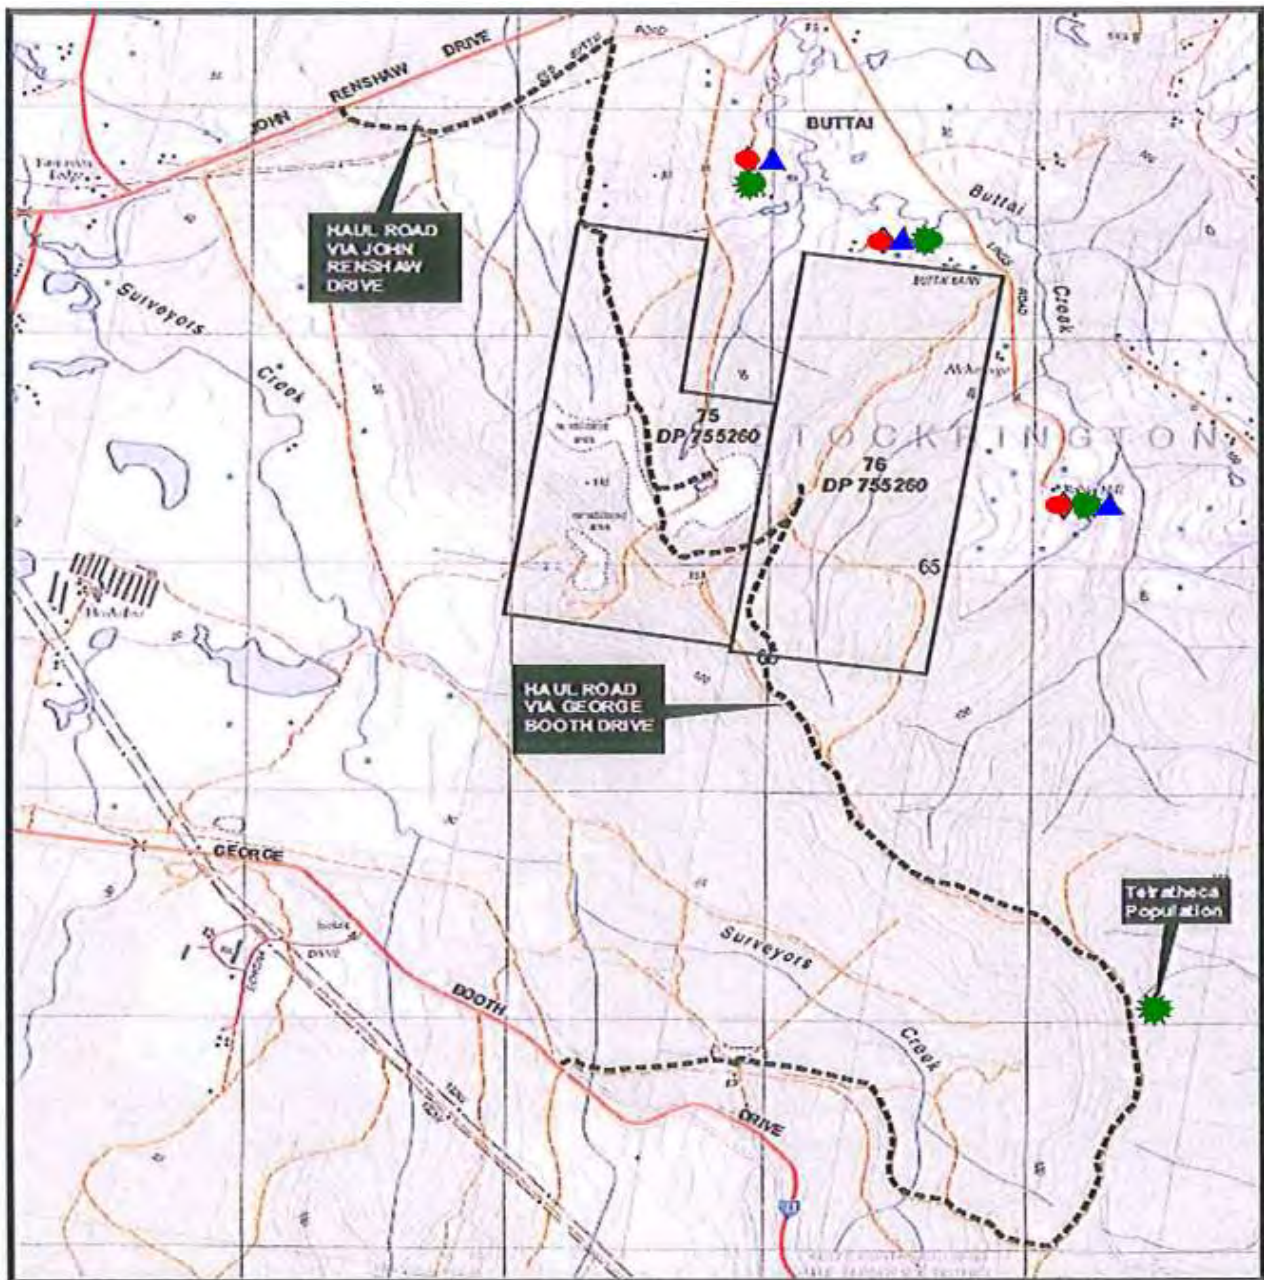
Figure 2: Blast Monitoring Locations

The Blast Monitoring program requires monitoring to take place at specified locations as shown in **Figure 2**.

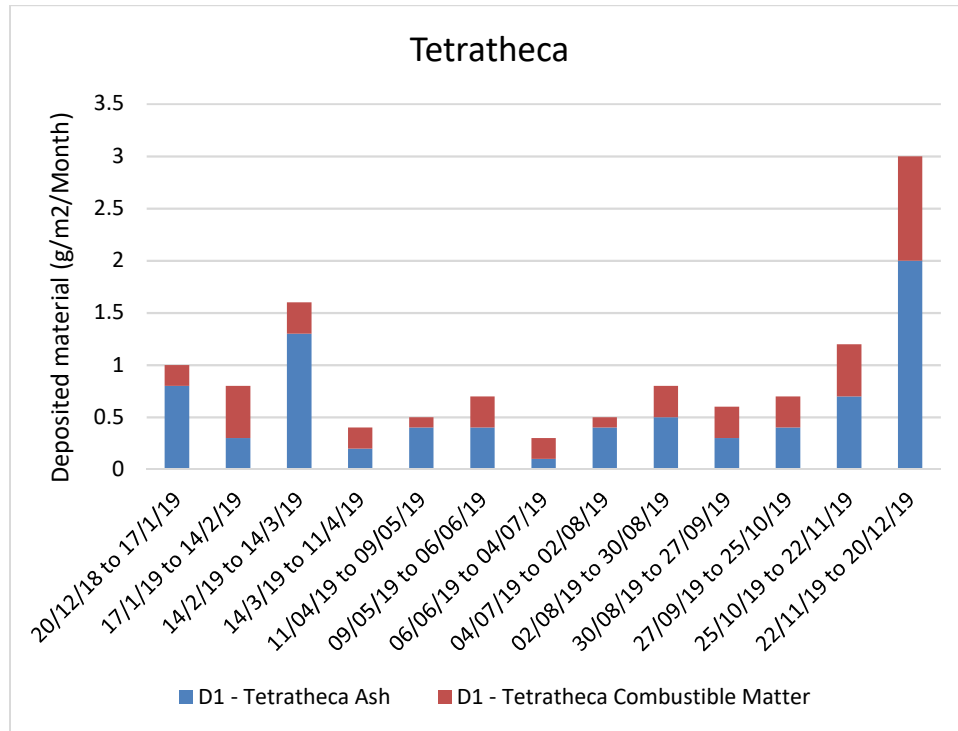
4.3.5.1 Tetratheca

As shown in the tables and graphs above, all of the Dust Deposition Gauge (DDG) monitoring results except for Buttai Barn were well below the 4g/m²/month (based on the annual average) threshold.

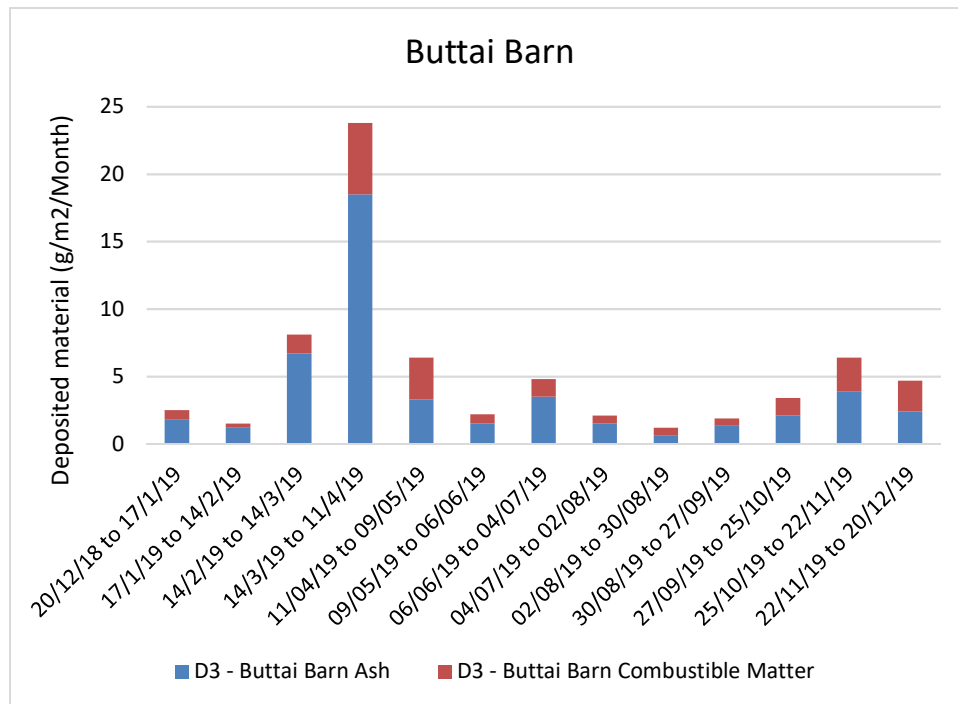
4.3.5.3 Buttai Barn

For the elevated DDG results obtained at “Buttai Barn”, we’ve compared them to the results obtained at “Buttai Barn #2” and note that there are a number of instances where both “Buttai Barn” and “Buttai Barn #2” coincided with elevated DDG results. We therefore undertook a more detailed investigation into the likely cause of the elevated DDG results and discovered the following information:

- Substantial evidence of ground disturbance activities occurring adjacent to Buttai Barn #2 DDG (non-quarry related);
- It appears that the land owner had undertaken some additional vegetation removal / earthworks for reasons only known to them;
- Ongoing drought conditions have inevitably contributed to elevated regional DDG results;
- For the period January 2019 to December 2019, the quarry was abnormally quiet from a production and sales perspective;

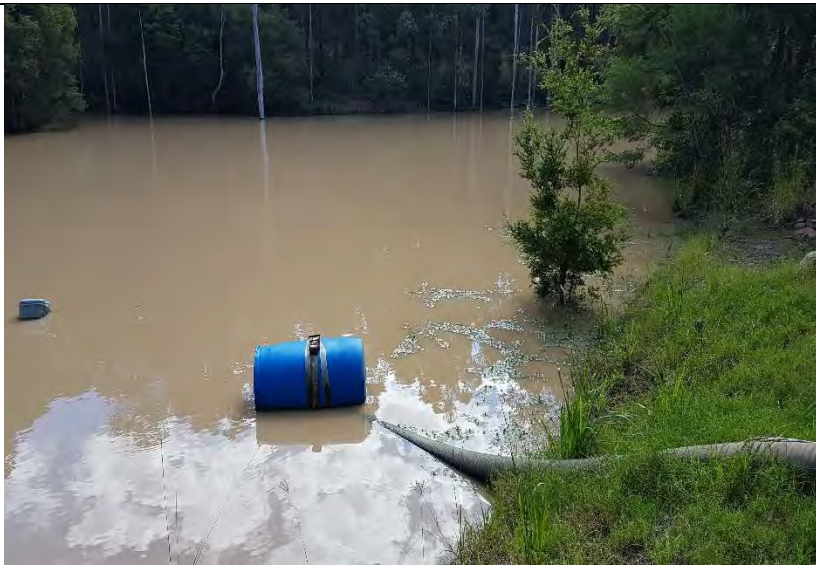
4	Lower Dam (Basin #4)

N/A	Nil – No issues identified at Basin #4. All water management processes are being implemented as required – Positive observation.	N/A
5	Sediment control fences along the main access road	 	N/A	Nil - The sediment control fences are in good condition and operating effectively – Positive observation.	N/A

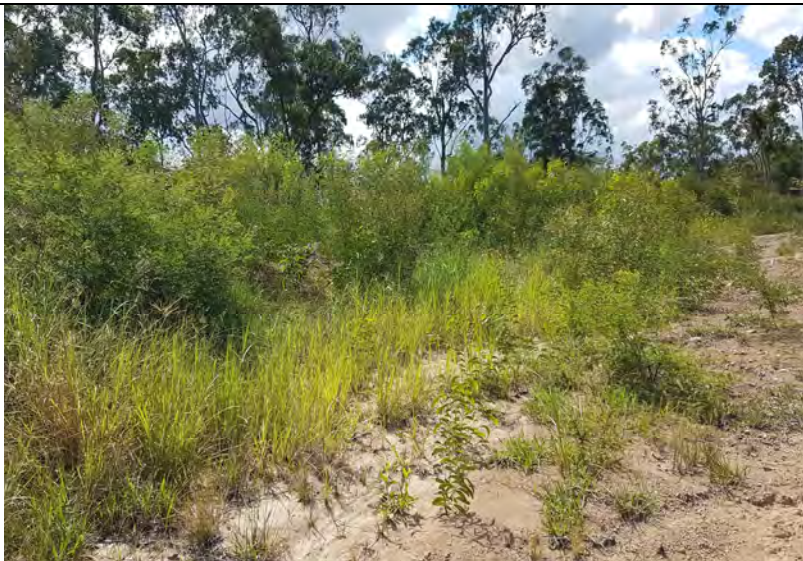
7	Bund on the upper western edge of the quarry pit "Lot 76" area

N/A	Nil – The revegetation work previously completed in this area is progressing well – Positive observation.	N/A
8	Various Quarry access roads and laydown areas

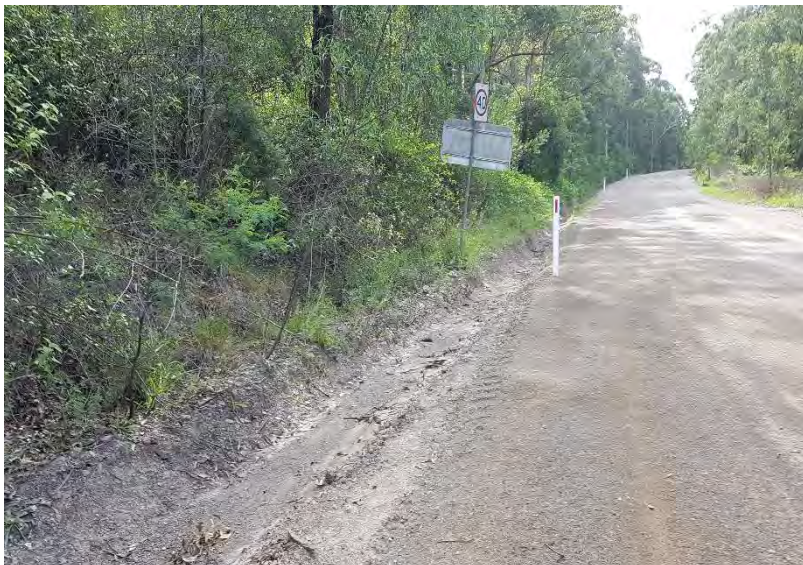
N/A	Nil - At the time of inspection, the various Quarry access roads and laydown areas had recently been regraded and desilted as required - Positive observation.	N/A

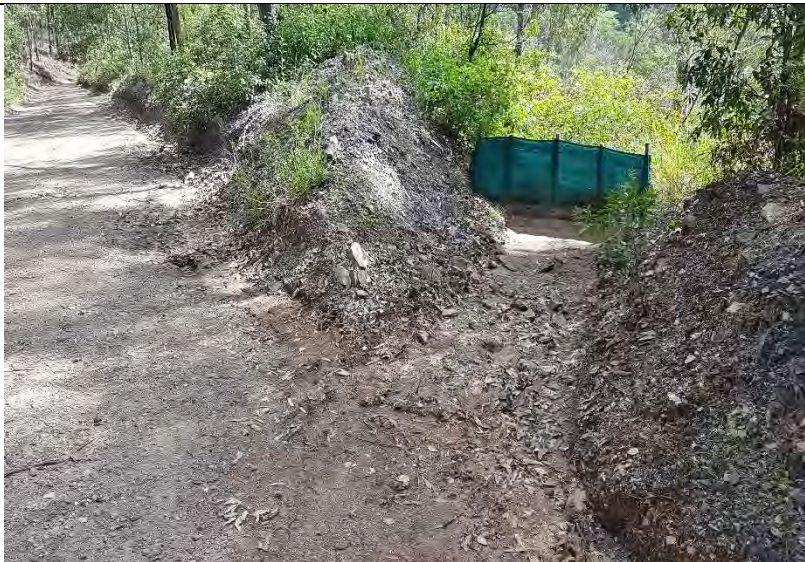
9	Back ramp

N/A	Nil – The sedimentation controls installed at strategic locations along the back ramp have recently been desilted and were operating effectively at the time of inspection – Positive observation.	N/A
10	Adjacent to the main quarry entrance

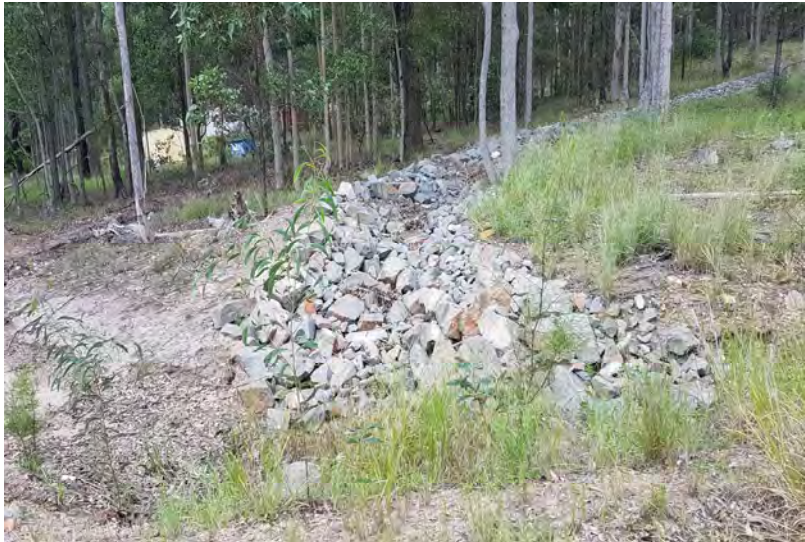
N/A	Nil – Rock lined drainage channel and sediment controls adjacent to the main access gate are all effective and well maintained - Positive observation.	N/A

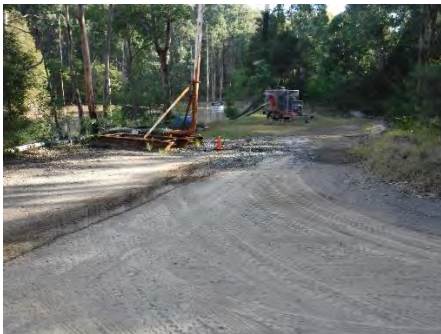
1.	Lower sediment basin and water cart loading area	The access road, standpipe and lower control dam was inspected. The controls in the area are well-established and maintained.		Continue to monitor, desilt and repair controls as required.

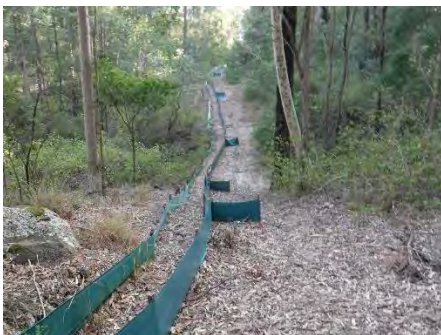
2.	Controls downslope from the north-western highwall.	As noted previously, sediment fencing had been installed downslope from the north western highwall, with an additional stand of sediment fence installed parallel and upslope from the older fence.		The fences remain in generally good condition, with some sections requiring re-securing to support posts or re-trenching/weighting at the tow. Continue to monitor, repair/replace controls as required.

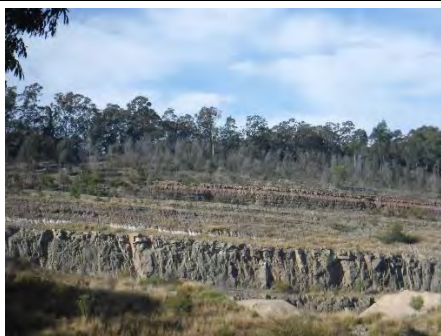
3.	Revegetation on and above Bench 1 of the southern highwall.	Significant generational dieback of predominantly <i>Acacia</i> species was noted on Bench 1 when viewed from the quarry floor.		See Point 4

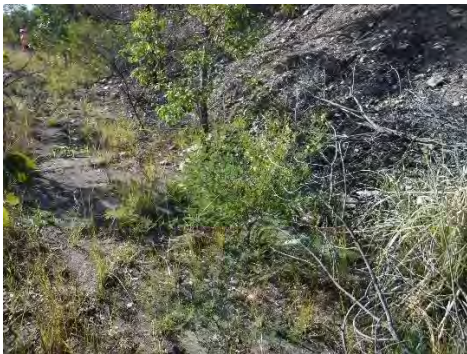
ISSUE NO.	LOCATION	ISSUE/MATTER	RECOMMENDATION/COMMENT	PHOTOGRAPH
4.	Revegetation on and above Bench 1 of the southern highwall.	As noted above, significant generational dieback of predominantly <i>Acacia</i> species was noted on Bench 1 which has reduced the vegetative canopy. The generational dieback of is common to many short-lived <i>Acacia</i> species.	A closer inspection of the upper benches revealed that there are an abundant number of naturally-sown seedlings and saplings of various <i>Acacia</i> species, together with a variety of other native species.

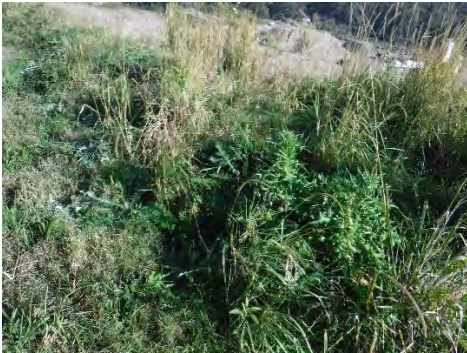
5.	Weed control on the rehabilitation areas on upper benches of the southern highwall.	A few minor weed outbreaks were noted along the revegetated benches, including Scotch Thistle, Castor Oil plant and a few isolated Pampas Grass specimens.	As discussed, we recommend this area is scheduled for treatment during the next round of targeted, periodic weed suppression.

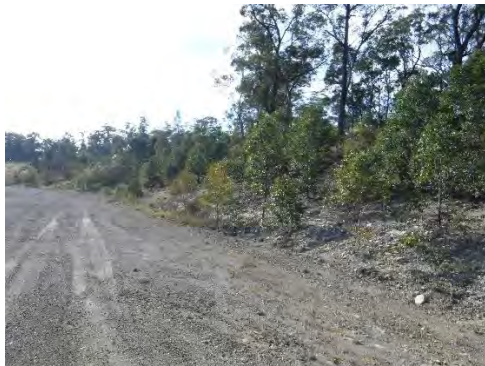
ISSUE NO.	LOCATION	ISSUE/MATTER	RECOMMENDATION/COMMENT	PHOTOGRAPH
7.	North east control bund	As noted during previous inspections, subsequent to the northward expansion of the quarry main workings, the control bund on the eastern area of clearing was being progressively formed and stabilised	One this inspection we noted the southern section has well-established natives and low weed occurrence. No actions required.

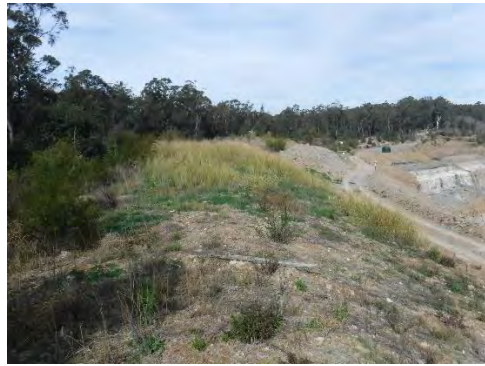
8.	North east control bund	The northern section of the bund has established ground cover, and native species are emerging in some areas.	As discussed, continue with periodic weed treatment. Some minor spoil stockpiles remain in the area, and following their removal, the areas should be progressively reformed, trimmed and stabilised by revegetation.

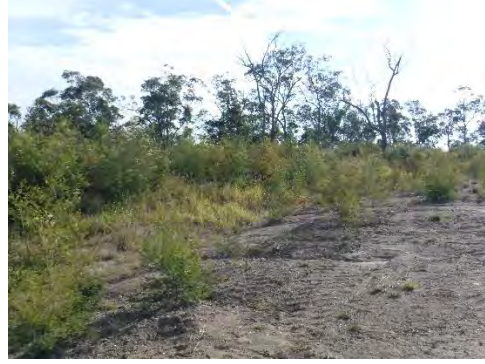
9.	Revegetation on the control bund near the north-western highwall.	As noted on the previous inspection, additional tube stock were planted on the control bund near the north-western highwall. The area was recommended for targeted, periodic weed suppression.	The native plantings in this area are well-established with a good canopy cover and surface cover. No actions required.

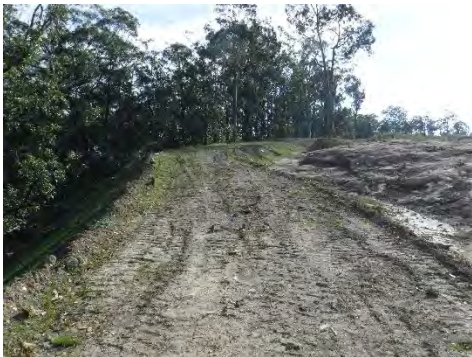
ISSUE NO.	LOCATION	ISSUE/MATTER	RECOMMENDATION/COMMENT	PHOTOGRAPH
10.	Revegetation on the control bund near the north-western highwall.	The control bund has recently been extended south along the north-western highwall. The extended bund ensures all runoff is directed to the quarry floor. The area has been topsoiled and recently seeded.	No actions required.

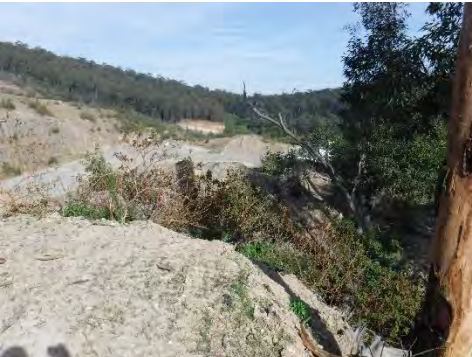
11.	Control bund near the north-western highwall.	We noted several outbreaks of Inkweed around the southern extent of the newly formed control bund.	As discussed, we recommend this area is scheduled for treatment during the next round of targeted, periodic weed suppression.

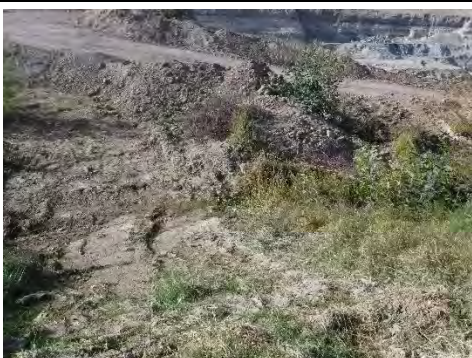
12.	Control bund near the north-western highwall.	One section of the drainage line along the toe of the control bund has an existing 'pinch point' in the drain invert.	We recommend that the placement of a rock check dam (cobble or ballast size), incorporating a central spill weir, in this location, will assist with coarse sediment capture, and is also in an accessible area for maintenance.

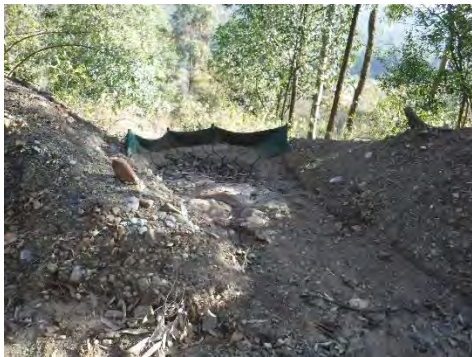
ISSUE NO.	LOCATION	ISSUE/MATTER	RECOMMENDATION/COMMENT	PHOTOGRAPH
13.	Sediment traps on the back ramp.	A series of sediment traps control run-off from the back ramp and generally the controls are well maintained.	As discussed, the traps should continue to be monitored and be desilted and reinstated as required.

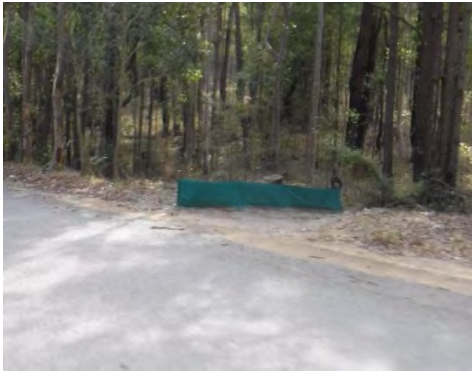
14.	Sediment traps on the main access road.	A series of sediment traps control run-off from the main access road and generally the controls are well maintained.	As discussed, the traps should continue to be monitored and be desilted and reinstated as required.

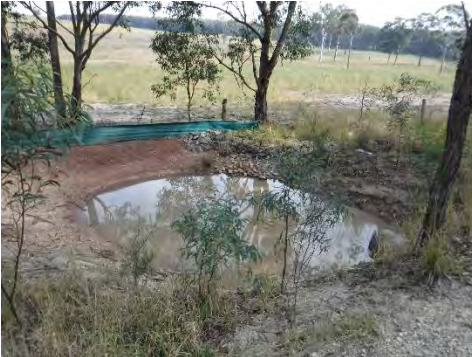
15.	Drainage structures on the western boundary at Main Gate.	The rock lined drainage system, sediment sumps and rock diffuser were inspected. The structures remain in good condition and are functioning correctly.	No actions required.

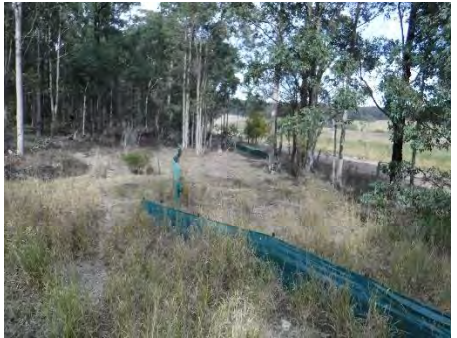
ISSUE NO.	LOCATION	ISSUE/MATTER	RECOMMENDATION/COMMENT	PHOTOGRAPH
16.	Western boundary downslope from sealed access road.	As noted on previous inspections, a series of sediment fence controls have been established along the western boundary and mid-slope below the sealed access road.	The stands of sediment fence were inspected and continue to be in good condition and are well maintained. No issues of erosion or scouring due to increased road run-off was noted.

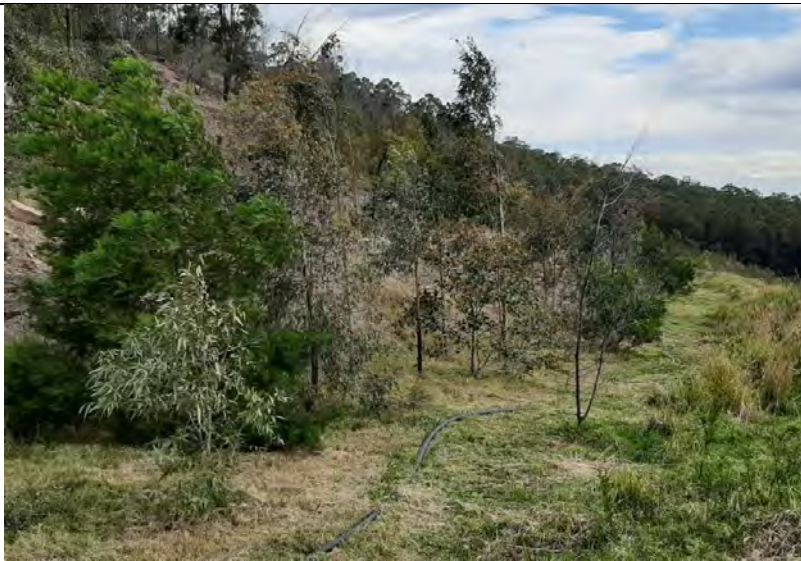
3	Bench #3 rehab' work

N/A	Nil - Bench #3 rehabilitation planting is progressing reasonably well with additional mature shrubs planted in April 2019. The quarry Supervisor continues to monitor and water as required – Positive observation.	N/A
---	----------------------	--	-----	---	-----

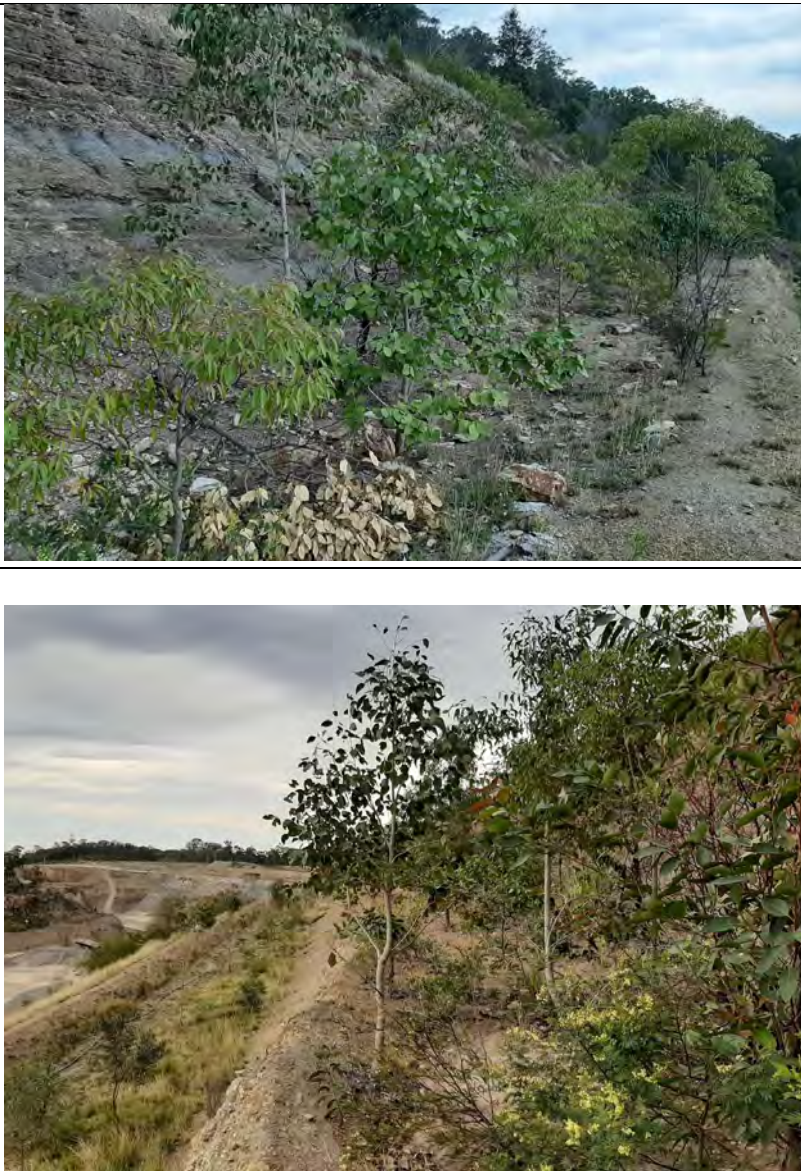
4	Bench #2

N/A	<p>Nil – Bench #2 rehabilitation planting is progressing reasonably well. Some of the older shrubs are expiring however there is substantial evidence of regrowth appearing despite the current drought conditions – Positive observations.</p>	N/A
---	----------	---	-----	---	-----

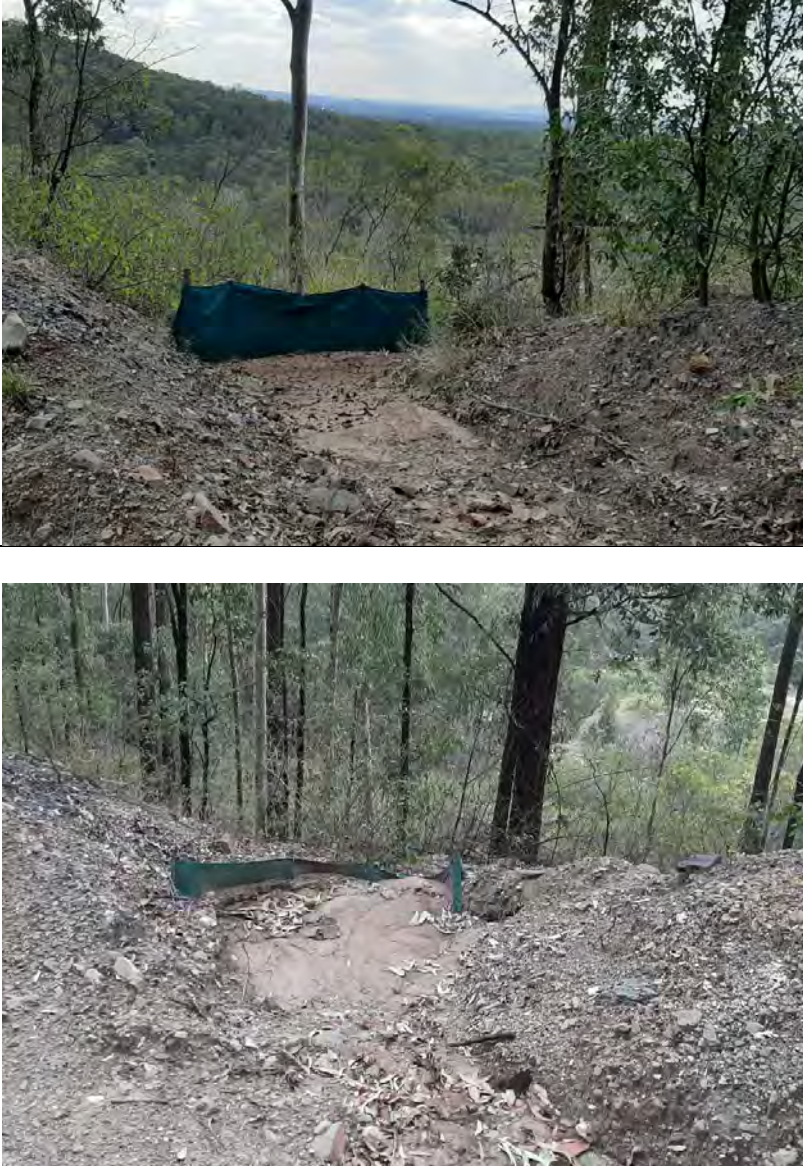
5	Back ramp

Low	<p>The majority of the sedimentation controls installed at strategic locations along the back ramp were operating effectively at the time of inspection. There were however one or two that required desilting as shown.</p>	<p>4-10-19</p> <p>GR</p>
---	-----------	---	-----	--	--------------------------

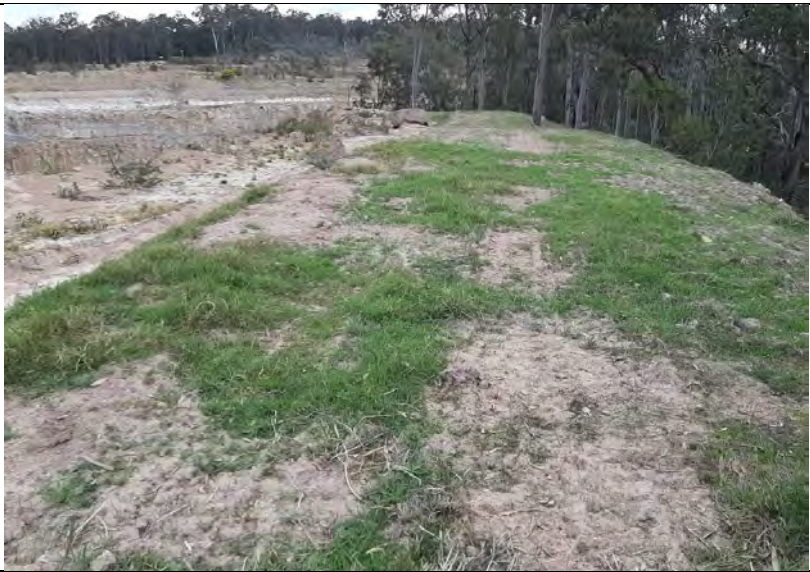
12	Rehab' work on the upper western side of the quarry pit "Lot 76" area

N/A	Nil – Following the completion of the re-shaping work on the upper western side of the quarry pit "Lot 76" area, the rehabilitation work completed as part of this task is progressing well as shown – Positive observation.	N/A
13	Quarry stockpile area

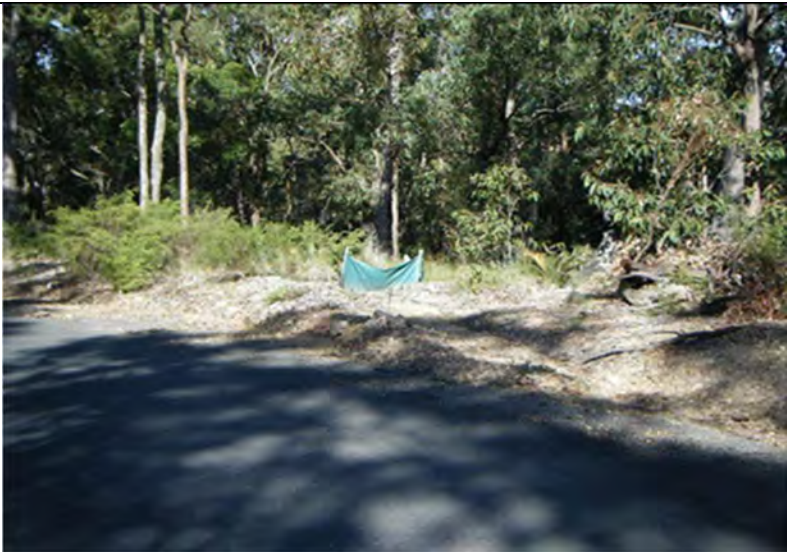
2	Access off Old Buttai Road and gate

N/A	Nil – The bitumen sealed sections of the access road are well maintained reducing the risk of erosion and dust generation. Appropriate signage is also present and visible - Positive observations.	N/A
3	Sediment controls along the western boundary of Lot 75 (near main access gate)

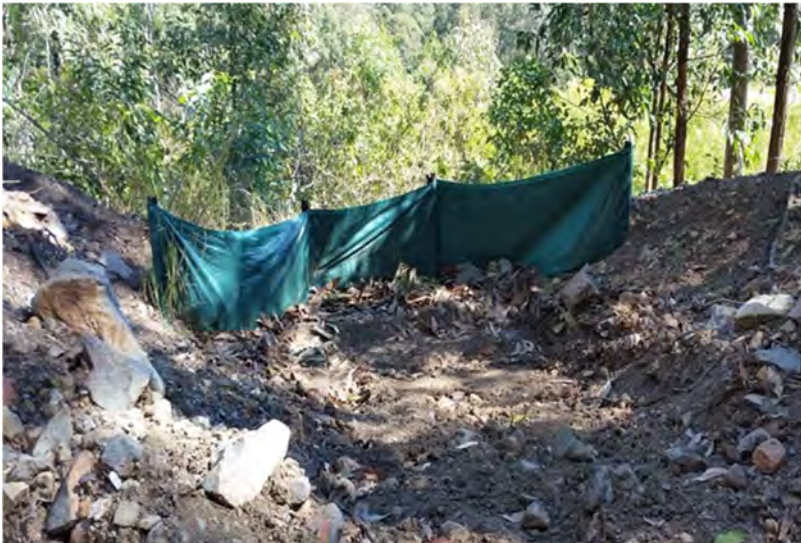
N/A	Nil - At the time of inspection, all sediment fences were intact and operating effectively – Positive observation.	N/A

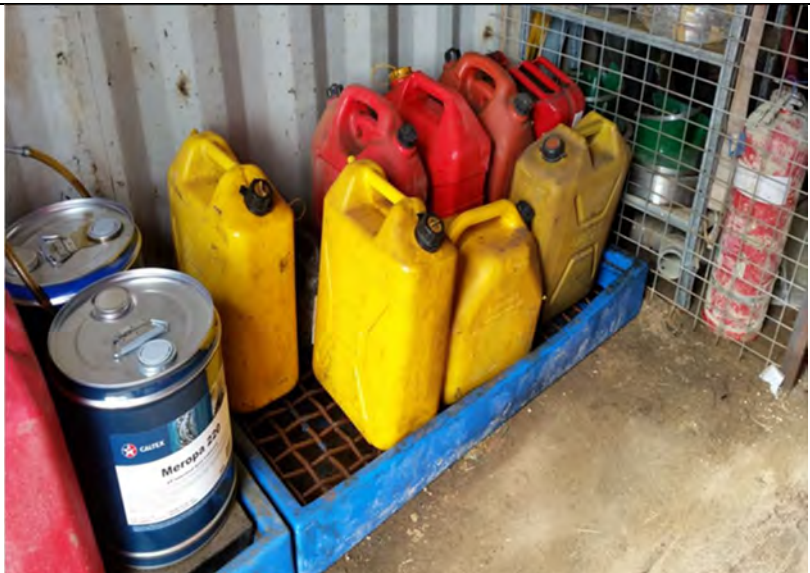
4	Chemical storage in site container

N/A	Nil – The various fuel containers and oil drums are stored in a bunded and ventilated area – Positive observation.	N/A
5	Summary	<p>Site is kept neat and tidy with all areas being well maintained with general site maintenance undertaken on a regular basis.</p> <p>All dam levels were well below spillways due to lack of rain and recent and continued hot weather.</p>
