BUTTAI QUARRY

ANNUAL ENVIRONMENTAL MANAGEMENT REPORT (AEMR)

2021

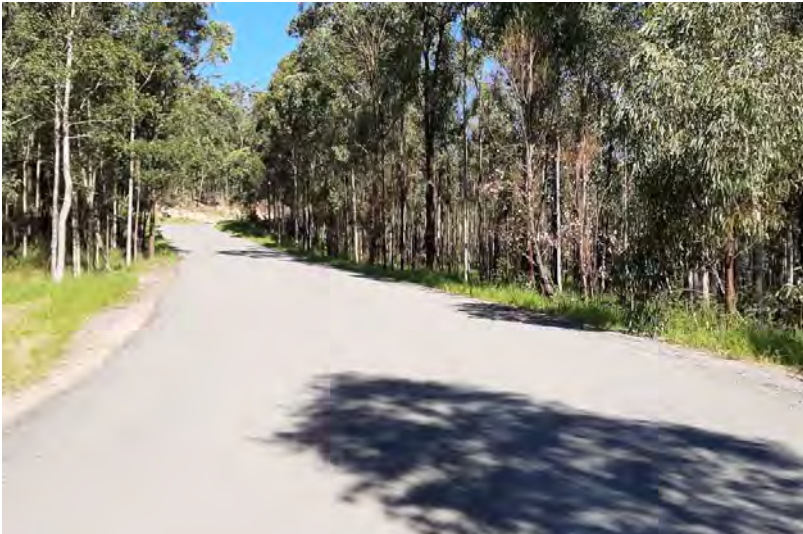
2	Old Buttai Road and quarry access road

N/A	<p>Nil – Appropriate signage and “call-up” points are present and visible along the access route. Additionally, the bitumen sealed sections of the access road are well maintained reducing the risk of erosion and dust generation. Large “trucks turning” signs installed at approach to the intersection with Old Buttai Rd - Positive observations.</p>	N/A
---	--	--	-----	---	-----

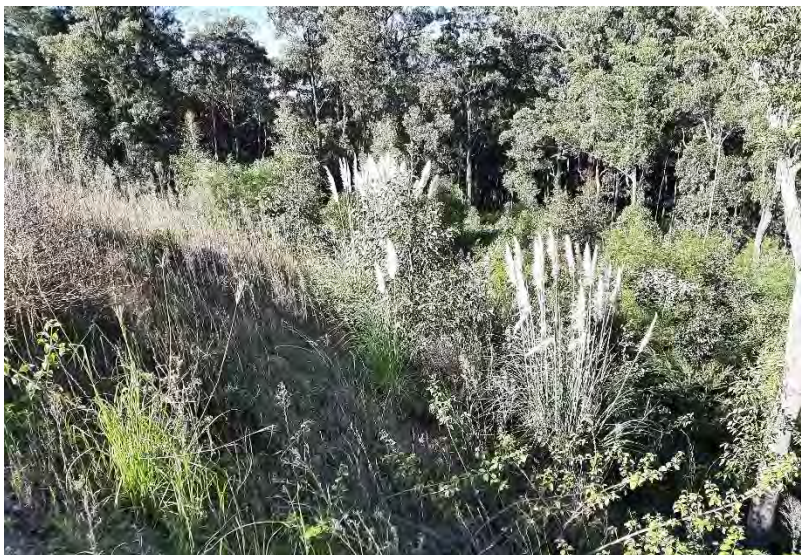
N/A	Nil – This previously disturbed area now has substantial vegetation cover with no further requirement for sedimentation controls - Positive observation.	N/A

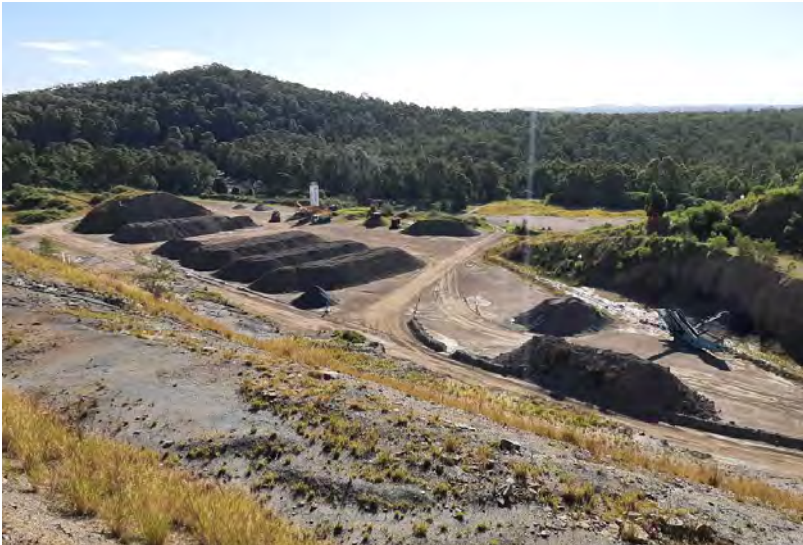
6	Stockpile and crushing areas

N/A	Nil – Both the stockpile and crushing areas were tidy with no evidence of dust generation at the time of inspection – Positive observations.	N/A
---	------------------------------	--	-----	--	-----

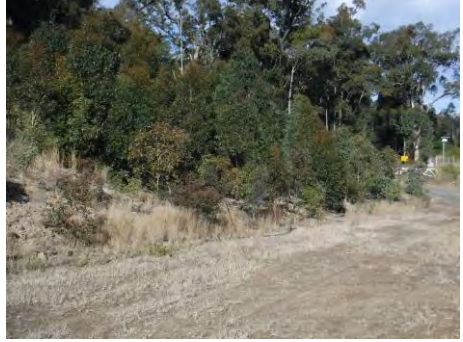
6.	Eastern bund.	The eastern bund rehabilitation area was inspected. The revegetation is healthy and well established.	The area remains stable and well vegetated, and no actions are required. As discussed, continue to schedule the area for periodic weed suppression.

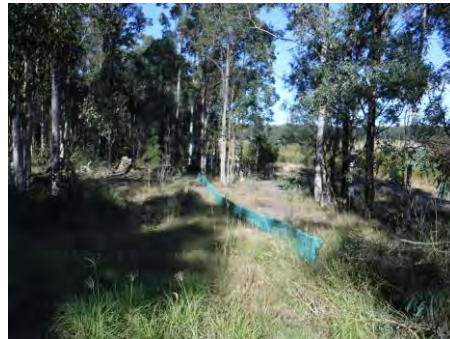
8.	Front entrance grate.	The area around the front entrance grate was inspected. The drainage line and outlet structures remain stable.	As discussed, the stands of sediment fence along the western boundary were installed some years ago for the batter reshaping for the road sealing. The catchment is now stabilised, and the sediment fences can be removed.

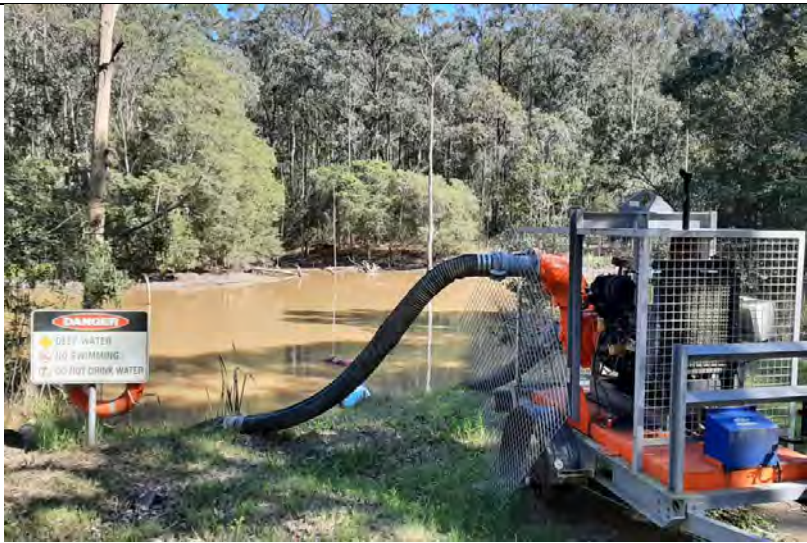
4	Dam #4

N/A	Nil – Dam #4 continues to be managed effectively to ensure water is available for the site to operate effectively whilst also ensuring that water does not discharge from Dam #4 by pumping back to other water storage areas on site when required – Positive observations.	N/A
---	--------	--	-----	--	-----

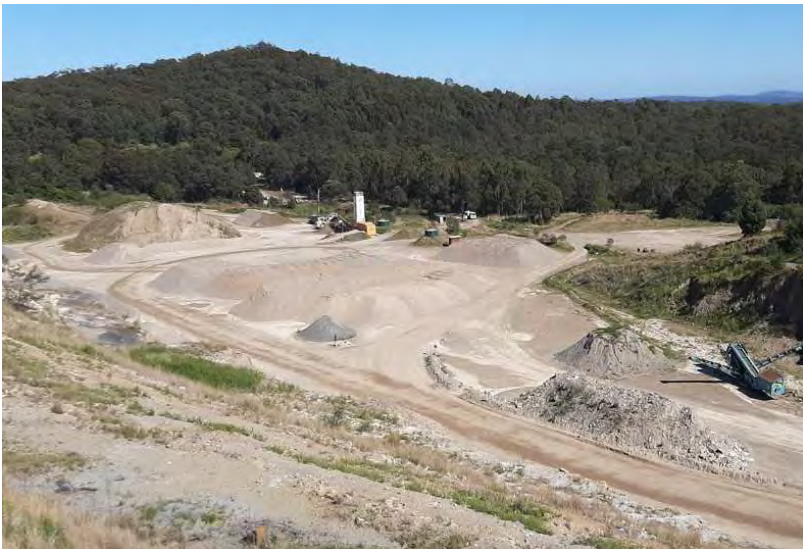
5	Stockpile and crushing areas

N/A	Nil – Both the stockpile and crushing areas were tidy with no evidence of dust generation at the time of inspection – Positive observations.	N/A
---	------------------------------	--	-----	--	-----

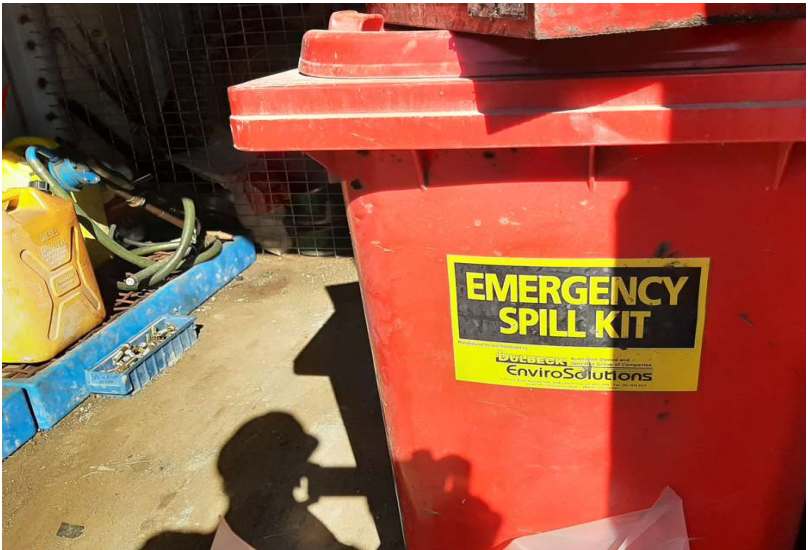
8	Chemical storage container

N/A	Nil – All relevant items were stored in a bunded area and were appropriately labelled. Spill kit was readily available – Positive observations.	N/A
---	----------------------------	--	-----	---	-----

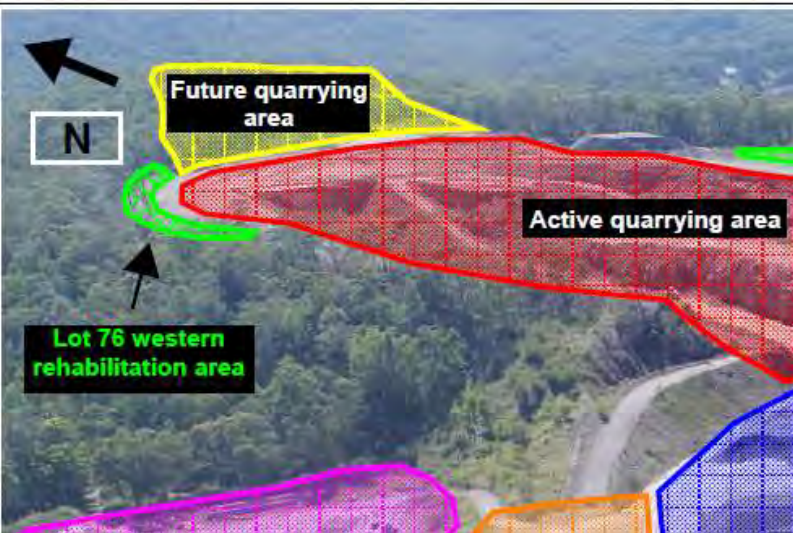
2	Rehab' area along western edge of the quarry pit "Lot 76" area

N/A	<p>Nil – As shown in the images, the western rehabilitation planting is progressing very well, with the naturally regenerated trees out growing the planted tube-stock. The annual rehabilitation inspection occurred at the same time as this inspection – Positive observation.</p>	N/A
---	---	--	-----	--	-----

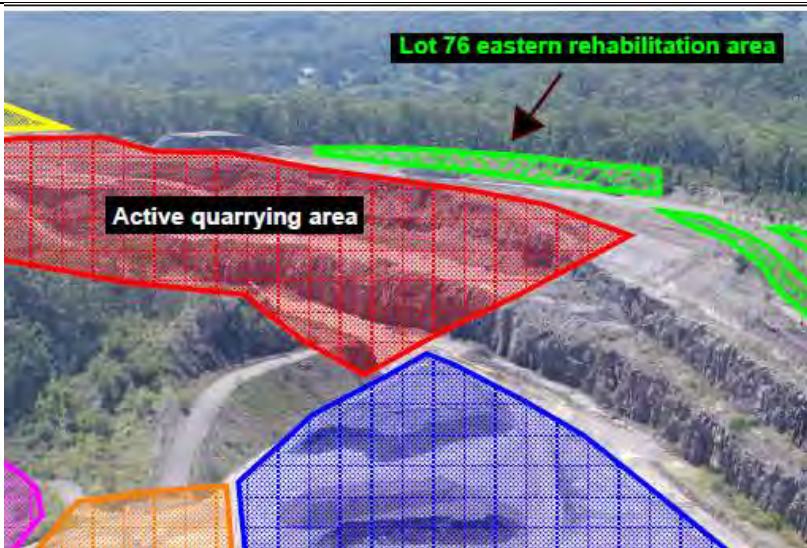
3	Recently re-shaped batter along eastern edge of the quarry pit "Lot 76" area

Medium	As previously described, the eastern batter was recently shaped and prepared for seeding. Seeding of the recently re-shaped eastern batter is required.	Completed 14/12/21 - LR
---	--	--	--------	---	-------------------------------

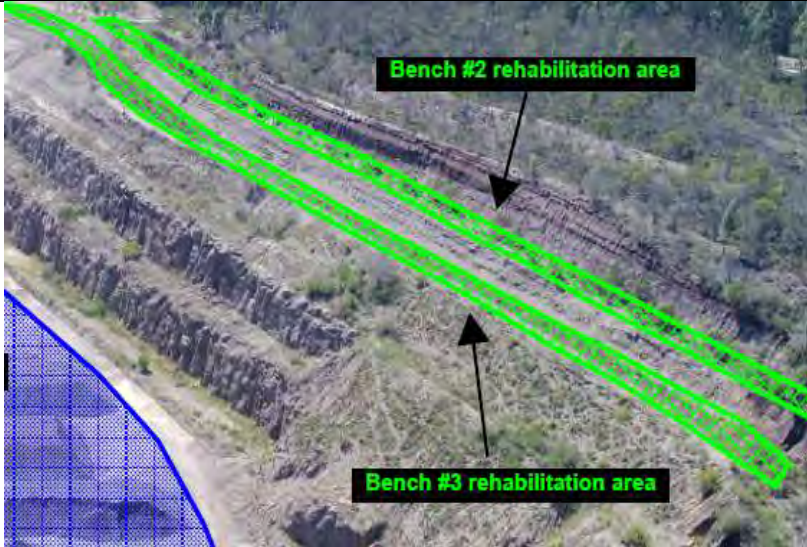
4	Bench #3 rehab' work

N/A	Nil –The Bench #3 rehab' planting is progressing adequately with the annual rehabilitation inspection occurring at the same time as this inspection – Positive observation.	N/A
---	----------------------	--	-----	---	-----
