BUTTAI QUARRY

ANNUAL ENVIRONMENTAL MANAGEMENT REPORT (AEMR)

2022

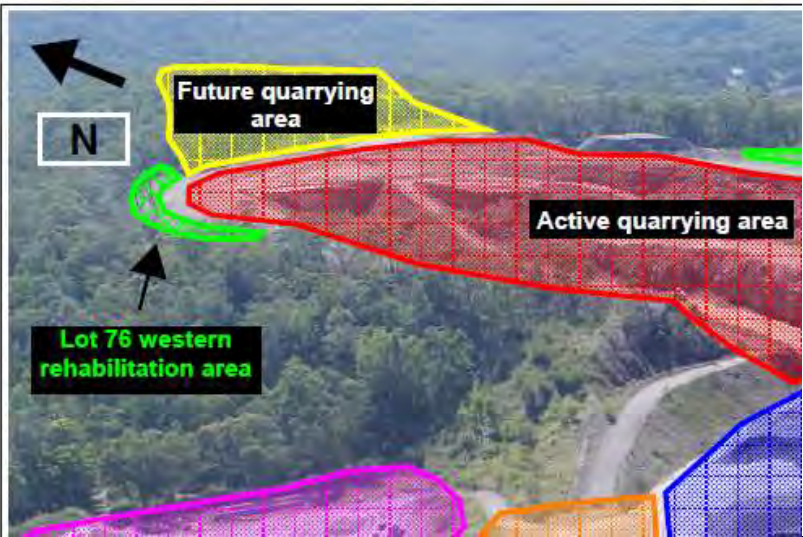
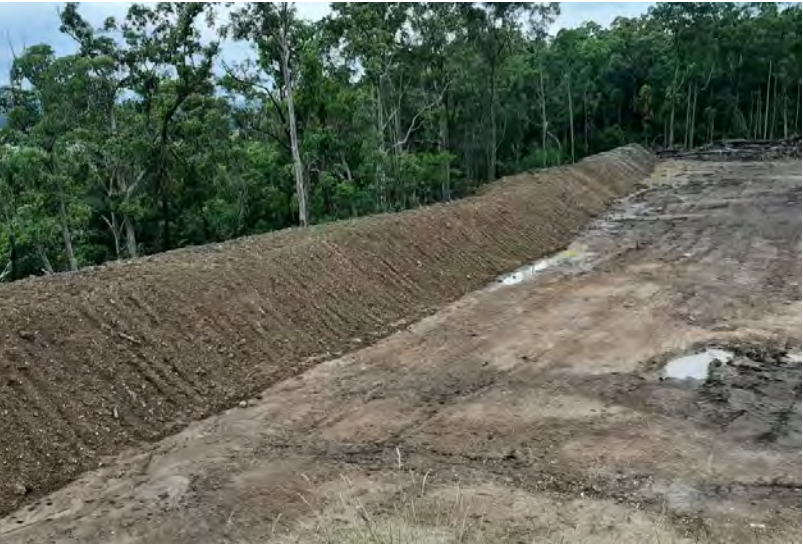
2	Rehab' area along western edge of the future quarrying area 'Lot 76'

<p>The aerial map shows a quarrying area with a yellow 'Future quarrying area' and a red 'Active quarrying area'. A green 'Lot 76 western rehabilitation area' is outlined. A north arrow points towards the top left. The ground-level photo shows a dirt bund with a line of trees in the background.</p>	N/A	<p>Nil – As shown in the images, the future quarrying area has progressed to the north and the bund has recently been shaped and seeded. All water is directed to the quarry Water Management System – Positive observations.</p>	N/A
---	--	--	-----	---	-----

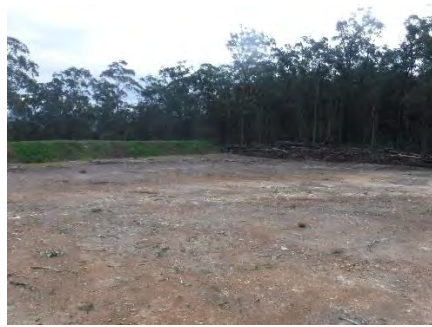
3.	Northern quarry development area.	The recent clearing undertaken for the northern quarry development area was inspected. Following vegetation removal, large earth berms have been formed on the eastern and western boundary, with a large timber windrow constructed along the northern boundary. Runoff from the exposed catchment is contained by the earthen berms and is filtered by the timber windrows.		The controls in the area remain functional and no actions were required.

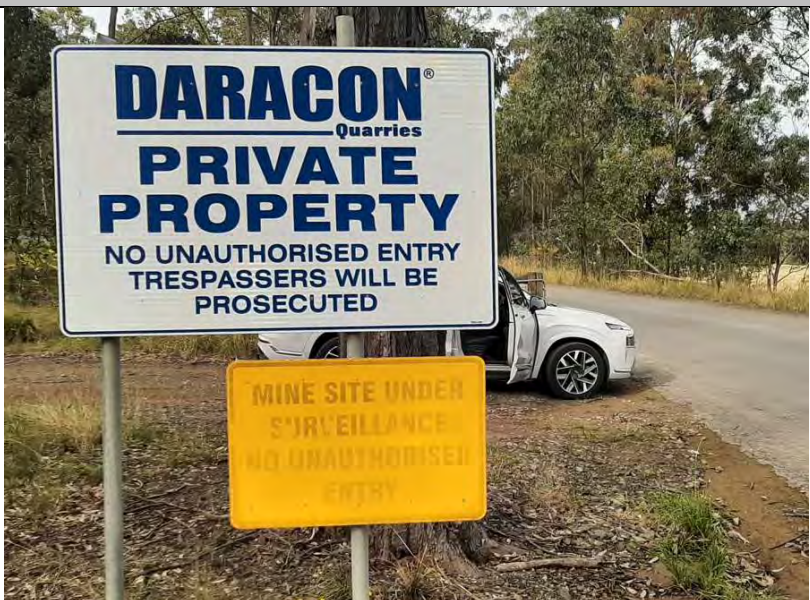
No.	Location (Area / description)	Issue / Comment	Recommended priority	Action	Close out date		
1	Buttai Quarry access

N/A	Nil – There was no evidence of dust generation on site during the inspection and appropriate signage installed at the main gate – Positive observations.	N/A

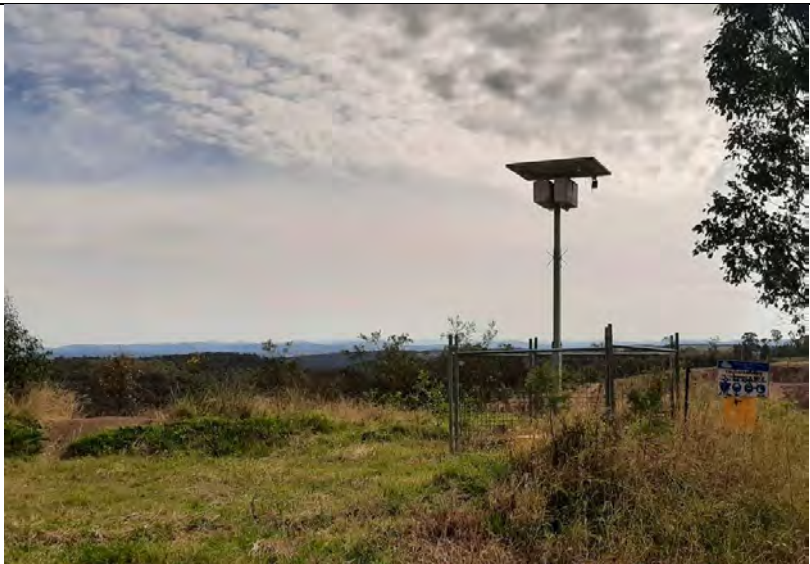
7	Site security

N/A	Nil – A number of remotely activated cameras are installed on site to mitigate unauthorised access – Positive observation.	N/A
8	Bench #3

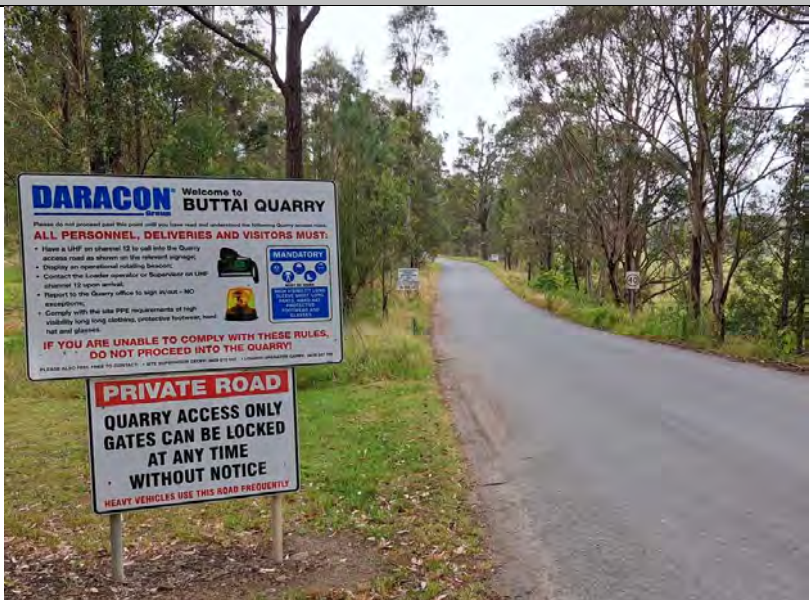
No.	Location (Area / description)	Issue / Comment	Recommended priority	Action	Close out date
1	Buttai Quarry access

N/A	Nil – There was appropriate signage installed at the main gate and no evidence of dust generation on site during the inspection – Positive observations.	N/A

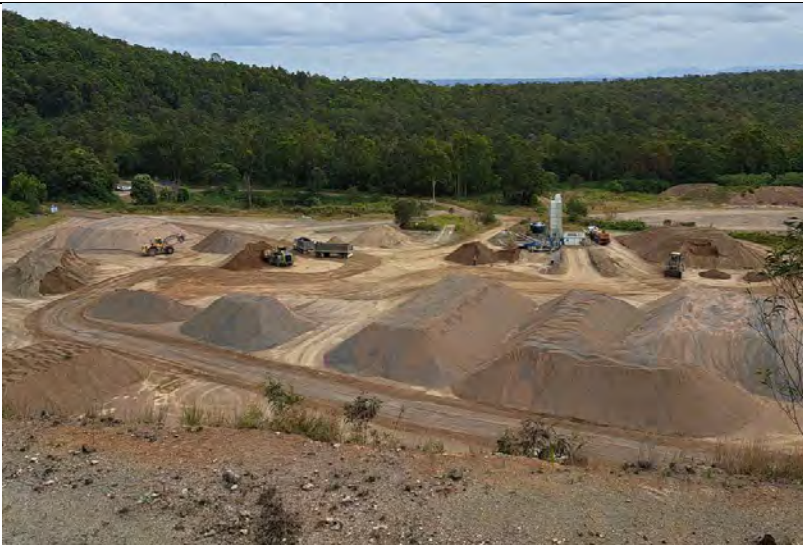
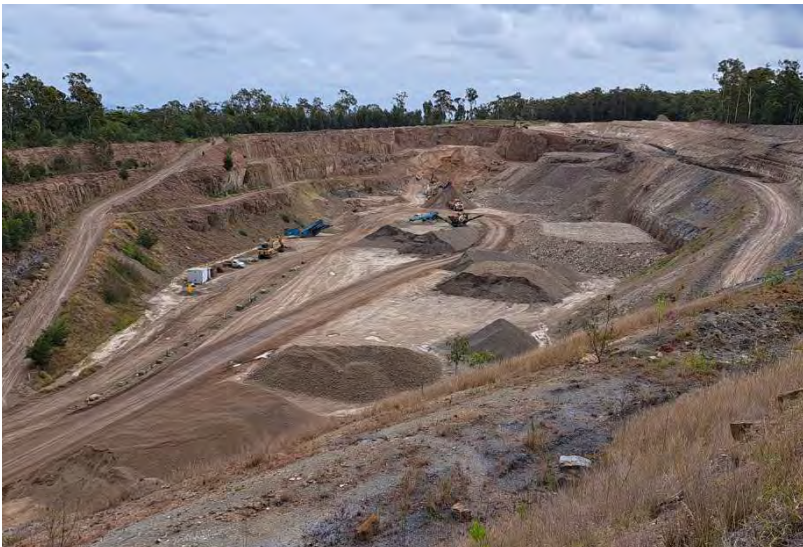
3	Active quarry and stockpile areas

N/A	Nil – There was no evidence of dust generation during the inspection due to active use of the watercart – Positive observations.	N/A
---	-----------------------------------	--	-----	--	-----

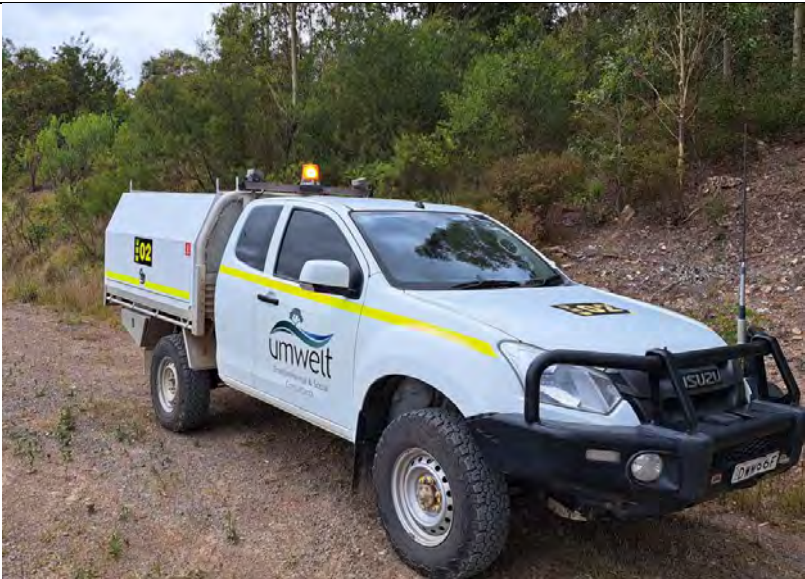
5	Annual rehab' inspection

N/A	Nil – An ecologist from Umwelt was undertaking the annual rehab' inspection on same day. All was in reasonable condition with a few minor recommendations to be provided shortly - Positive observation.	N/A
6	Site security

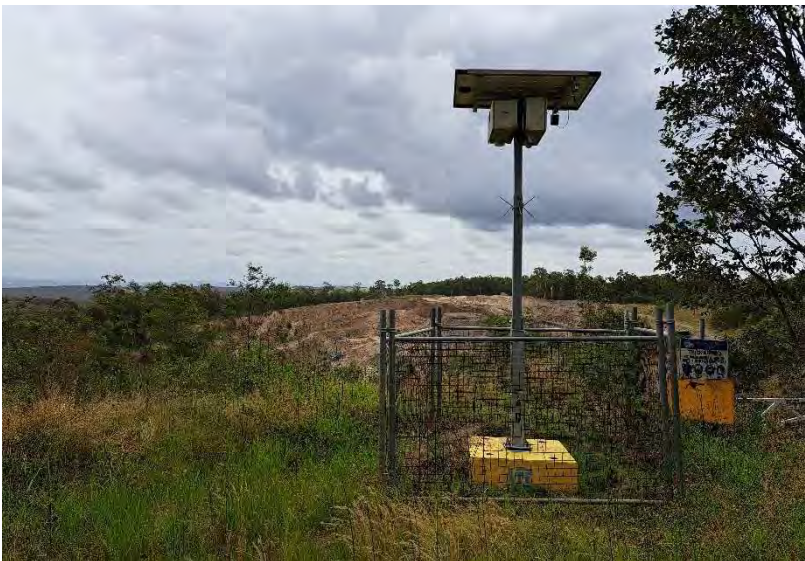
N/A	Nil – A number of remotely activated cameras are installed on site to mitigate unauthorised access – Positive observation.	N/A

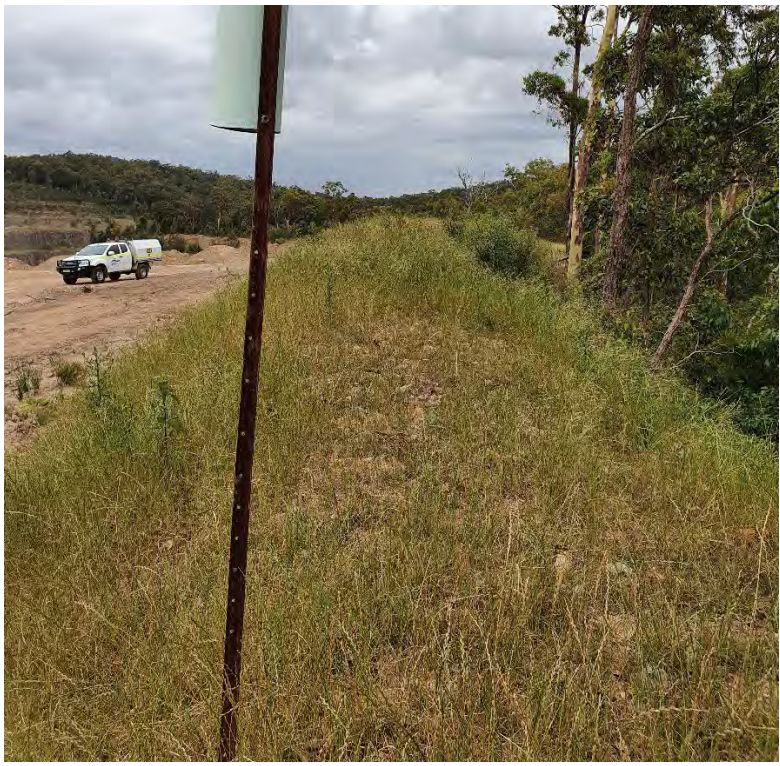
Table 2.2 Lot 76 Western Rehabilitation (North End)

Adjoining Native Vegetation?	Yes, to west	
Establishment date	2022	
Monitoring Point Co-ordinates	365271, 6365707	
High Threat Weeds Present	Nil	
Other Exotics	Sow thistle (<i>Sonchus oleracea</i>), <i>Conyza</i> sp., cobbler's pegs (<i>Bidens pilosa</i>), spear thistle (<i>Cirsium vulgare</i>).	
General Description	Recently shaped bund that forms an extension of Lot 76 Western Rehabilitation (Southern End) towards the north. Bund has been shaped and seeded with a native shrub and tree mix that includes a cover crop of perennial rye grass (<i>Lolium perenne</i>). Stripped topsoil has also been used over the bund.	
Canopy Description	Nil.	
Mid-storey/Shrub Layer Description	Height to 0.3m. <i>Acacia</i> spp. and <i>Pultenaea</i> spp. starting to emerge.	
Ground Cover Description	Height 0.1 – 0.5m. Dominated by the exotic species perennial rye grass (<i>Lolium perenne</i>), with some natives including paddock lovegrass (<i>Eragrostis leptostachya</i>), Indian weed (<i>Sigesbeckia orientalis</i>) and purple coral pea (<i>Hardenbergia violacea</i>).

Health and Condition	The rehabilitated bund is well vegetated with the rye grass cover crop. Soil is holding well, and no erosion was observed.	
Fauna Utilisation	Nil observed.	
Management Recommendations	Nil for this area. Continue to use stripped topsoil for rehabilitation in the future.

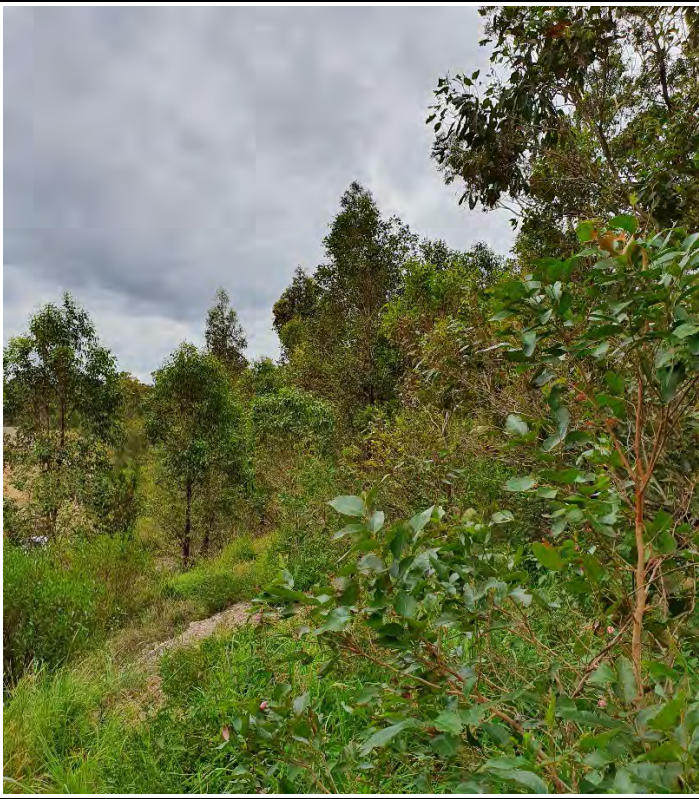
Table 2.3 Lot 76 Eastern Rehabilitation (South End)

Adjoining Native Vegetation?	Yes, to east	
Establishment date	Prior to 2017	
Monitoring Point Co-ordinates	365131, 6365262	
High Threat Weeds Present	Lantana (<i>Lantana camara</i>) encroaching from adjoining native vegetation, some pampas grass (<i>Cortaderia selloana</i>) at the northern end and golden wreath wattle (<i>Acacia saligna</i>) at southern end.	
Other Exotics	Fleabane (<i>Conyza</i> sp.), purpletop (<i>Verbena bonariensis</i>), cobbler's pegs (<i>Bidens pilosa</i>) and Paddy's Lucerne (<i>Sida rhombifolia</i>).	
General Description	Linear area of rehabilitated forest adjoining remnant vegetation at the eastern edge of the quarry. The southern half of the rehabilitated bund has a dense canopy, while the northern half has a more open canopy.	
Canopy Description	Height 2 – 7m. Canopy is mid-dense, dominated by grey gum (<i>Eucalyptus punctata</i>), spotted gum (<i>Corymbia maculata</i>) and red ironbark (<i>Eucalyptus fibrosa</i>).

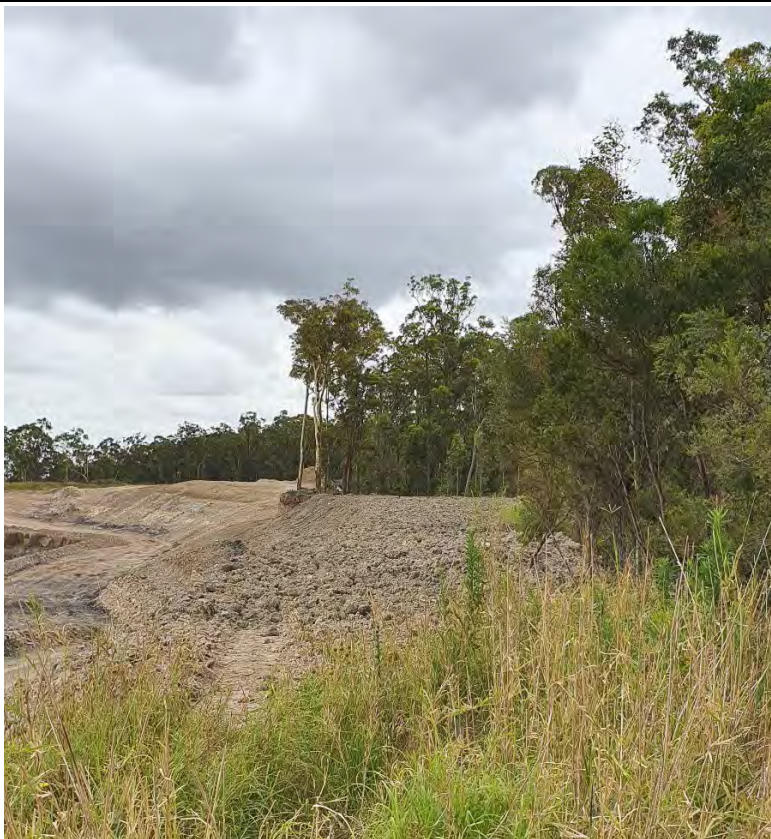
Table 2.4 Lot 76 Eastern Rehabilitation (North End)

Adjoining Native Vegetation?	Yes, to east	
Establishment date	2022	
Monitoring Point Co-ordinates	365254, 6365426	
High Threat Weeds Present	Nil	
Other Exotics	Nil	
General Description	Newly shaped bund that forms an extension of Lot 76 Eastern Rehabilitation (South End) to the north. This area is due for rehabilitation.	
Canopy Description	Nil	
Mid-storey/Shrub Layer Description	Nil	
Ground Cover Description	Nil	
Health and Condition	N/A – no vegetation as yet.	
Fauna Utilisation	Nil	
Management Recommendations	Recommend addition of stripped topsoil and seeding with native species as per other rehabilitated areas as soon as possible. If left bare for too long, it is likely that exotic species will colonise the area.

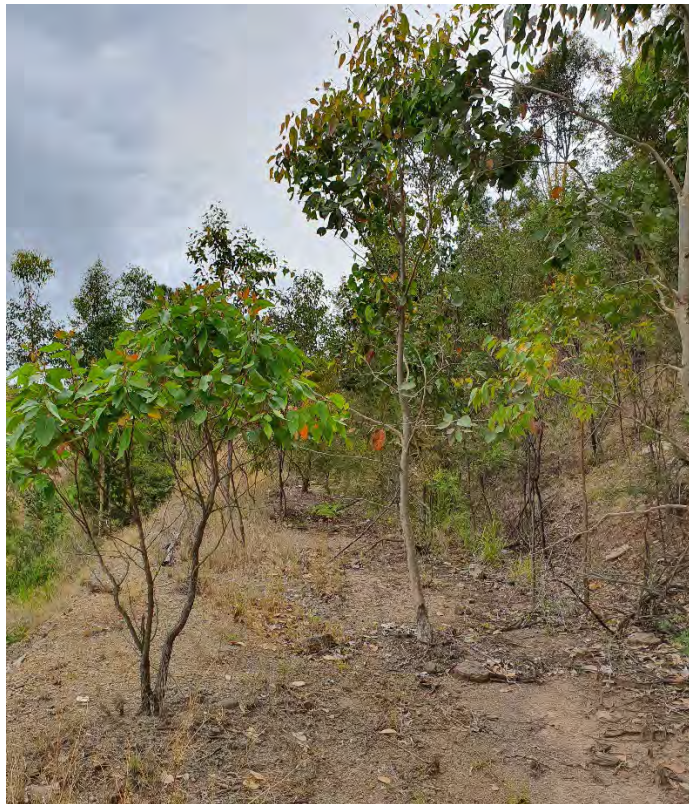
Table 2.5 Bench #2 (Upper Bench)

Adjoining Native Vegetation?	No direct adjoining vegetation.	
Establishment date	2013	
Monitoring Point Co-ordinates	364974, 6365205	
High Threat Weeds Present	Golden wreath wattle (<i>Acacia saligna</i>) towards the northern entrance to the bench, fireweed (<i>Senecio madagascariensis</i>).	
Other Exotics	Balloon cotton (<i>Gomphocarpus fruticosus</i>) red natal grass (<i>Melinis repens</i>) and purpletop (<i>Verbena bonariensis</i>).	
General Description	Strip of planted vegetation along upper bench of southern side of the quarry. Growth pattern is slightly patchy, with some sparse areas and others densely vegetated. Bench faces north-west and is very exposed, particularly to mid-afternoon sun.	
Canopy Description	Height 1 – 6m. Canopy is open and is dominated by grey gum (<i>Eucalyptus punctata</i>), spotted gum (<i>Corymbia maculata</i>), forest she-oak (<i>Allocasuarina torulosa</i>) and swamp mahogany (<i>Eucalyptus robusta</i>).

Mid-storey/Shrub Layer Description	Height 0.5 – 4m. Mid-storey is dominated by Acacias such as green wattle (<i>Acacia decurrens</i>), swamp wattle (<i>Acacia elongata</i>) and sickle wattle (<i>Acacia falcata</i>). Large-leaf bush pea (<i>Pultenaea daphnoides</i>) and spiny bush-pea (<i>Pultenaea spinosa</i>) are emerging from the seed bank.	
Ground Cover Description	Height 0.1 – 1m. Ground cover is sparse, comprising exotic species such as lamb's tongues (<i>Plantago lanceolata</i>), Rhodes grass (<i>Chloris gayana</i>) and natives such as two-colour panic (<i>Panicum simile</i>). The ground cover becomes extremely sparse towards the southern end of the bench where exposure is greatest.	
Health and Condition	Canopy exhibiting signs of active growth. Some Eucalypts with mistletoes, and a high proportion of the canopy and mid-storey species are flowering and fruiting. Ground texture is extremely rocky, and it is possible that the soil profile may be hindering the growth of the rehabilitation. There is a large and prominent erosion rill at the far west end of the bench, however this is a known issue and is being stabilised by <i>Acacia</i> species.

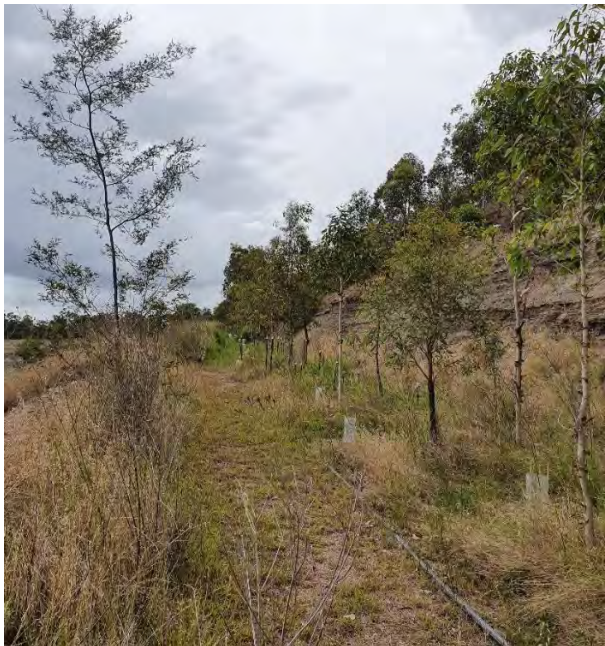
Table 2.6 Bench #3 (Lower Bench)

Adjoining Native Vegetation?	No direct adjoining vegetation.	
Establishment date	2015 (additional plantings in 2016, 2018, 2020 and 2022).	
Monitoring Point Co-ordinates	364935, 6365195	
High Threat Weeds Present	Golden wreath wattle (<i>Acacia saligna</i>) towards the northern entrance to the bench, fireweed (<i>Senecio madagascariensis</i>).	
Other Exotics	Balloon cotton (<i>Gomphocarpus fruticosus</i>), red natal grass (<i>Melinis repens</i>), Paddy's lucerne (<i>Sida rhombifolia</i>), Conyza sp. and purpletop (<i>Verbena bonariensis</i>).	
General Description	Strip of planted vegetation along upper bench of southern side of the quarry. Growth pattern is quite patchy. Bench faces north-west and is very exposed, particularly to mid-afternoon sun. Supplementary plantings of mulched tubestock made in 2022 have had an 87% success rate.

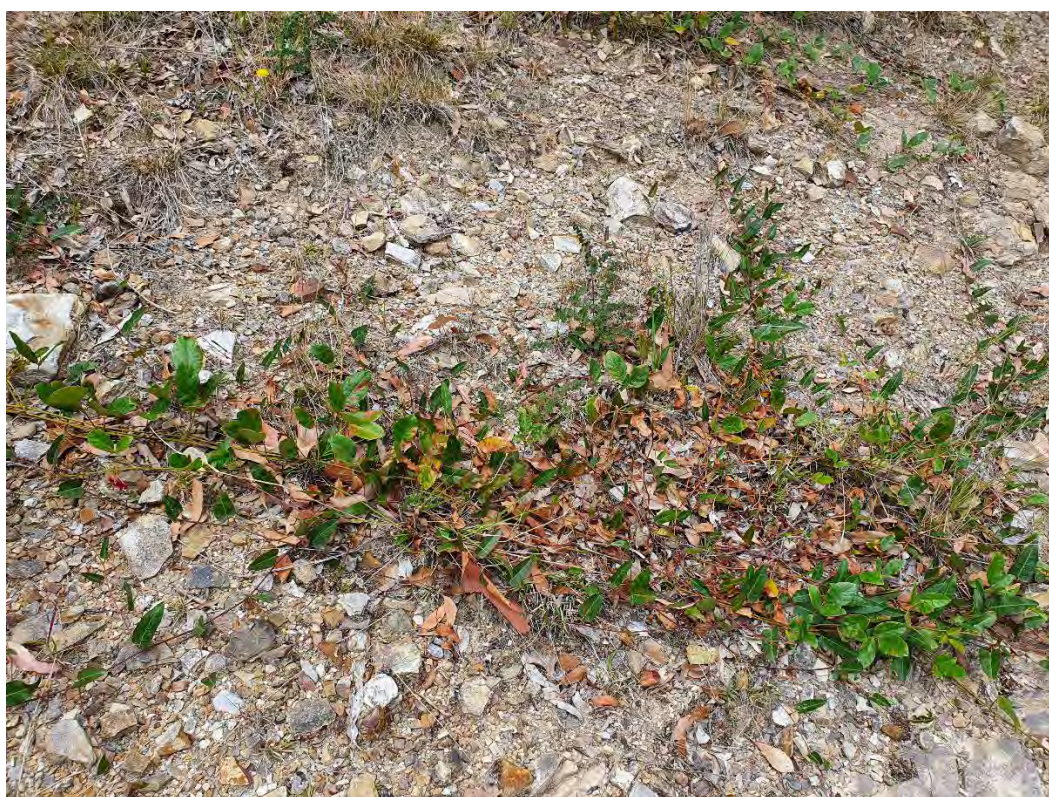
The planting of native scrambling plants to cover the exposed rocky slope is a potential mitigation measure for this issue, however the success of this strategy cannot be predicted. There are existing plants on this site that have been observed colonising rocky slopes (see **Photo 3.2** for example), such as purple coral pea (*Hardenbergia violacea*), dusky coral pea (*Kennedia rubicunda*) and variable glycine (*Glycine tabacina*), however these were observed on slopes that had more shade and protected than that found at Bench #3. It is unknown how these plants would fare in the proposed location. If this mitigation measure is chosen, planting the tubestock with mulch and/or topsoil will increase chances of survival.

Photo 3.2 *Hardenbergia violacea*, *Kennedia rubicunda* and *Glycine tabacina* colonising rocky slope at Lot 76 Eastern Rehabilitation (South End)
