BUTTAI FACILITY

ANNUAL ENVIRONMENTAL MANAGEMENT REPORT (AEMR)

2023

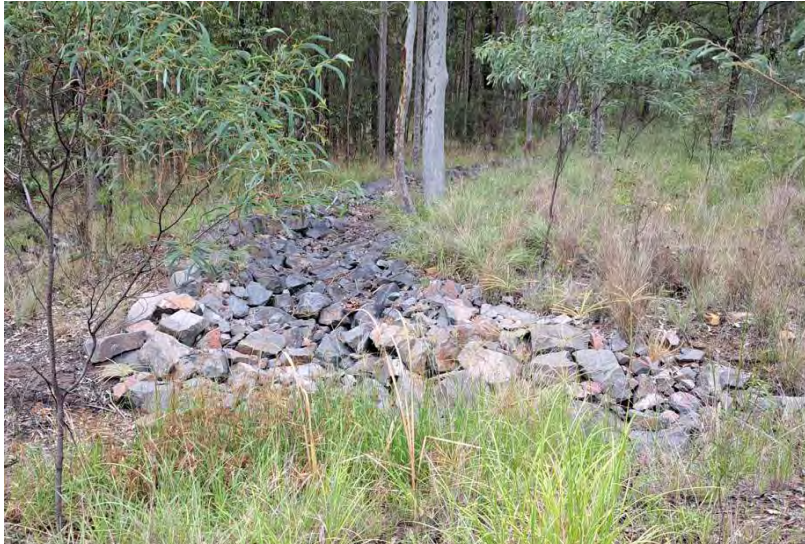
N/A	Nil – The rock lined drain was functional and operating as expected – Positive observation.	N/A

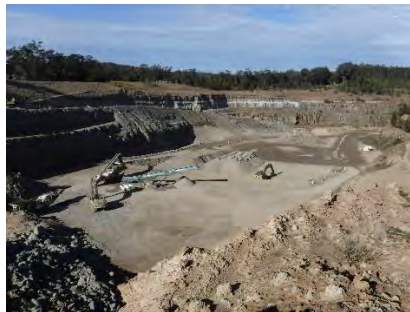
3.	Air quality – general.	The main quarry workings have extended north, with additional access ramps formed around the void. Two processing areas have been established and regular dust suppression is being undertaken in the various work areas.		At the time of the inspection, air quality was visibly good within the quarry workings and the adjacent areas. As discussed, continue to implement effective dust mitigation measures.

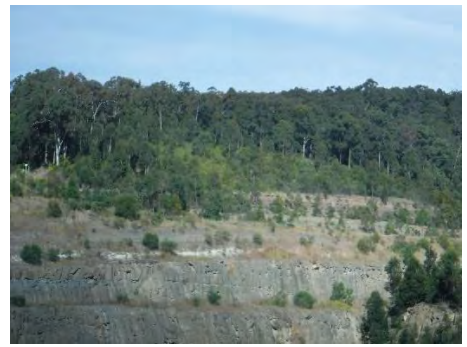
6.	Bench 2 and Bench 3 rehabilitation areas.	At the time of the inspection, the access ramp to the Bench 2 and Bench 3 rehabilitation area was in the process of being realigned. Access to the area was not readily available. Site controllers indicated that the rehabilitation area continues to be managed with periodic weed suppression and regular maintenance inspections.	Based on a distant view of the area, it appears that the vegetation is establishing well, and no significant issues are anticipated beyond continued weed suppression.

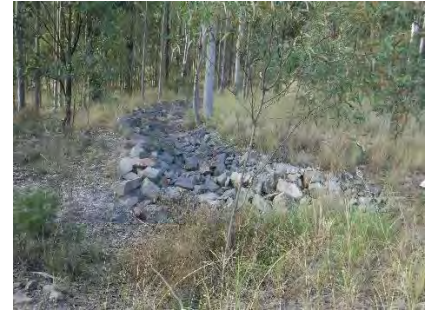
8.	Drainage lines and culvert - front gate.	The area around the pipe culvert at the front gate was inspected. The drainage lines remain stable, and the downslope sump continues to remain stable with spill flows continuing to discharge via a vegetated spillway.	The controls in the area remain functional and no actions were required.

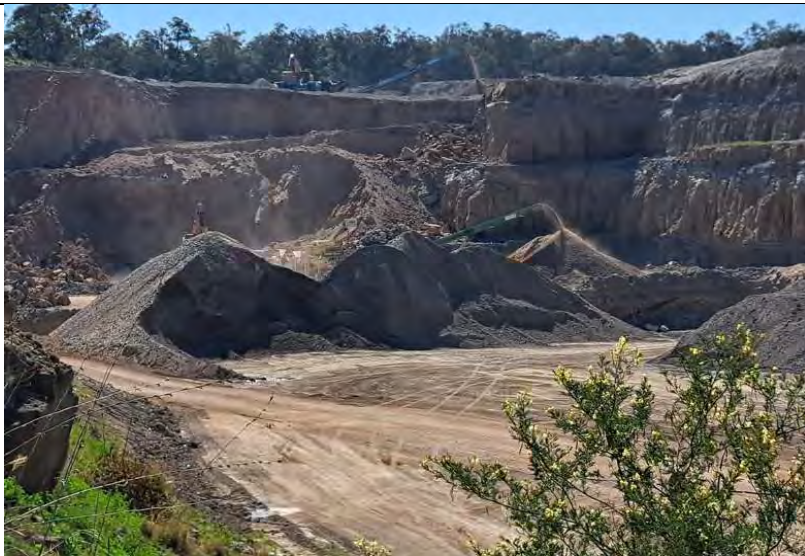
3	Active quarry and stockpile areas

Medium	Watercart was actively being used to control dust on site but the dust suppression on the crusher was not functioning correctly at the time of inspection.	The dust suppression on the crusher was resolved on the 18/09/23
---	-----------------------------------	--	--------	--	--

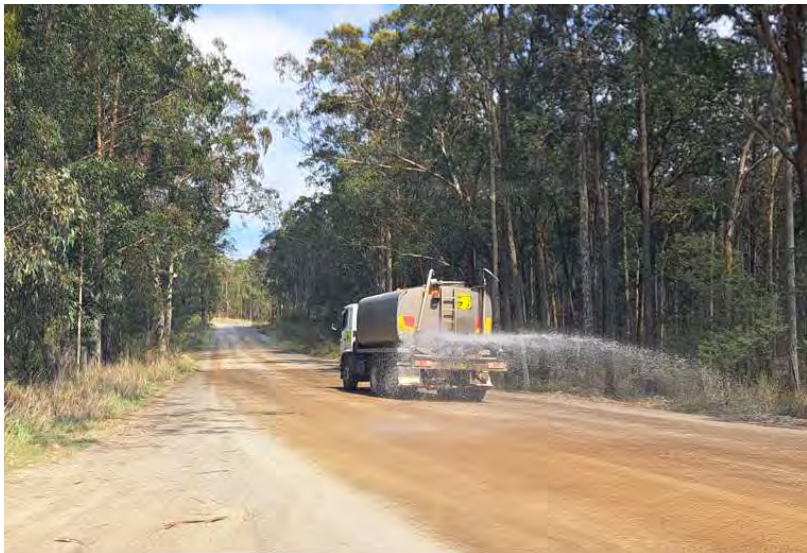
2	Dust control on site

N/A	<p>Nil – At the time of the inspection, there were two watercarts operating due to the extremely low quantity of site water available from the site dams. No evidence of dust generation – Positive observations.</p>	N/A
---	----------------------	--	-----	---	-----

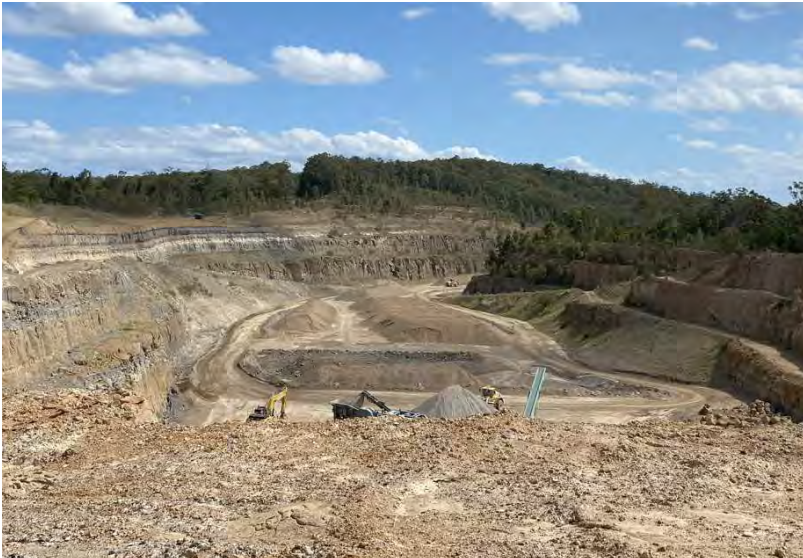
3	Active quarry and stockpile areas

N/A	Nil – No issues were identified within the active quarry face and stockpile areas of the site – Positive observations.	N/A
---	-----------------------------------	--	-----	--	-----

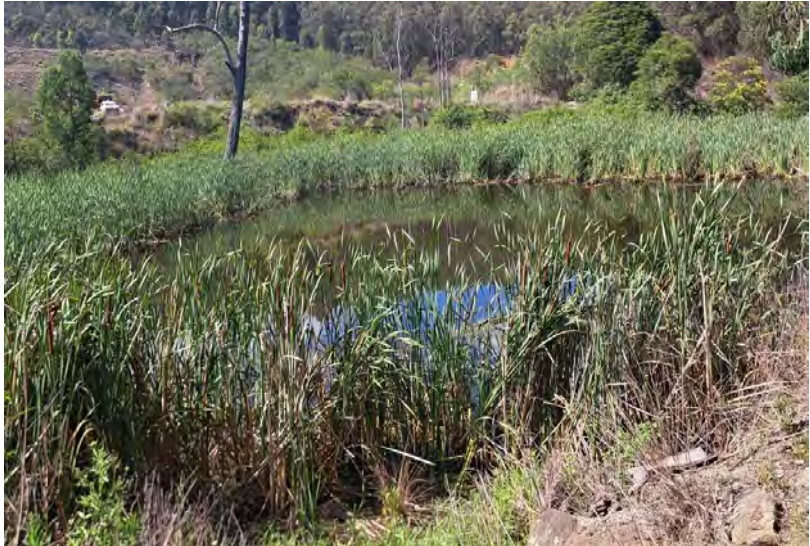
N/A	Nil - At the time of inspection, Dam 2 was holding a small quantity of water that is being used for the pugmilling operations – Positive observation.	N/A

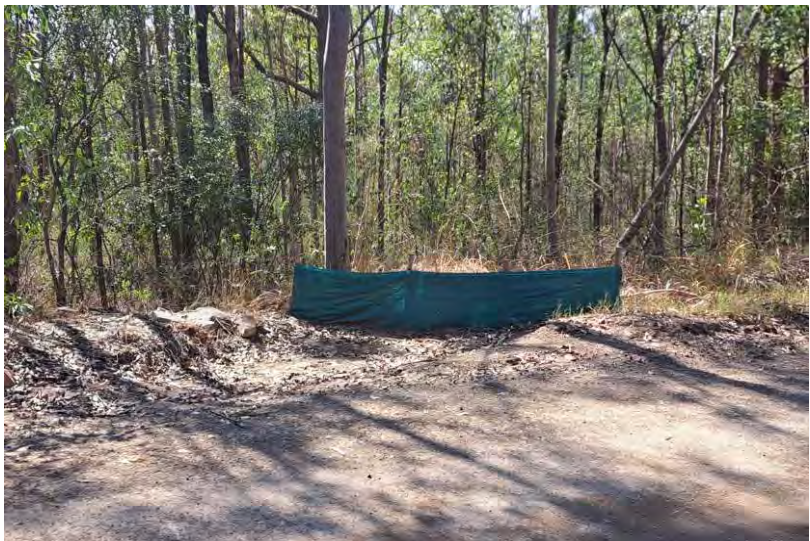
N/A	Nil – The silt fences along the access road were serviceable and operating effectively – Positive observations.	N/A

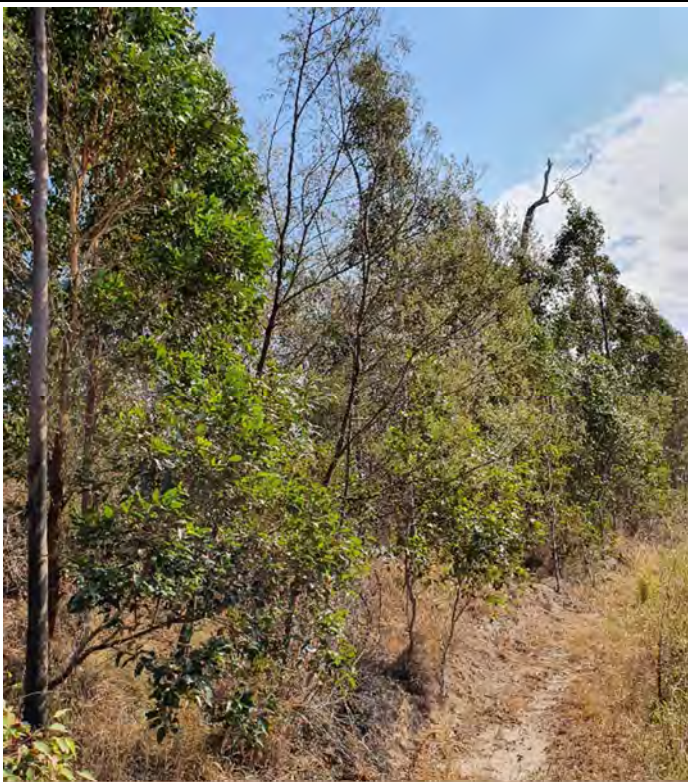
Table 2.1 Lot 76 Western Rehabilitation (South End)

Adjoining Native Vegetation?	Yes, to west	
Establishment Date	2017	
Monitoring Point Co-ordinates	365151, 6365644	
High Threat Weeds Present	Nil	
Other Exotics	Purpletop (<i>Verbena bonariensis</i>), Rhodes grass (<i>Chloris gayana</i>).	
General Description	Linear area of rehabilitated forest that occurs between access road at the top of quarry, and remnant vegetation. Quarrying is planned to continue to the north-east of this area and the bund has been extended to the north (see following table). This area has regenerated from stripped topsoil and displays high native diversity.	
Canopy Description	Height 1.5 – 8m. Canopy was dense prior to 2021, however since this time is now becoming thinner, dominated by spotted gum (<i>Corymbia maculata</i>), with occurrences of grey gum (<i>Eucalyptus punctata</i>), smooth-barked apple (<i>Angophora costata</i>), narrow-leaved ironbark (<i>Eucalyptus crebra</i>) and red ironbark (<i>Eucalyptus fibrosa</i>).

Mid-storey/Shrub Layer Description	Height 0.5 – 3m. Mid-storey/shrub was dominated with Acacias such as green wattle (<i>Acacia decurrens</i>), silver-stemmed wattle (<i>Acacia parvipinnula</i>) and sickle wattle (<i>Acacia falcata</i>) in previous years however there has been increased dieback of these species. They do remain present, albeit in lower abundances or cover. Spiny bush-pea (<i>Pultenaea spinosa</i>) is also dying off however gorse bitter pea (<i>Daviesia ulicifolia</i>) is colonising the lower shrub layer.	
Ground Cover Description	Height 0.1 – 1.5m. Previously dominated by exotic grasses such as Rhodes grass (<i>Chloris gayana</i>), however these are dying off and are being replaced by the native wiry panic (<i>Entolasia stricta</i>). The only leguminous species observed was purple coral pea (<i>Hardenbergia violacea</i>).	
Health and Condition	This area is in moderate health. As observed in 2022, <i>Acacia</i> dieback is accelerating; however this is to be expected after the five-year mark since the rehabilitated area was established as <i>Acacia</i> species generally have a short lifespan. A large amount of <i>Acacia</i> seed was seen on the ground and this will facilitate the growth of the next generation of <i>Acacias</i> . A number of spotted gums had fallen over, and died back, likely a result of overcrowding (which is a natural self-thinning process). Evidence of fruiting, recruitment and new growth for both mid-storey and canopy species is also present, though there is dieback. No

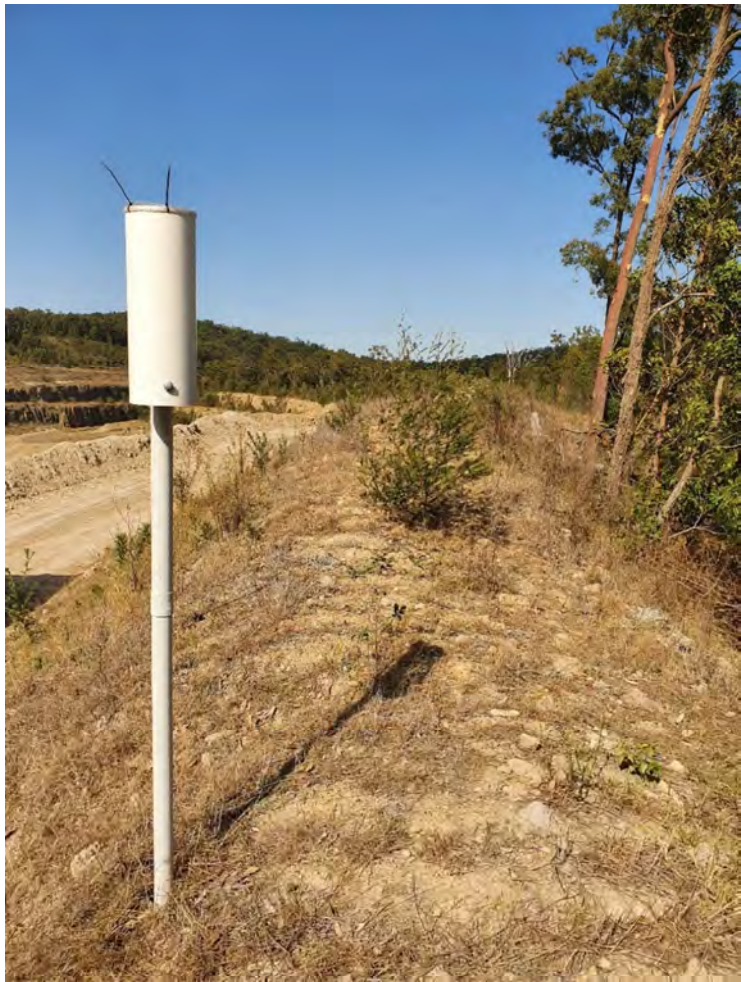
Table 2.2 Lot 76 Western Rehabilitation (North End)

Adjoining Native Vegetation?	Yes, to west	
Establishment date	2022	
Monitoring Point Co-ordinates	365271, 6365707	
High Threat Weeds Present	Tobacco plant (<i>Solanum mauritianum</i>).	
Other Exotics	Sow thistle (<i>Sonchus oleracea</i>), perennial rye grass (<i>Lolium perenne</i>), <i>Conyza</i> sp., spear thistle (<i>Cirsium vulgare</i>), <i>Senecio pterophorus</i> pigeon grass (<i>Setaria sphacelata</i>), Kikuyu (<i>Cenchrus clandestinus</i>), white clover (<i>Trifolium repens</i>) and proliferous pink (<i>Petrorhagia nanteuilii</i>).	
General Description	Bund that forms an extension of Lot 76 Western Rehabilitation (Southern End) towards the north. Bund has been shaped and seeded with a native shrub and tree mix that includes a cover crop of perennial rye grass (<i>Lolium perenne</i>). Stripped topsoil has also been used over the bund.

Canopy Description	Nil.	
Mid-storey/Shrub Layer Description	Height 0.3m – 1.4m. Green wattle (<i>Acacia decurrens</i>), and sickle wattle (<i>Acacia falcata</i>) starting to emerge. Some juvenile Eucalypts emerging.	
Ground Cover Description	Height 0.1 – 0.5m. Dominated by exotic species such as pigeon grass (<i>Setaria sphacelata</i>), Kikuyu (<i>Cenchrus clandestinus</i>), white clover (<i>Trifolium repens</i>) and proliferous pink (<i>Petrorhagia nanteuilii</i>). Native species include cut-leaf daisy (<i>Brachyscome multifida</i>) and kidney weed (<i>Dichondra repens</i>).	
Health and Condition	This area is very dry. There is evidence that the bund was well colonised by grasses at a previous point in time, but these have died back and the bund is now colonised by hardier, more undesirable exotic species. The vegetation is healthier in swales where moisture is retained, however there are large patches of bare ground.

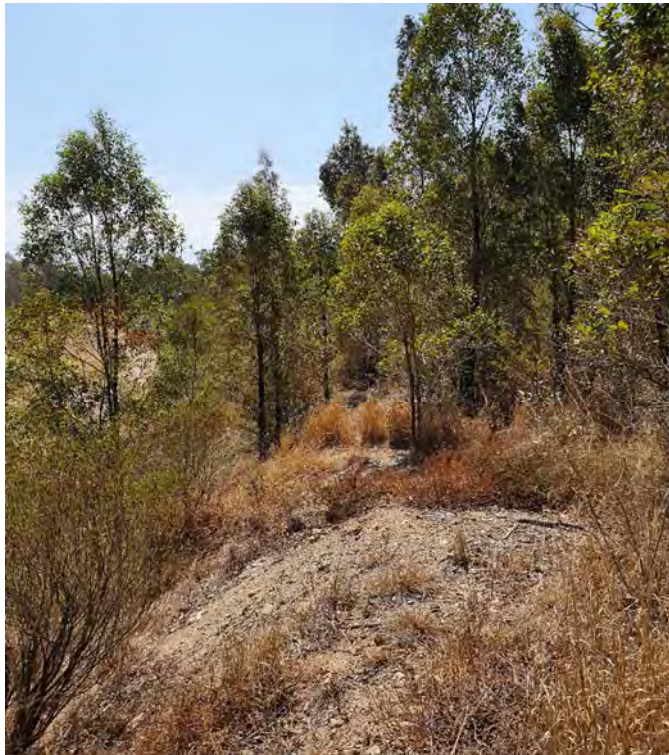
Table 2.3 Lot 76 Eastern Rehabilitation (South End)

Adjoining Native Vegetation?	Yes, to east	
Establishment date	Prior to 2017	
Monitoring Point Co-ordinates	365131, 6365262	
High Threat Weeds Present	Lantana (<i>Lantana camara</i>) and pampas grass (<i>Cortaderia selloana</i>) – though control appears to have been successful.	
Other Exotics	Purpletop (<i>Verbena bonariensis</i>), Rhodes grass (<i>Chloris gayana</i>).	
General Description	Linear area of rehabilitated forest adjoining remnant vegetation at the eastern edge of the quarry. The southern half of the rehabilitated bund has a dense canopy, while the northern half has a more open canopy.	
Canopy Description	Height 1.3 – 7m. Canopy is healthy, dominated by grey gum (<i>Eucalyptus punctata</i>), spotted gum (<i>Corymbia maculata</i>) and red ironbark (<i>Eucalyptus fibrosa</i>).	
Mid-storey/Shrub Layer Description	Height 0.5 – 2.5m. Mid-storey is dominated with Acacias such as green wattle (<i>Acacia decurrens</i>), silver-stemmed wattle (<i>Acacia parvipinnula</i>) and sickle wattle (<i>Acacia falcata</i>), though some are dying back. The native rosella (<i>Hibiscus heterophyllus</i>) observed in 2022 is no longer present. Spiny bush-pea (<i>Pultenaea spinosa</i>) and gorse bitter pea (<i>Daviesia ulicifolia</i>) are colonising the lower shrub layer.

Ground Cover Description	Height 0.1 – 1m. Ground cover has largely died back and is very dry. Persistent species include Rhodes grass (<i>Chloris gayana</i>) and fishweed (<i>Einadia trigonos</i>). The only leguminous species observed this year was purple coral pea (<i>Hardenbergia violacea</i>).	
Health and Condition	The canopy in this area is in good health, though there has been significant dieback in the mid and ground layers, likely due to the dry conditions. There are patches of bare ground, and some cracking of the soil. It is likely that this area will recover after a period of rain. No substantial erosion was recorded in the area.	
Fauna Utilisation	An array of small woodland birds were seen and heard in the area, along with macropod scats. Large ant nests were recorded, and these will promote bioturbation of the soil.	
Management Recommendations	Follow-up high threat weed control if necessary.

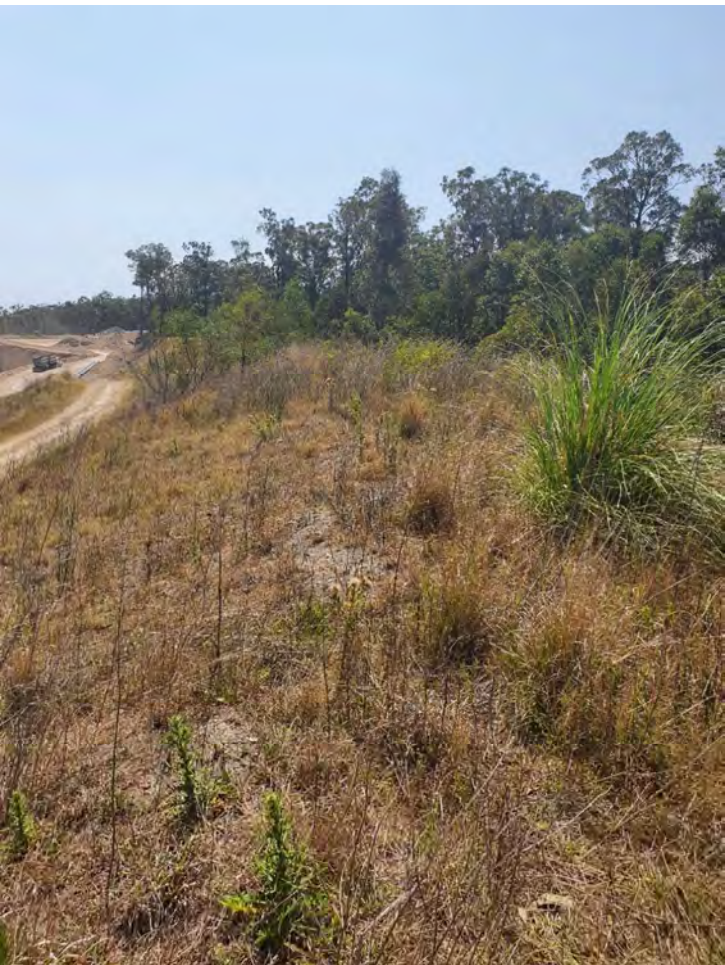
Table 2.4 Lot 76 Eastern Rehabilitation (North End)

Site Name	Lot 76 Eastern Rehabilitation (North End)	
Form	Linear strip on bund

Adjoining Native Vegetation?	Yes, to east	
Establishment date	2022	
Monitoring Point Co-ordinates	365254, 6365426	
High Threat Weeds Present	Lantana (<i>Lantana camara</i>), golden wreath wattle (<i>Acacia saligna</i>), pampas grass (<i>Cortaderia selloana</i>).	
Other Exotics	Sow thistle (<i>Sonchus oleraceus</i>), veined verbena (<i>Verbena rigida</i>), proliferous pink (<i>Petrorhagia nanteuilii</i>), cats ear (<i>Hypochaeris radicata</i>), kikuyu (<i>Cenchrus clandestinus</i>), purpletop (<i>Verbena bonariensis</i>) and balloon cotton (<i>Gomphocarpus fruticosus</i>).	
General Description	Newly shaped bund that forms an extension of Lot 76 Eastern Rehabilitation (South End) to the north. This area has been sowed with native topsoil. It has been largely colonised by exotics and grasses with some native mid-storey species emerging.

Canopy Description	Nil	
Mid-storey/Shrub Layer Description	Height 0.5 – 2.5m Minor occurrence of green wattle (<i>Acacia decurrens</i>). Some <i>Acacia saligna</i> which requires control.	
Ground Cover Description	Height 0.1 – 1m Grasses such as kikuyu (<i>Cenchrus clandestinus</i>) and couch (<i>Cynodon dactylon</i>) dominate, with co-occurrence of exotics such as purpletop (<i>Verbena bonariensis</i>) and balloon cotton (<i>Gomphocarpus fruticosus</i>). Some instances as native forbs such as star cudweed (<i>Euchiton involucratus</i>) and Indian weed (<i>Sigesbeckia orientalis</i>).	
Health and Condition	Vegetation is somewhat dry, though the ground has been well colonised. Native diversity is very low at this site.	
Fauna Utilisation	Multiple brown quail (<i>Coturnix ypsilophora</i>) were observed in the ground layer.	
Management Recommendations	Tubestock plantings may be recommended if canopy species do not emerge by next monitoring event.

- The bund at Lot 76 Eastern Rehabilitation (North End) should be monitored closely to ensure that canopy and mid-storey species emerge, as this site currently has very low native diversity and is dominated by exotic species. Tubestock planting may be recommended if native diversity does not improve.

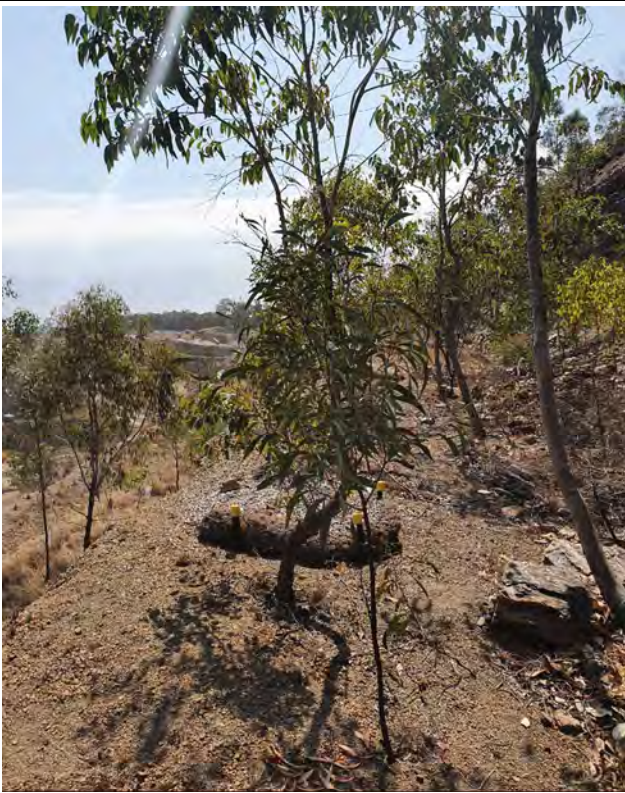
Table 2.5 Bench #2 (Upper Bench)

Site Name	Bench #2 (Upper Bench)	
Form	Linear strip along bench

Adjoining Native Vegetation?	No direct adjoining vegetation.	
Establishment date	2013, additional plantings in 2023	
Monitoring Point Co-ordinates	364974, 6365205	
High Threat Weeds Present	Golden wreath wattle (<i>Acacia saligna</i>) towards the northern entrance to the bench	
Other Exotics	Nil	
General Description	Strip of planted vegetation along upper bench of southern side of the quarry. Growth pattern is slightly patchy, with some sparse areas and others densely vegetated. Bench faces north-west and is very exposed, particularly to mid-afternoon sun.	
Canopy Description	Height 1 – 6m. Canopy is open and is dominated by grey gum (<i>Eucalyptus punctata</i>), spotted gum (<i>Corymbia maculata</i>), forest she-oak (<i>Allocasuarina torulosa</i>) and swamp mahogany (<i>Eucalyptus robusta</i>), which was fruiting profusely at the time of survey.

Mid-storey/Shrub Layer Description	Height 0.3 – 3m. Mid-storey is dominated by emerging Acacias such as green wattle (<i>Acacia decurrens</i>), swamp wattle (<i>Acacia elongata</i>) and sickle wattle (<i>Acacia falcata</i>). Forest she-oak (<i>Allocasuarina torulosa</i>) was emerging from the seedbank, though the two <i>Pultenaea</i> species from 2022 had died back.	
Ground Cover Description	Height 0.1 – 1m. There was little living ground cover on this bench. “Top down” plantings of dusky coral pea (<i>Kennedia rubicunda</i>) and purple coral pea (<i>Hardenbergia violacea</i>) had been planted in April 2023, and were in poor condition at the time of monitoring – grazing and exposure have contributed to dieback of these species. There was evidence that the bench had previously been colonised in parts by Rhodes grass (<i>Chloris gayana</i>) however this was all senescent at the time of monitoring due to the dry conditions.

Health and Condition	Established plantings are showing signs of active growth with a high proportion of the canopy and mid-storey species are flowering and fruiting. There has been dieback in the ground layer due to hot and dry conditions. There is a large and prominent erosion rill at the far west end of the bench, however this is a known issue and is being stabilised by <i>Acacia</i> species.	
Fauna Utilisation	Macropod scats present. Grazing evident, bandicoot diggings and woodland birds observed.	
Management Recommendations	Follow-up weed control of <i>Acacia saligna</i> is recommended. If surplus stripped topsoil is available, it would be worthwhile spreading on some of the sparser areas along Bench #2 to promote growth. Mulch may be another alternative to help retain moisture and build a soil profile.

- Mulch may be spread on Bench #3 and/or Bench #2 to help build the soil profile and retain soil moisture.
- Seeding or tubestock planting of sticky hop-bush (*Dodonaea viscosa* subsp. *cuneata*) on Bench #3 may help with screening and visual amenity.

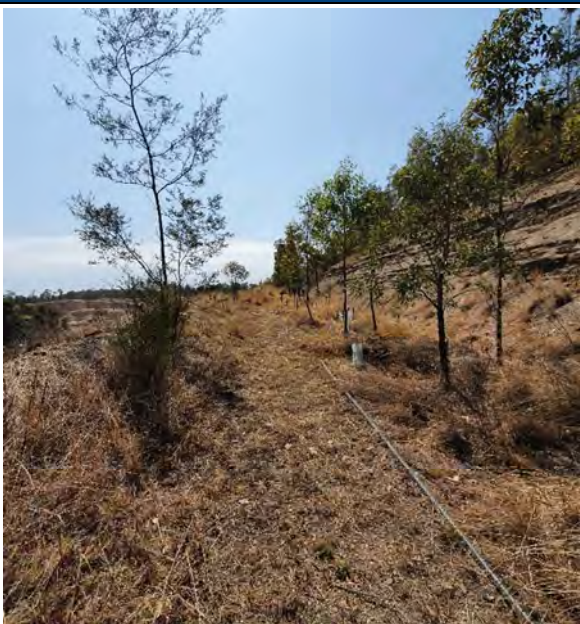
Table 2.6 Bench #3 (Lower Bench)

Site Name	Bench #3 (Lower Bench)	
Form	Linear strip along bench

Adjoining Native Vegetation?	No direct adjoining vegetation.	
Establishment date	2015 (additional plantings in 2016, 2018, 2020 and 2022).	
Monitoring Point Co-ordinates	364935, 6365195	
High Threat Weeds Present	Golden wreath wattle (<i>Acacia saligna</i>) towards the northern entrance to the bench.	
Other Exotics	Rhodes grass (<i>Chloris gayana</i>).	
General Description	Strip of planted vegetation along upper bench of southern side of the quarry. Growth pattern is quite patchy. Bench faces north-west and is very exposed, particularly to mid-afternoon sun. Supplementary plantings have been made across many years with variable success rates due to the aspect.	
Canopy Description	Height 1 – 5m. Open canopy is dominated by grey gum (<i>Eucalyptus punctata</i>), spotted gum (<i>Corymbia maculata</i>), narrow-leaved ironbark (<i>Eucalyptus crebra</i>) and rough-barked apple (<i>Angophora floribunda</i>). Some dieback observed. Mistletoe (<i>Amyema</i> sp.) present.

Mid-storey/Shrub Layer Description	Height 1 – 3m. Sparse mid-storey dominated with Acacias such as green wattle (<i>Acacia decurrens</i>) and sickle wattle (<i>Acacia falcata</i>), with some hickory wattle (<i>Acacia implexa</i>). A high number of species were producing seed.	
Ground Cover Description	Height 0.1 – 1m. Ground cover is very sparse and experiencing dieback, with a variety of both native and exotic species. These include Rhodes grass (<i>Chloris gayana</i>), kidney weed (<i>Dichondra repens</i>), couch (<i>Cynodon dactylon</i>), though little has persisted in the dry conditions.	
Health and Condition	The canopy continues to exhibit some noticeable gaps, though established plantings are doing well. Plantings in these gaps have been moderately successful, though growth has been slow given the exposed western aspect of the bench. Older plantings are doing well, however some of the newer tubestock have been browsed by grazing mammals. Some mistletoes are present in Eucalypt species, and most canopy species were showing signs of active growth. Ground cover is in poor condition due to the dry conditions.

Fauna Utilisation	Superb fairy wrens (<i>Malurus cyaneus</i>) were observed in the area, macropod scats recorded.	
Management Recommendations	Continue to monitor the success of plantings. Weed control of <i>Acacia saligna</i> is recommended. Tubestock planting or seeding of sticky hop bush (<i>Dodonaea viscosa</i> subsp. <i>cuneata</i>) is an alternate suggestion to “top down” plantings above this bench to aid in screening the bench wall for visual amenity. Sticky hop bush is a locally abundant native shrub (to 4m height) that thrives in full sun and poor soils that may assist with the screening issue. This plant is a pioneer species and may provide some protection from the exposed aspect to assist the growth of other species on this bench.
